CITY OF SOUTH SAN FRANCISCO

AMERICANS WITH DISABILITIES ACT self evaluation and transition plan

APPENDICES

Appendix D: Pedestrian Rights-of-Way Reports and Maps

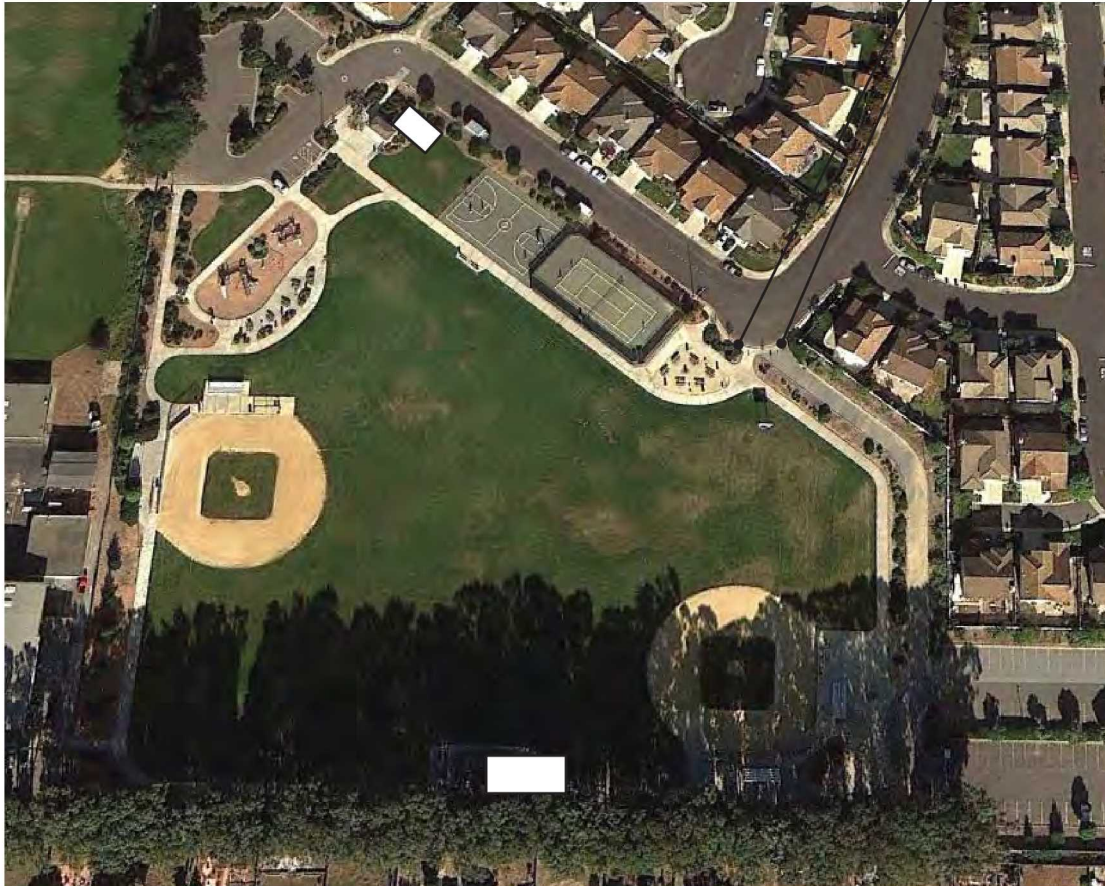
Alta Loma Park

4 - 1	Walk	Priority: 1	
Regrade surface			\$2,000
Notes: 2.1%-3.4% cross slope for 50 lf. (2% max.)			
State: 1133B.7.1.3			
Federal: 403.3			
4 - 2	Walk	Priority: 1	
Regrade surface			\$800
Notes: 9% cross slope across drive for 20 lf. (2% max.)			
State: 1133B.7.1.3			
Federal: 403.3

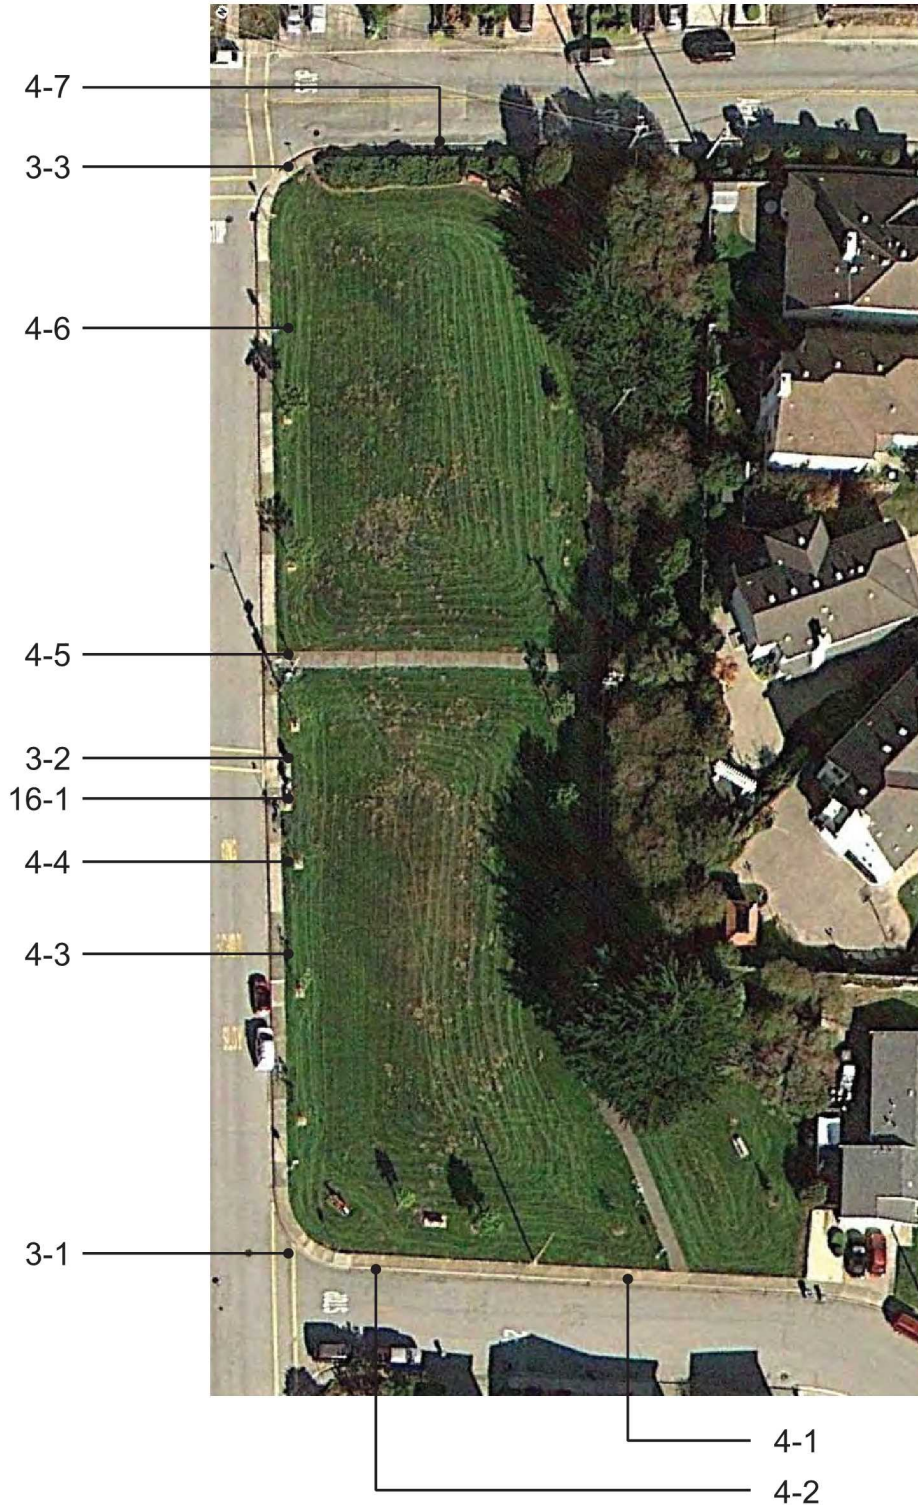
Avalon Memorial Lots

3 - 1 Curb Ramp		Priority: 1
Provide detectable warning strip		\$0
Notes: No detectable warning provided.		
State: 1127B.5.7, IR11B-4		
Federal: -		
Install, replace or modify curb ramp		\$2,500
Notes: Flared sides have slopes 11.3% and 14.1%. (10% max.)		
State: 1127B.5.3, 1127B.5.4		
Federal: 406.3		
Provide level landing		\$0
Notes: 14.7% gutter slope, no level landing provided at bottom of ramp. (5% max.) Combined slope is less than 13%.		
State: 1127B.5.3		
Federal: 406.2		
Repair surface		\$0
Notes: .5" lip at bottom of ramp.		
State: 1127B.5.3		
Federal: 405.4		
3 - 2 Curb Ramp		Priority: 1
Provide detectable warning strip		\$0
Notes: No detectable warning provided.		
State: 1127B.5.7, IR11B-4		
Federal: -		
Install, replace or modify curb ramp		\$2,500
Notes: Flared sides have slopes 11.7% and 12%. (10% max.)		
State: 1127B.5.3, 1127B.5.4		
Federal: 406.3		
Provide level landing		\$0
Notes: 9.7% gutter slope, no level landing provided at bottom of ramp. (5% max.)

State: 1127B.5.3, 1127B.5.4		
Federal: 406.2		
Repair surface		\$0
Notes: .5" lip at bottom of ramp.		
State: 1127B.5.3		
Federal: 405.4

3 - 3	Curb Ramp	Priority: 1	
	Provide detectable warning strip		\$0
	Notes: No detectable warning provided.		
	State: 1127B.5.7, IR11B-4		
	Federal: -		
	Install, replace or modify curb ramp		\$2,500
	Notes: Flared sides have slopes 14.2% and 23%. (10% max.)		
	State: 1127B.5.3, 1127B.5.4		
	Federal: 406.3		
4 - 1	Walk	Priority: 1	
	Regrade surface		\$1,200
	Notes: 2.1%-2.8% cross slope for 30 lf. (2% max.)		
	State: 1133B.7.1.3		
	Federal: 403.3		
4 - 2	Walk	Priority: 1	
	Regrade surface		\$1,200
	Notes: 2.1%-2.8% cross slope for 30 lf. (2% max.)		
	State: 1133B.7.1.3		
	Federal: 403.3		
4 - 3	Walk	Priority: 1	
	Repair surface		\$250
	Notes: Deteriorated concrete surface.		
	State: 1124B.2		
	Federal: 303.2, 303.3		
	Regrade surface		\$1,000
	Notes: Combined running slope of 14% at concrete slice.		
	State: 1133B.7.3		
	Federal: 403.3		
4 - 4	Walk	Priority: 1	
	Repair surface		\$250
	Notes: .75" gap at cracked concrete flag.

State: 1124B.2		
	Federal: 303.2, 303.3

4 - 5	Walk	Priority: 1	
Regrade surface			\$480
Notes: 2.1%-2.8% cross slope for 12 lf. at pathway (2% max.)			
State: 1133B.7.1.3			
Federal: 403.3			
4 - 6	Walk	Priority: 1	
Regrade surface			\$3,400
Notes: 2.1%-3.2% cross slope for 85 lf. (2% max.)			
State: 1133B.7.1.3			
Federal: 403.3			
4 - 7	Walk	Priority: 1	
Widen walk			\$150
Notes: Overgrown vegetation. Path of travel down to 30" for 90 lf. Maintenance needed.			
State: 1133B.7.1			
Federal: -			
16 - 1	Built-in Elements	Priority: 3	
Increase or provide maneuvering or clear floor area			\$150
Notes: No companion seating provided at bus stop bench, relocate trash can.			
State: -			
Federal: 903.2

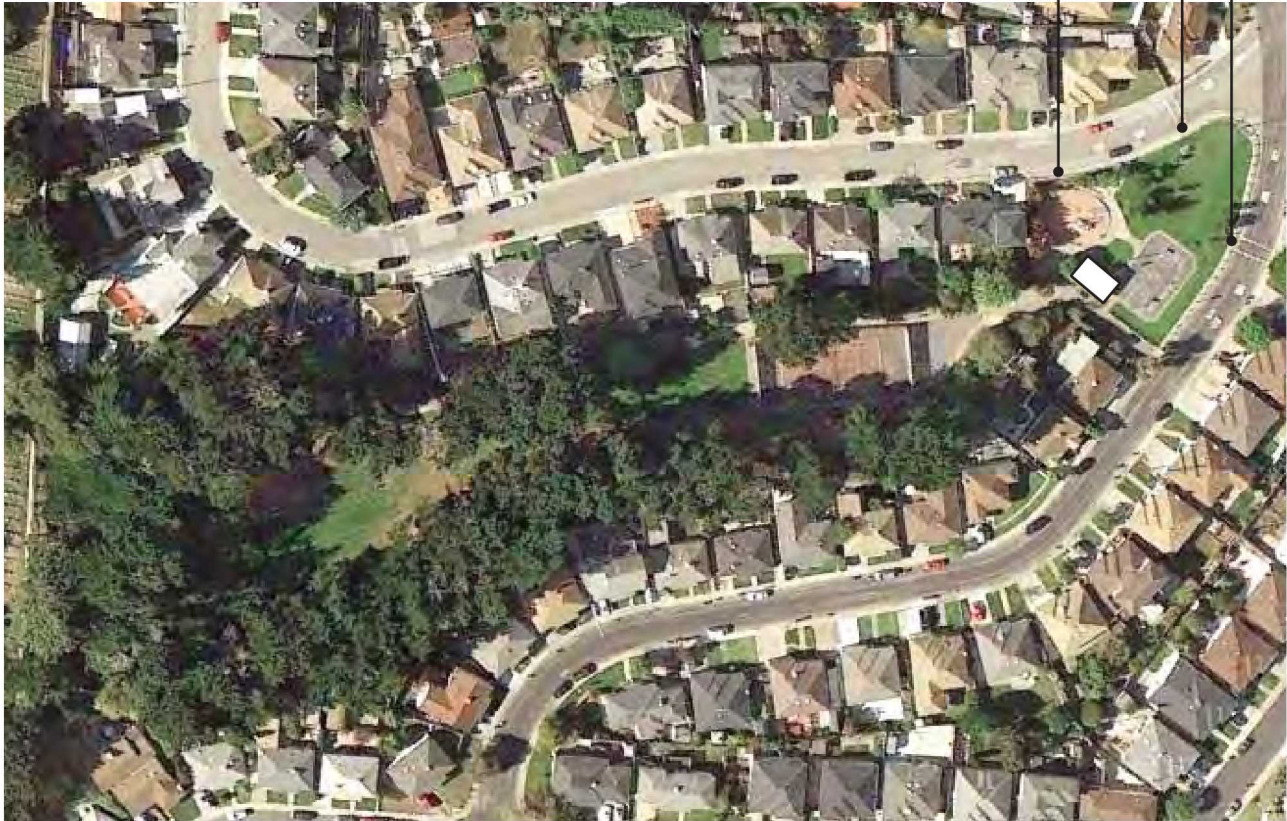
Brentwood Park

3 - 1	Curb Ramp	Priority: 1	
Provide or relocate crossing or curb markings			\$2,500
Notes: No curb ramp provided at marked pedestrian crossing.			
State: 1127B.5			
Federal: 406.1			
3 - 2	Curb Ramp	Priority: 1	
Provide or relocate crossing or curb markings			\$2,500
Notes: No curb ramp provided at marked pedestrian crossing.			
State: 1127B.5			
Federal: 406.1			
4 - 1	Walk	Priority: 1	
Regrade surface			\$1,200
Notes: 2.1%-4.1% cross slope for 30 lf. (2% max.)			
State: 1133B.7.1.3			
Federal: 403.3

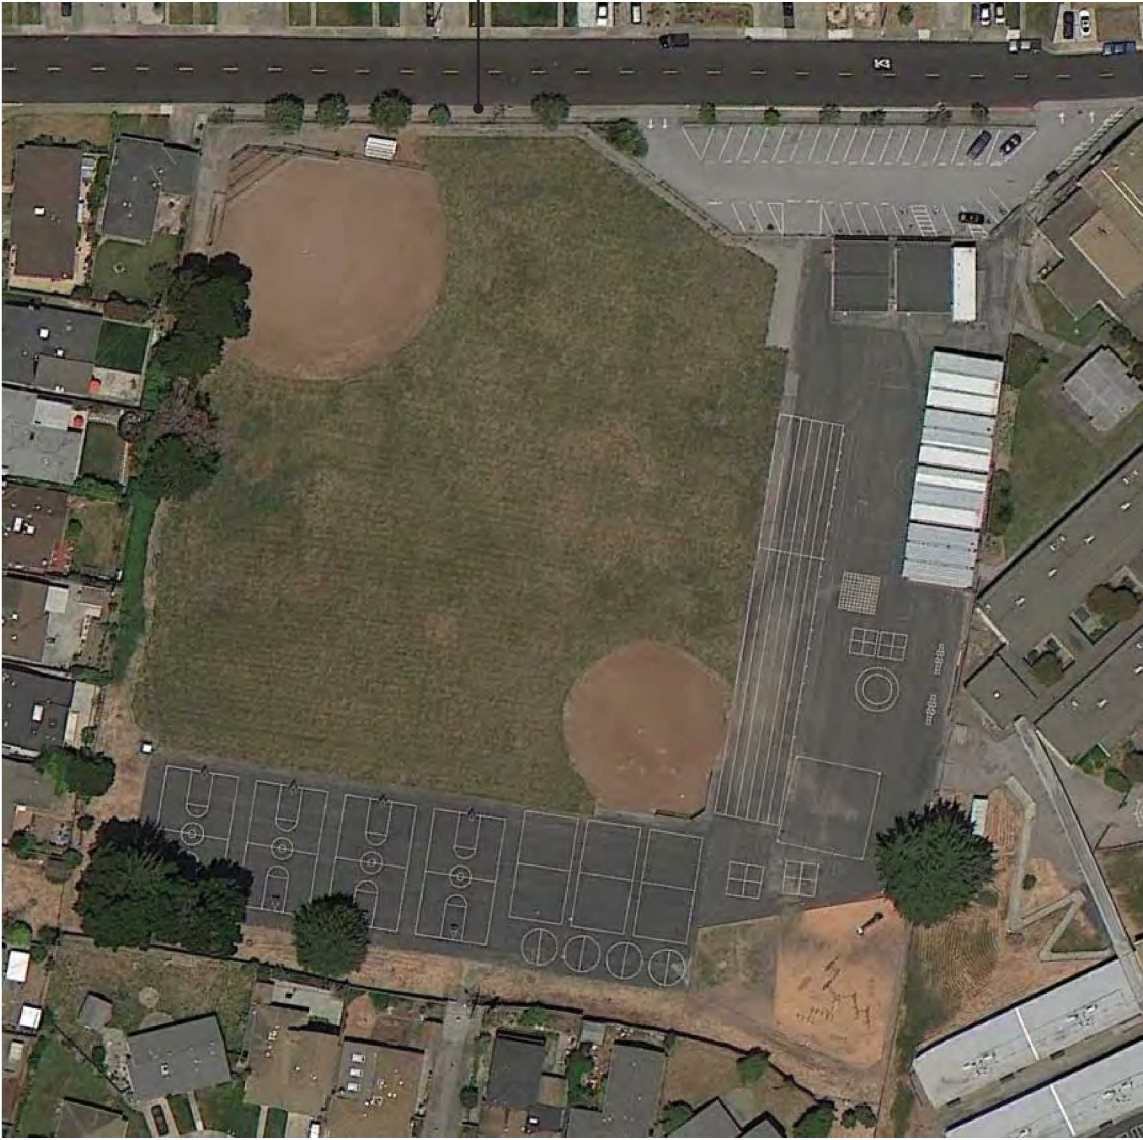
Buri Buri School Ballfields

4 - 1	Walk	Priority: 1
Regrade surface		\$9,600
Notes: 2.1%-5.5% cross slope for 240 lf. (2% max.)		
State: 1133B.7.1.3		
Federal: 403.3		
Repair surface		\$0
Notes: Changes in level of greater than .5" along length of sidewalk particularly near trees.		
State: 1124B.2		
Federal: 303.2, 303.3

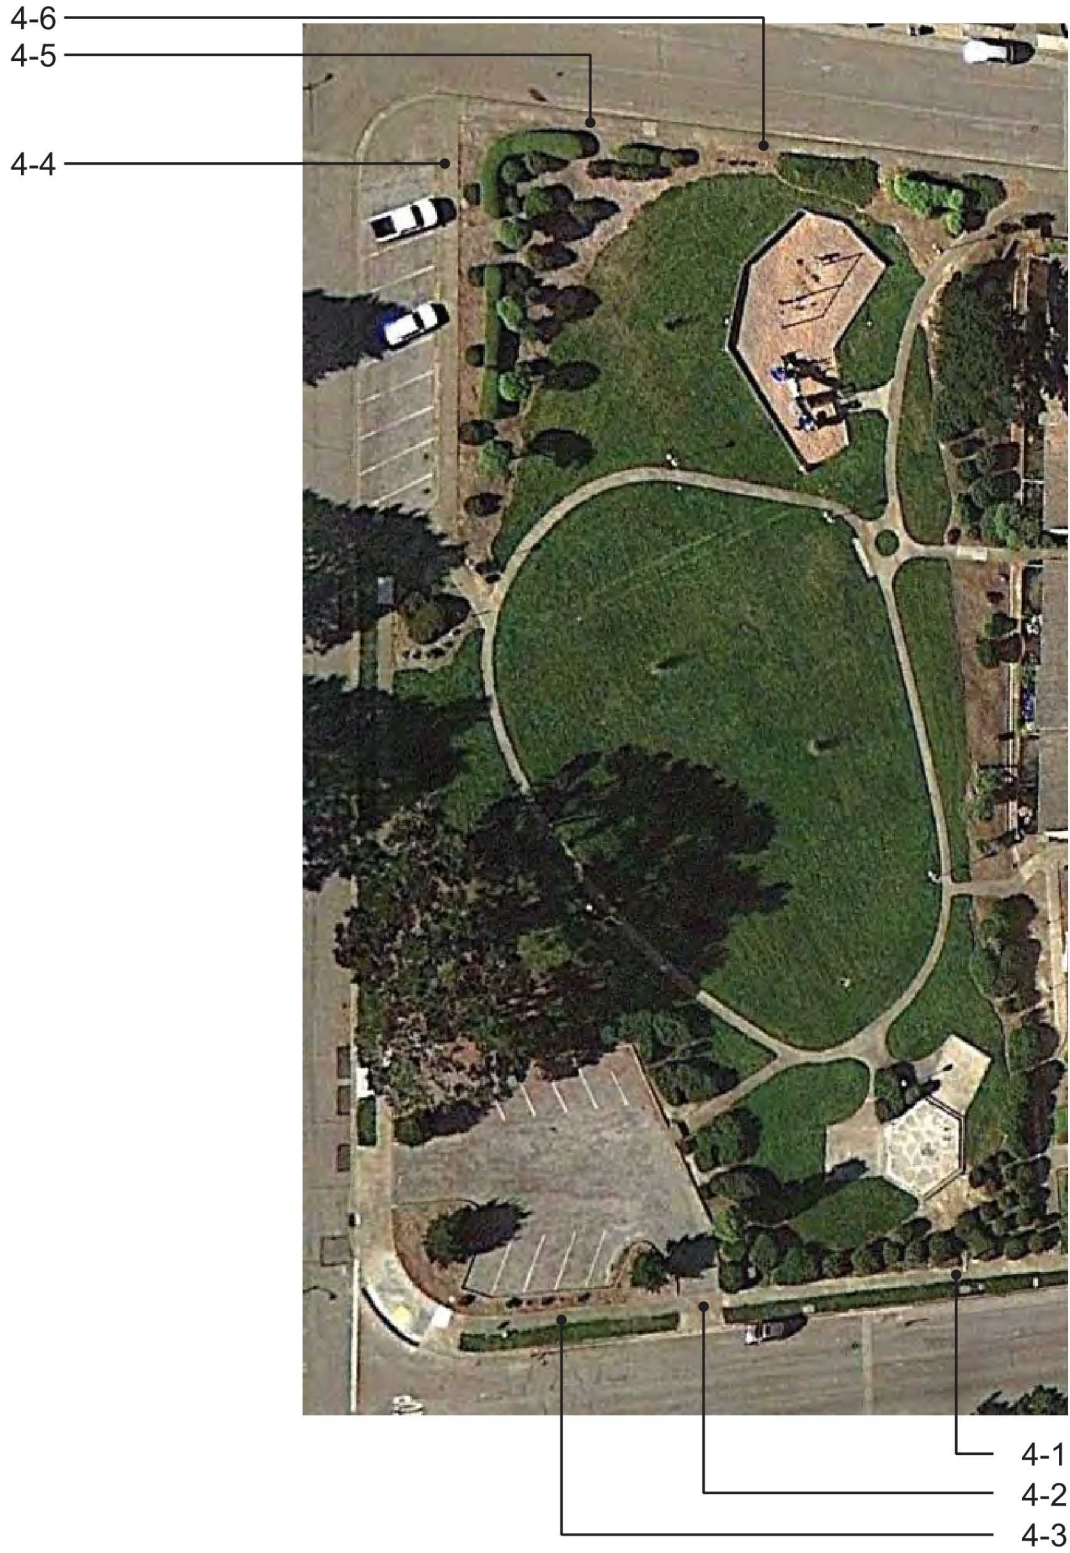
Cal West Park

4 - 1	Walk	Priority: 1	
Repair surface			\$0
Notes: .5" change in level at expansion joint.			
State: 1124B.2			
Federal: 303.2, 303.3			
Regrade surface			\$240
Notes: 3.9% cross slope for 8 lf. (2% max.)			
State: 1133B.7.1.3			
Federal: 403.3			
4 - 2	Walk	Priority: 1	
Regrade surface			\$560
Notes: 3.9% cross slope for 14 lf. at drive. (2% max.)			
State: 1133B.7.1.3			
Federal: 403.3			
4 - 3	Walk	Priority: 1	
Regrade surface			\$2,000
Notes: 2.4%-3.5% cross slope for 50 lf. to hydrant. (2% max.)			
State: 1133B.7.1.3			
Federal: 403.3			
Repair surface			\$0
Notes: .5" change in level at cracked flag.			
State: 1124B.2			
Federal: 303.2, 303.3			
4 - 4	Walk	Priority: 1	
Regrade surface			\$480
Notes: Running slope of walk is 9.2% for 12 lf. (5% max.)			
State: 1133B.7.3			
Federal: 403.3			
4 - 5	Walk	Priority: 1	
Regrade surface			\$880
Notes: 2.1%-3% cross slope for 22 lf. (2% max.)			
State: 1133B.7.1.3			
Federal: 403.3

Repair surface			\$250
Notes: 3"x8" gap at cracked utility cover.			
State: 1124B.2			
Federal: 303.2, 303.3

4 - 6	Walk	Priority: 1
Widen walk		\$150
Notes: Overgrown vegetation. Path of travel down to 47" for 8 lf. Maintenance needed.		
State: 1133B.7.1		
Federal: -

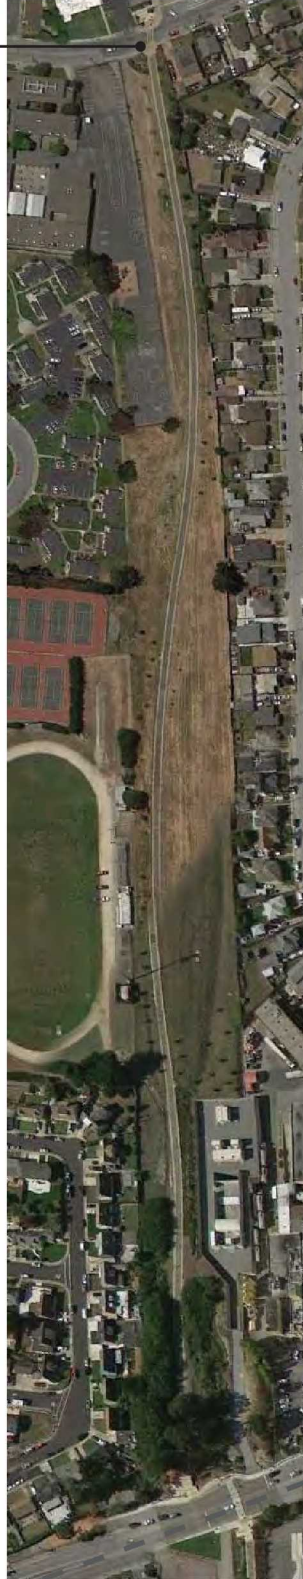
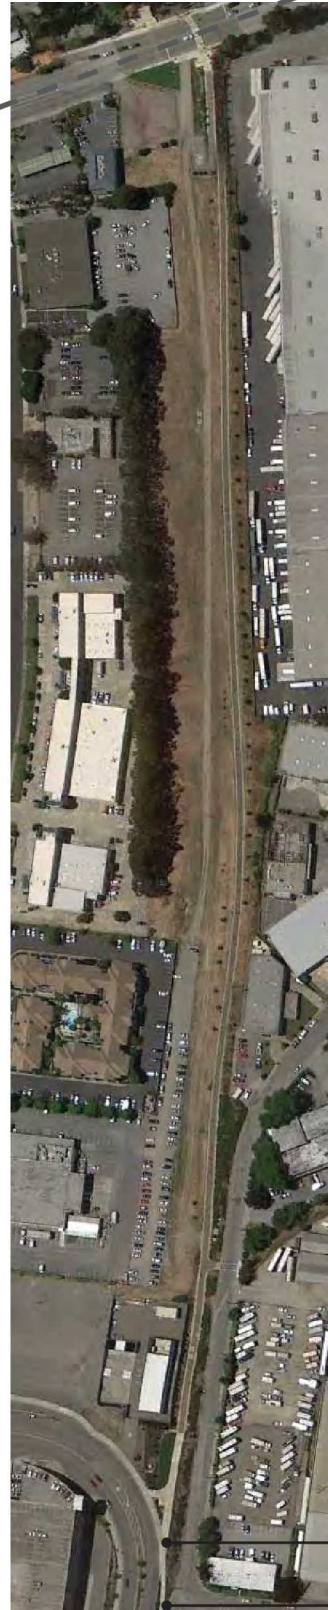
Centennial Way Phase 1

3 - 1	Curb Ramp	Priority: 1	
	Provide detectable warning strip		\$1,000
Notes: No detectable warning provided.			
State: 1127B.5.7, IR11B-4			
Federal: -			
4 - 1	Walk	Priority: 1	
	Regrade surface		\$2,000
Notes: 2.5% cross slope across drive for 50 lf. (2% max.)			
State: 1133B.7.1.3			
Federal: 403.3			
4 - 2	Walk	Priority: 1	
	Regrade surface		\$400
Notes: Running slope of walk is 5.5% for 10 lf. (5% max.)			
State: 1133B.7.3			
Federal: 403.3

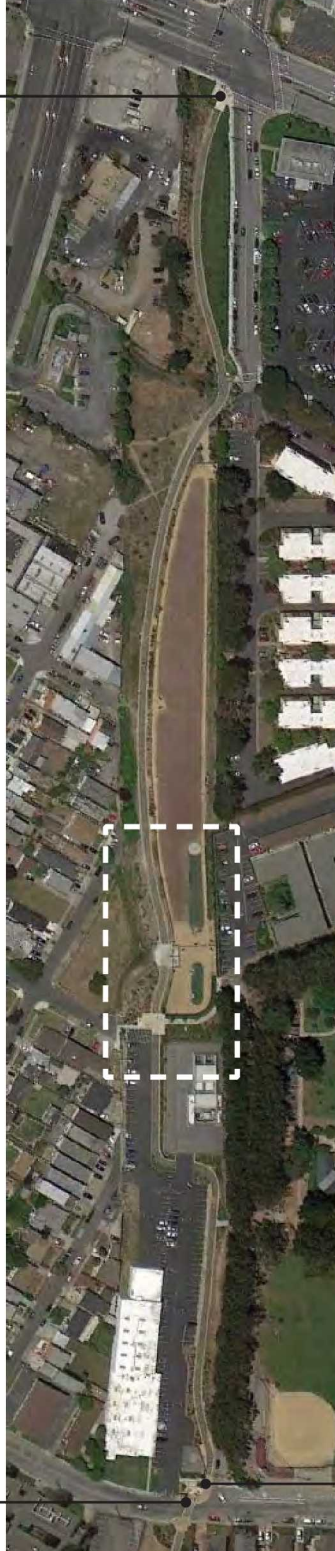
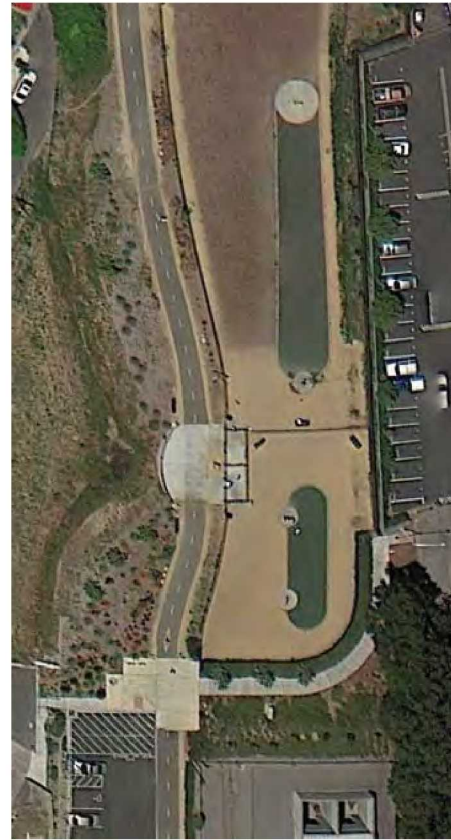
Centennial Way Phase 2

3 - 1	Curb Ramp	Priority: 1	
	Install, replace or modify curb ramp		\$2,500
	Notes: Flared side has slope up to 11.4%. (10% max.)		
	State: 1127B.5.3, 1127B.5.4		
	Federal: 406.3		
3 - 2	Curb Ramp	Priority: 1	
	Provide detectable warning strip		\$1,000
	Notes: No detectable warning provided.		
	State: 1127B.5.7, IR11B-4		
	Federal: -		
3 - 3	Curb Ramp	Priority: 1	
	Provide detectable warning strip		\$0
	Notes: No detectable warning provided.		
	State: 1127B.5.7, IR11B-4		
	Federal: -		
	Install, replace or modify curb ramp		\$2,500
	Notes: Running slope is 9%. (8.33% max.)		
	State: 1127B.5.3		
	Federal: 405.2

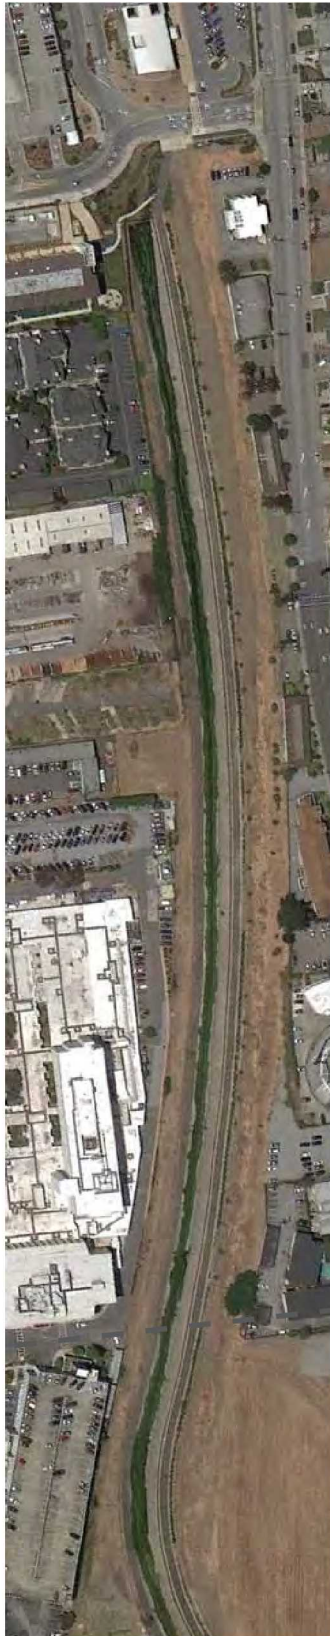
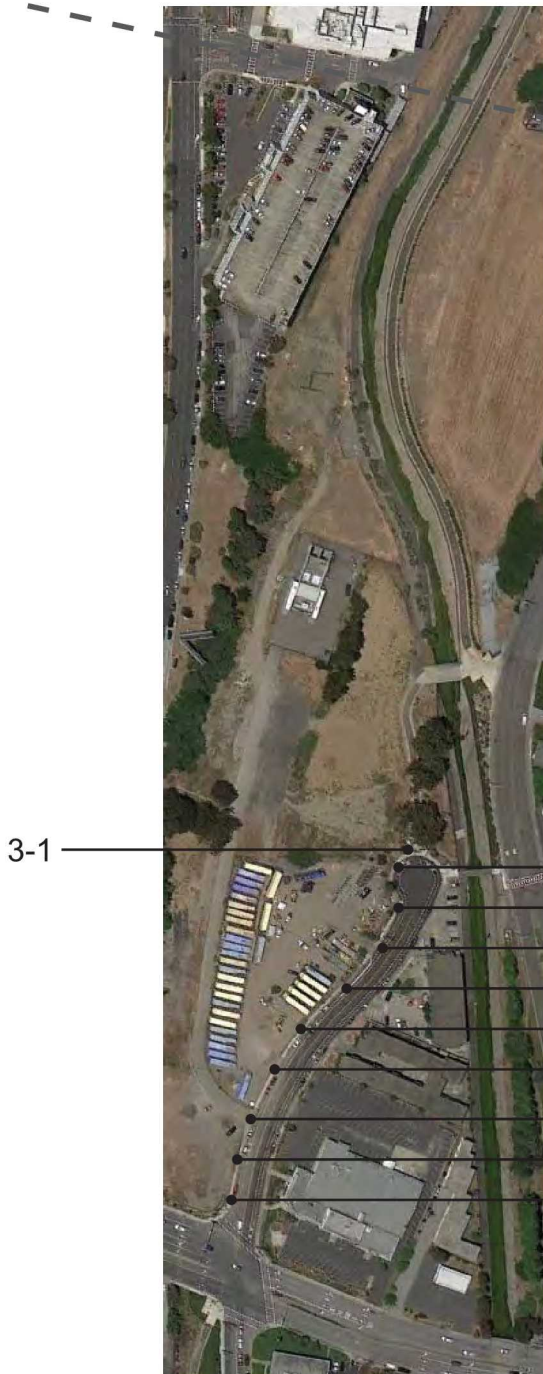
Centennial Way Phase 3

3 - 1	Curb Ramp	Priority: 1	
	Provide level landing		\$250
	Notes: 10.6% gutter slope, no level landing provided at bottom of ramp. (5% max.)		
	State: 1127B.5.3		
	Federal: 406.2		
4 - 1	Walk	Priority: 1	
	Regrade surface		\$1,200
	Notes: Up to 11.6% cross slope across former drive for 30 lf. (2% max.)		
	State: 1133B.7.1.3		
	Federal: 403.3		
4 - 2	Walk	Priority: 1	
	Regrade surface		\$2,000
	Notes: 3.3%-5.3% cross slope for 50 lf. (2% max.)		
	State: 1133B.7.1.3		
	Federal: 403.3		
4 - 3	Walk	Priority: 1	
	Widen walk		\$150
	Notes: Overgrown vegetation and guide wires reduce path of travel down to 25" for 3 lf. Maintenance needed.		
	State: 1133B.7.1		
	Federal: -		
4 - 4	Walk	Priority: 1	
	Repair surface		\$800
	Notes: Deteriorated asphalt surface at concrete/asphalt joint, 20 lf.		
	State: 1124B.2		
	Federal: 303.2, 303.3		
4 - 5	Walk	Priority: 1	
	Regrade surface		\$3,680
	Notes: 2.4%-3.3% cross slope for 92 lf. (2% max.)

State: 1133B.7.1.3		
	Federal: 403.3		
4 - 6	Walk	Priority: 1	
	Regrade surface		\$1,000
	Notes: 4.1%-10% cross slope for 25 lf. (2% max.)		
	State: 1133B.7.1.3		
	Federal: 403.3

4 - 7	Walk	Priority: 1	
Regrade surface			\$1,200
Notes: Up to 9.8% cross slope across former drive for 30 lf. (2% max.)			
State: 1133B.7.1.3			
Federal: 403.3			
4 - 8	Walk	Priority: 1	
Repair surface			\$250
Notes: .75" change in level at expansion joint.			
State: 1124B.2			
Federal: 303.2, 303.3			
4 - 9	Walk	Priority: 1	
Regrade surface			\$2,640
Notes: 2.2%-4.6% cross slope for 66 lf. (2% max.)			
State: 1133B.7.1.3			
Federal: 403.3

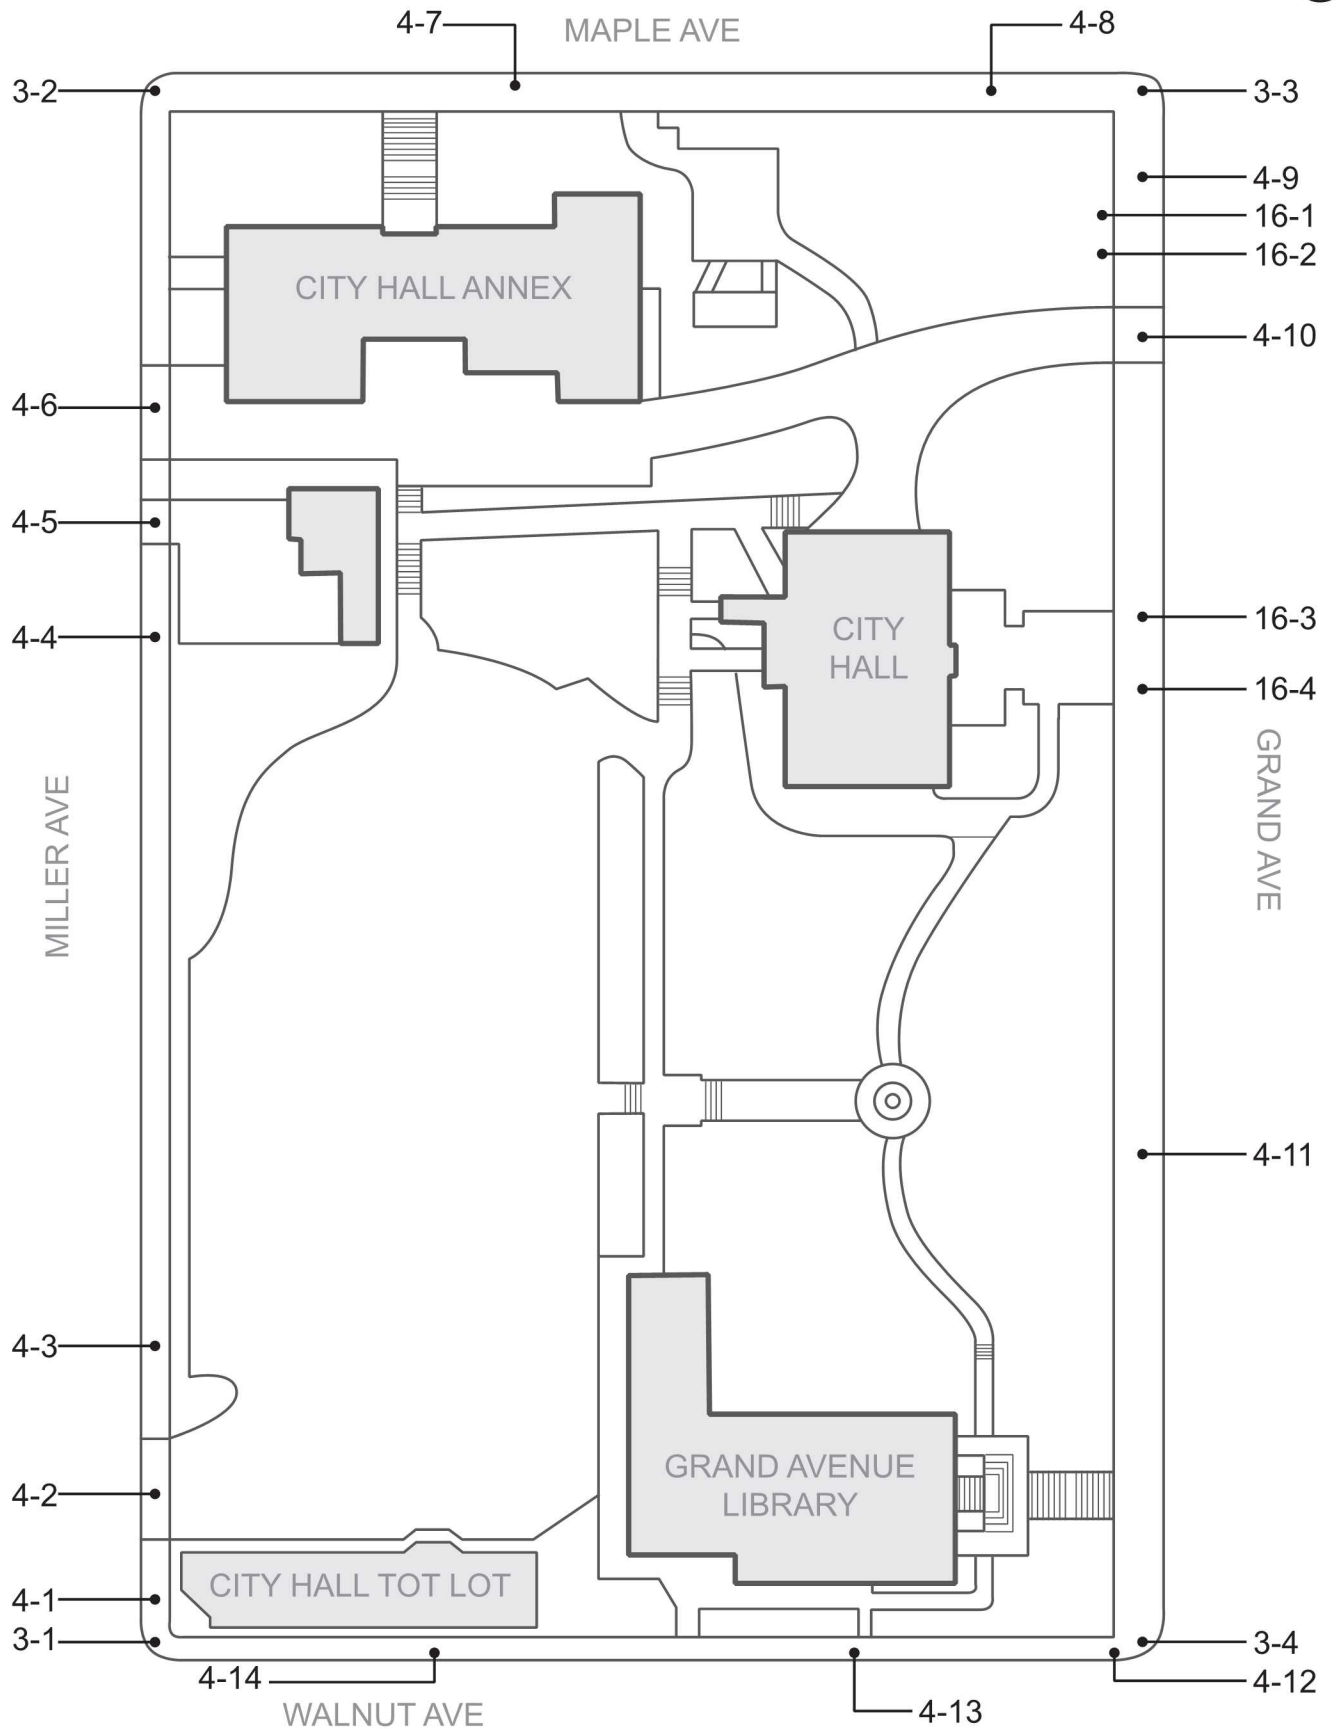
City Hall Campus

3 - 1	Curb Ramp	Priority: 1
Install, replace or modify curb ramp		\$2,500
Notes: Flared side has slope up to 21.4%. (10% max.)		
State: 1127B.5.3, 1127B.5.4		
Federal: 406.3		
Provide level landing		\$0
Notes: Level landing at top of ramp is 5.7% (2% max.) Level landing at bottom extends 36" before crosswalk marking. (48" clear floor space located at the base of the curb ramp shall be withing crossing markings.		
State: 1127B.5.3, 1127B.5.4		
Federal: 406.2		
Provide detectable warning strip		\$0
Notes: No detectable warning provided.		
State: 1127B.5.7, IR11B-4		
Federal: -		
Repair surface		\$0
Notes: 1" lip at bottom of ramp.		
State: 1127B.5.3		
Federal: 405.4		
3 - 2	Curb Ramp	Priority: 1
Install, replace or modify curb ramp		\$2,500
Notes: Flared sides have slopes 15.2% and 19.2%. (10% max.)		
State: 1127B.5.3, 1127B.5.4		
Federal: 406.3		
Provide level landing		\$0
Notes: Level landing at top of ramp is 7.6% (2% max.)

State: 1127B.5.4		
Federal: -		
Provide detectable warning strip		\$0
Notes: No detectable warning provided.		
State: 1127B.5.7, IR11B-4		
Federal: -

3 - 3	Curb Ramp	Priority: 1
Provide level landing		\$250
Notes: Level landing at top of ramp is 2.9% (2% max.)		
State: 1127B.5.4		
Federal: -		
Provide detectable warning strip		\$1,000
Notes: No detectable warning provided.		
State: 1127B.5.7, IR11B-4		
Federal: -		
Provide surface texturing		\$1,000
Notes: No grooved border provided.		
State: 1127B.5.6		
Federal: -		
3 - 4	Curb Ramp	Priority: 1
Provide detectable warning strip		\$1,000
Notes: No detectable warning provided.		
State: 1127B.5.7, IR11B-4		
Federal: -		
Provide surface texturing		\$1,000
Notes: No grooved border provided.		
State: 1127B.5.6		
Federal: -		
4 - 1	Walk	Priority: 1
Regrade surface		\$1,280
Notes: 2.1%-2.8% cross slope for 32 lf. (2% max.)		
State: 1133B.7.1.3		
Federal: 403.3		
4 - 2	Walk	Priority: 1
Regrade surface		\$1,640
Notes: 10.4%-10.9% cross slope at drive for 41 lf. (2% max.)		
State: 1133B.7.1.3		
Federal: 403.3		
4 - 3	Walk	Priority: 1

Regrade surface		\$2,400
Notes: 2.1%-3.5% cross slope for 60 lf. (2% max.)		
State: 1133B.7.1.3		
Federal: 403.3

4 - 4	Walk	Priority: 1
Regrade surface		\$5,200
Notes: 2.1%-3.4% cross slope for 130 lf. And up to 4.8% cross slope for the last 30 lf. closest to the City Hall Annex. (2% max.)		
State: 1133B.7.1.3		
Federal: 403.3		
4 - 5	Walk	Priority: 1
Regrade surface		\$1,000
Notes: 2.1%-4.7% cross slope at drive for 25 lf. (2% max.)		
State: 1133B.7.1.3		
Federal: 403.3		
4 - 6	Walk	Priority: 1
Regrade surface		\$960
Notes: 5.7%-9.1% cross slope at drive for 24 lf. (2% max.)		
State: 1133B.7.1.3		
Federal: 403.3		
4 - 7	Walk	Priority: 1
Regrade surface		\$2,600
Notes: 2.1%-3.2% cross slope for 65 lf. (2% max.)		
State: 1133B.7.1.3		
Federal: 403.3		
4 - 8	Walk	Priority: 1
Regrade surface		\$2,800
Notes: 2.1%-3.1% cross slope for 70 lf. (2% max.)		
State: 1133B.7.1.3		
Federal: 403.3		
4 - 9	Walk	Priority: 1
Regrade surface		\$2,600
Notes: 2.1%-5.2% cross slope for 65 lf. (2% max.)		
State: 1133B.7.1.3		
Federal: 403.3		
4 - 10	Walk	Priority: 1

Regrade surface		\$880
Notes: 2.1%-6.9% cross slope at drive for 22 lf. (2% max.)		
State: 1133B.7.1.3		
Federal: 403.3

4 - 11	Walk	Priority: 1	
	Regrade surface		\$16,000
	Notes:	2.1%-4.5% cross slope for 400 lf. (2% max.)	
	State:	1133B.7.1.3	
	Federal:	403.3	
4 - 12	Walk	Priority: 1	
	Regrade surface		\$2,000
	Notes:	Up to 19.1% cross slope at corner for 200 sf. (2% max.)	
	State:	1133B.7.1.3	
	Federal:	403.3	
4 - 13	Walk	Priority: 1	
	Regrade surface		\$4,000
	Notes:	2.1%-5.1% cross slope for 100 lf. (2% max.)	
	State:	1133B.7.1.3	
	Federal:	403.3	
4 - 14	Walk	Priority: 1	
	Regrade surface		\$4,800
	Notes:	2.1%-4.7% cross slope for 120 lf. (2% max.)	
	State:	1133B.7.1.3	
	Federal:	403.3	
16 - 1	Built-in Elements	Priority: 3	
	Increase or provide maneuvering or clear floor area		\$2,000
	Notes:	No companion seating provided.	
	State:	-	
	Federal:	903.2	
16 - 2	Built-in Elements	Priority: 3	
	Increase or provide maneuvering or clear floor area		\$2,000
	Notes:	No companion seating provided.	
	State:	-	
	Federal:	903.2	
16 - 3	Built-in Elements	Priority: 3

Increase or provide maneuvering or clear floor area		\$2,000
	Notes:	No companion seating provided.	
	State:	-	
	Federal:	903.2

16 - 4	Built-in Elements	Priority: 3
Increase or provide maneuvering or clear floor area		\$2,000
Notes: No companion seating provided.		
State: -		
Federal: 903.2

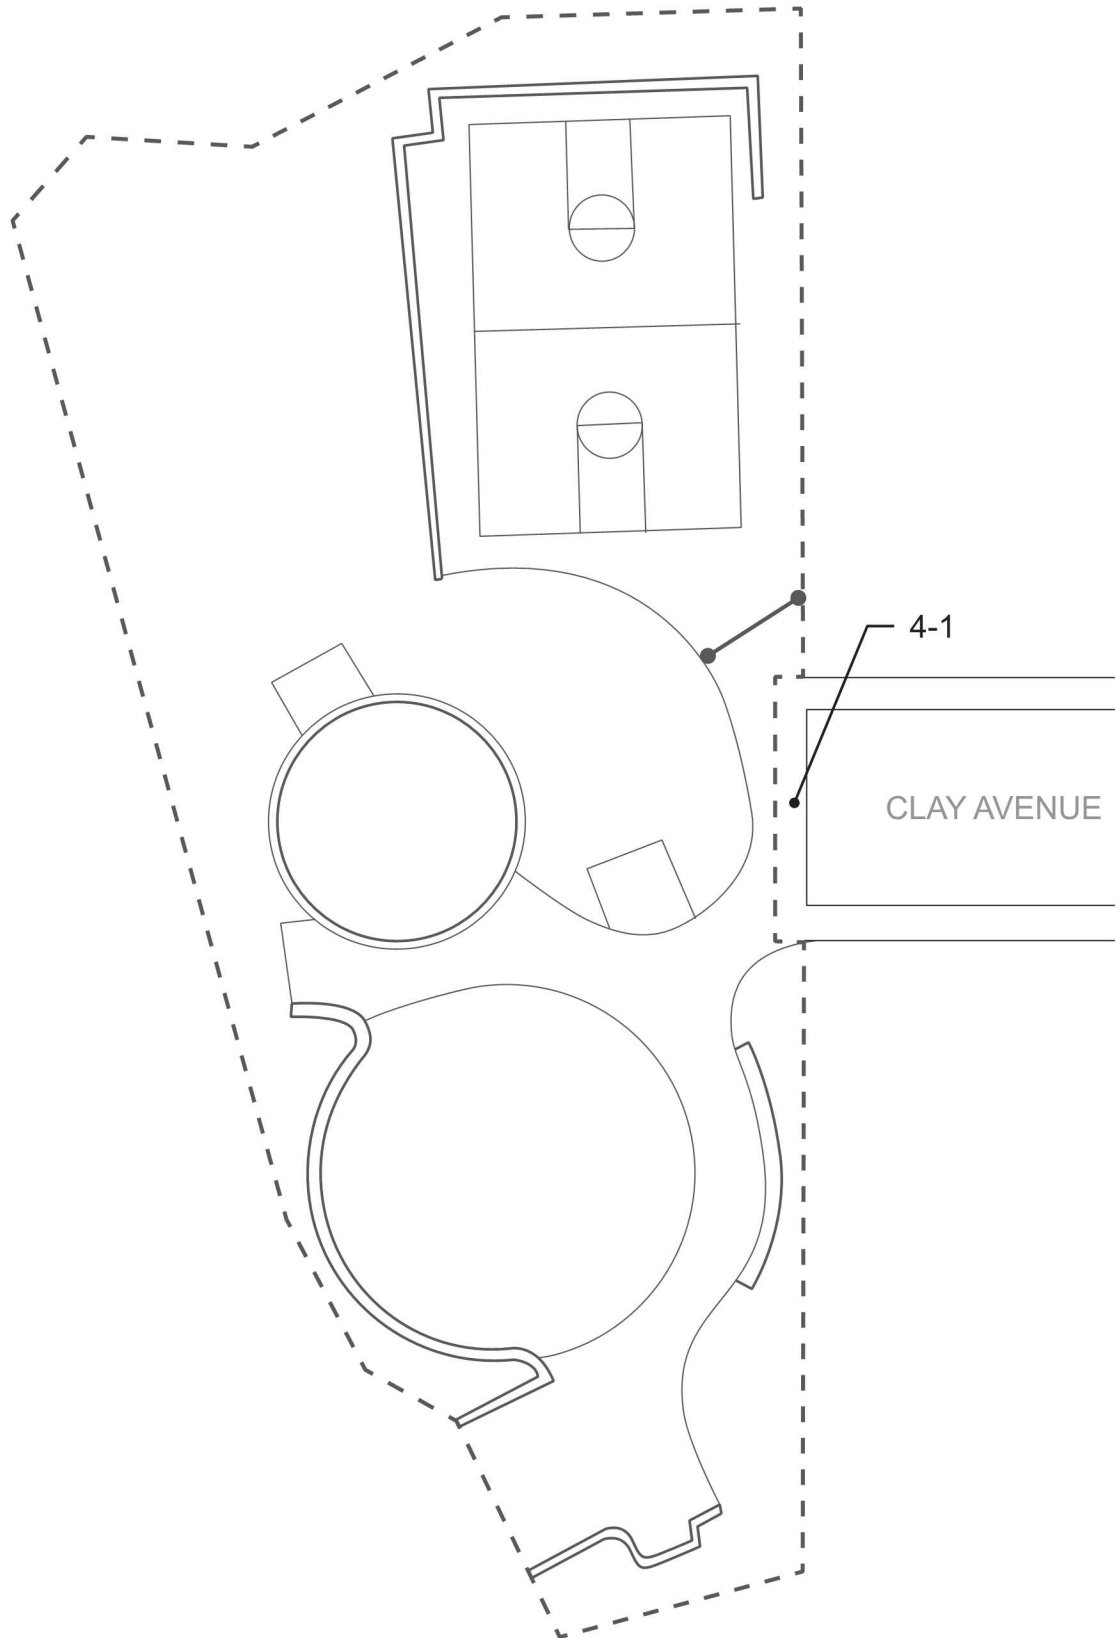
Clay Park

4 - 1	Walk	Priority: 1
Repair surface		\$2,400
Notes: Deteriorated asphalt surface 60 lf.		
State: 1124B.2		
Federal: 303.2, 303.3

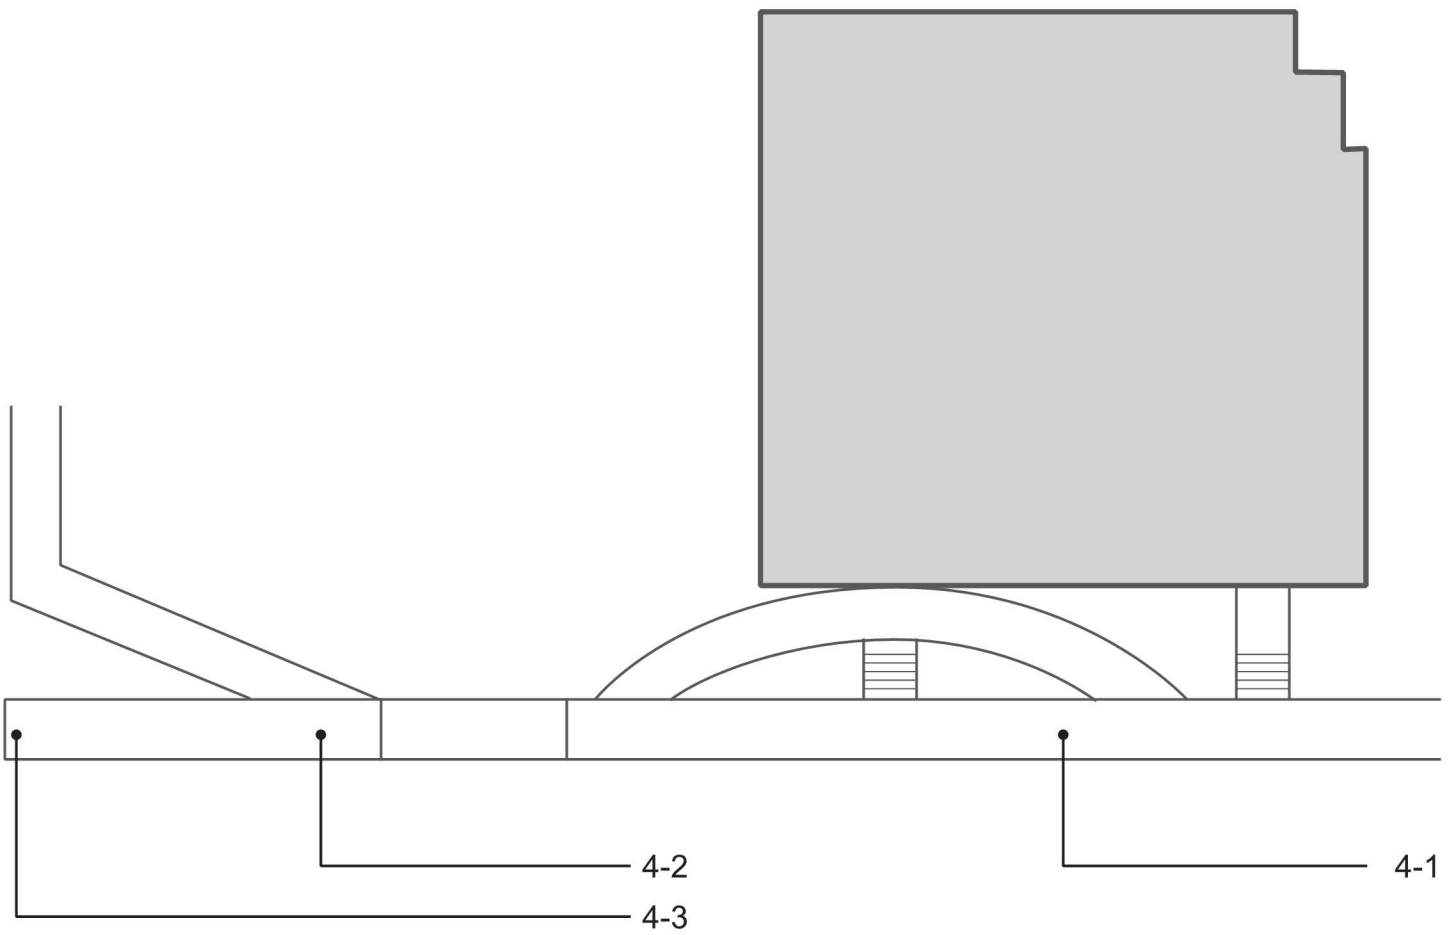
Community Learning Center
520 Tamarack Lane, South San Francisco, CA
Exterior

4 - 1	Walk	Priority: 1	
Regrade surface			\$4,400
Notes: 2.1%-3.7% cross slope for 110 lf. (2% max.)			
State: 1133B.7.1.3			
Federal: 403.3			
4 - 2	Walk	Priority: 1	
Regrade surface			\$800
Notes: 2.1%-3.3% cross slope for 20 lf. at drive (2% max.)			
State: 1133B.7.1.3			
Federal: 403.3			
4 - 3	Walk	Priority: 1	
Regrade surface			\$2,400
Notes: Up to 5% cross slope for 80 lf. (2% max.)			
State: 1133B.7.1.3			
Federal: 403.3			
Provide an accessible path of travel			\$2,500
Notes: No curb ramp provided.			
State: 1133B.7.1			
Federal: 206.2.2

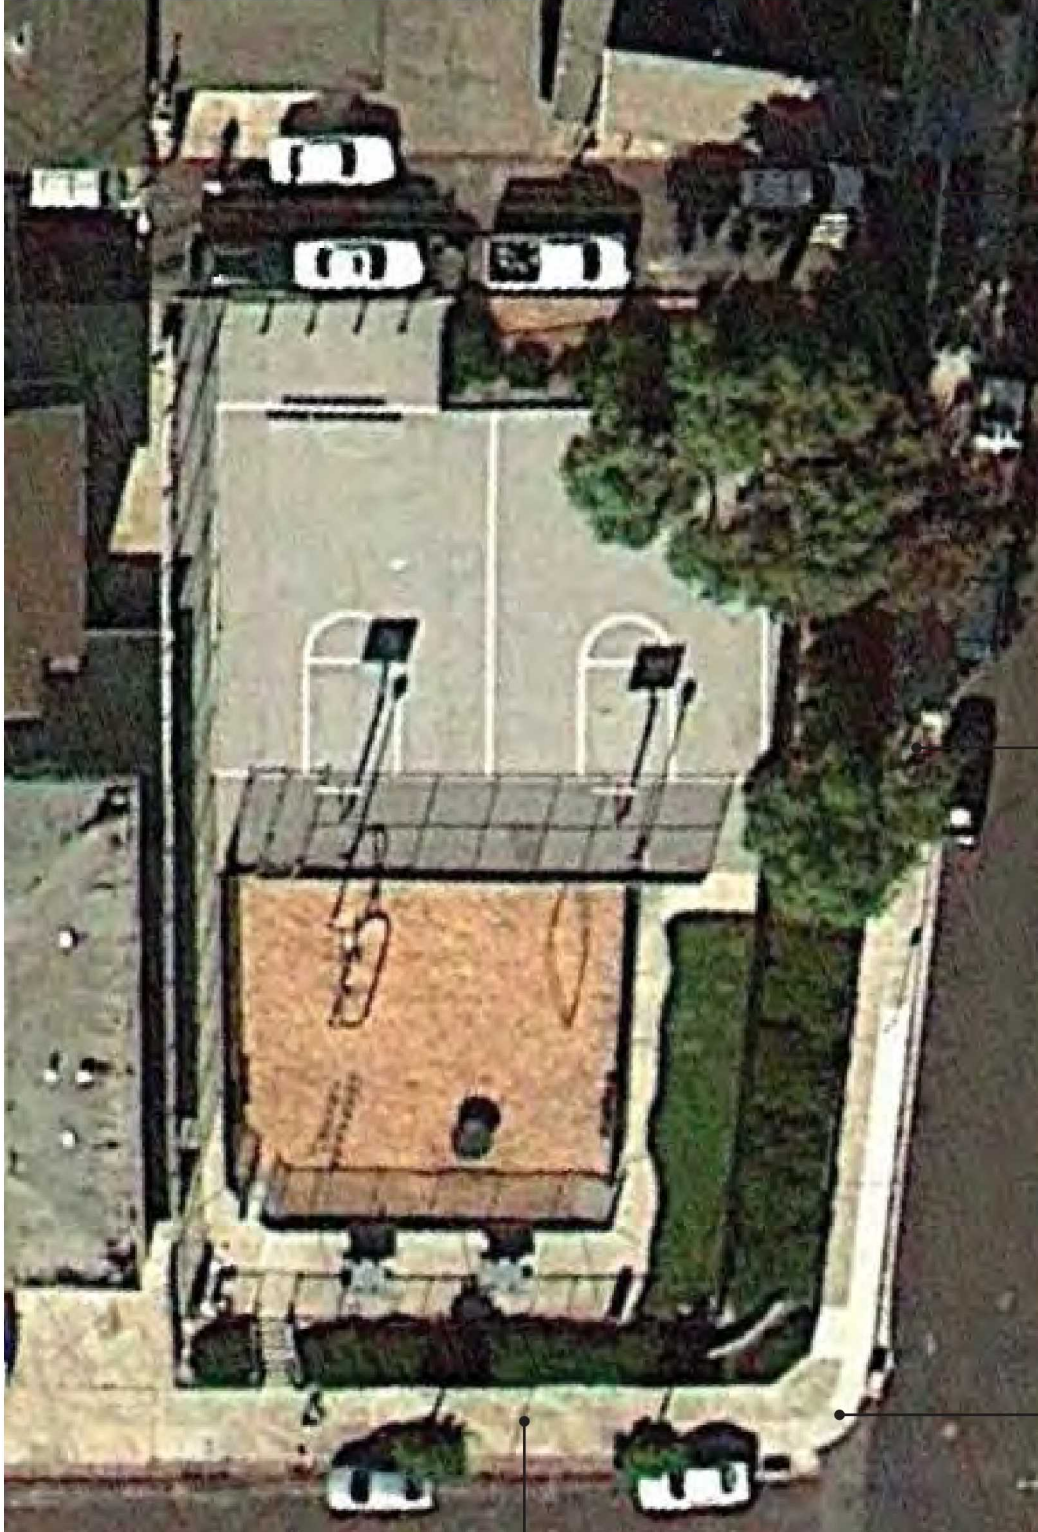
Cypress and Pine Park (Tot Lot)

4 - 1	Walk	Priority: 1	
Provide detectable warning strip			\$1,000
Notes: No detectable warning provided.			
State: 1133B.8.5			
Federal: -			
4 - 2	Walk	Priority: 1	
Regrade surface			\$4,400
Notes: 2.1%-3.3% cross slope for 110 lf. (2% max.)			
State: 1133B.7.1.3			
Federal: 403.3			
Repair surface			\$0
Notes: Changes in level include .75" at tree near ground flag and two 1 sf holes. Patch and grind where needed.			
State: 1124B.2			
Federal: 303.2, 303.3			
4 - 3	Walk	Priority: 1	
Provide detectable warning strip			\$1,000
Notes: No detectable warning provided.			
State: 1133B.8.5			
Federal: -			
4 - 4	Walk	Priority: 1	
Regrade surface			\$3,200
Notes: 2.1%-4.6% cross slope for 80 lf. (2% max.)			
State: 1133B.7.1.3			
Federal: 403.3			
Repair surface			\$0
Notes: Deteriorated surface. Patch and grind where needed.			
State: 1124B.2			
Federal: 303.2, 303.3
