CITY OF SOUTH SAN FRANCISCO

AMERICANS WITH DISABILITIES ACT self evaluation and transition plan

APPENDICES

Appendix D: Pedestrian Rights-of-Way Reports and Maps

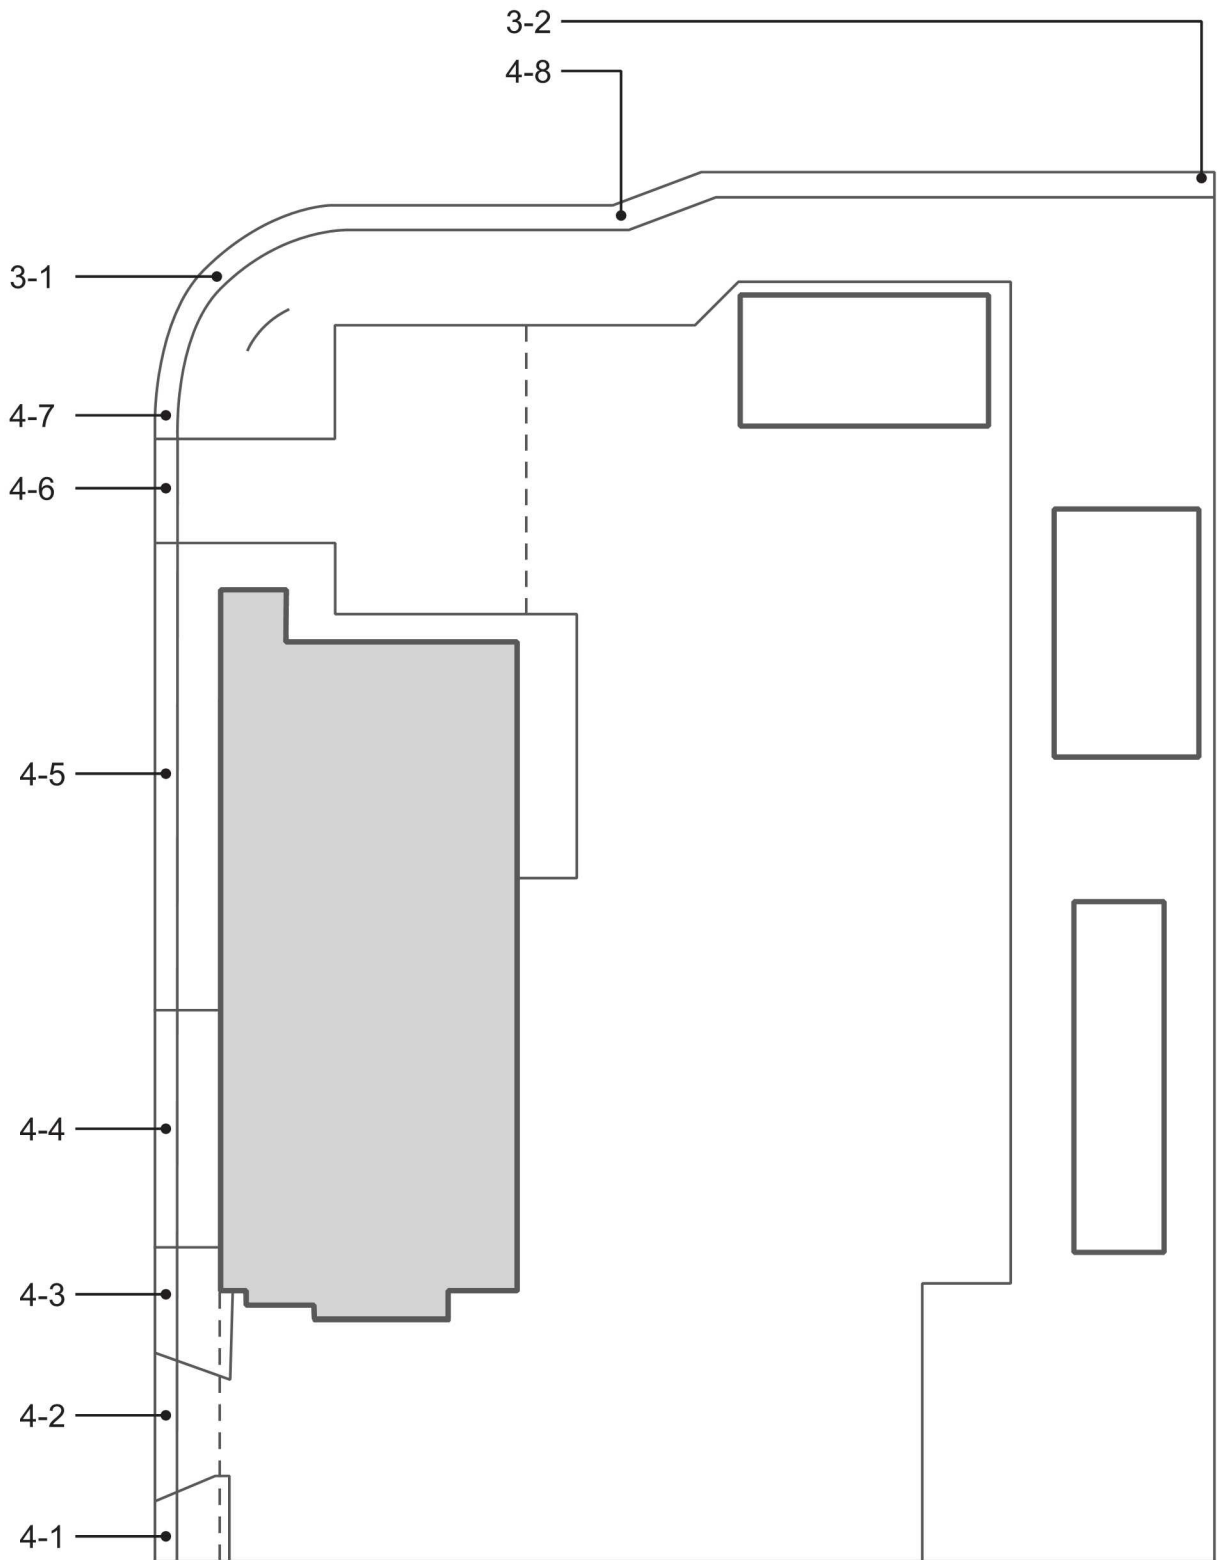
Fire Station 61

3 - 1 Curb Ramp		Priority: 1
Install, replace or modify curb ramp		\$2,500
Notes: Running slope is 11.5%. (8.33% max.)		
State: 1127B.5.3		
Federal: 405.2		
Provide detectable warning strip		\$0
Notes: No detectable warning provided.		
State: 1127B.5.7, IR11B-4		
Federal: -		
Provide level landing		\$0
Notes: 7.3% gutter slope, no level landing provided at bottom of ramp. (5% max.)		
State: 1127B.5.3		
Federal: 406.2		
Provide surface texturing		\$0
Notes: No grooved border provided.		
State: 1127B.5.6		
Federal: -		
Repair surface		\$0
Notes: .5" lip at bottom of ramp.		
State: 1127B.5.3		
Federal: 405.4		
3 - 2 Curb Ramp		Priority: 1
Install, replace or modify curb ramp		\$2,500
Notes: Running slope is 12% on built up curb ramp. (8.33% max.) Ramp is 44" wide. (48" min.)		
State: 1127B.5.2, 1127B.5.3		
Federal: 405.2		
Provide detectable warning strip		\$0
Notes: No detectable warning provided.		
State: 1127B.5.7, IR11B-4

Federal: -		
Provide surface texturing		\$0
Notes: No grooved border provided.		
State: 1127B.5.6		
Federal: -

4 - 1	Walk	Priority: 1	
Regrade surface			\$760
Notes: 2.1%-5.3% cross slope for 19 lf. (2% max.)			
State: 1133B.7.1.3			
Federal: 403.3			
4 - 2	Walk	Priority: 1	
Regrade surface			\$1,440
Notes: 13% cross slope at drive for 36 lf. (2% max.)			
State: 1133B.7.1.3			
Federal: 403.3			
4 - 3	Walk	Priority: 1	
Regrade surface			\$480
Notes: 2.1%-3.5% cross slope for 12 lf. (2% max.)			
State: 1133B.7.1.3			
Federal: 403.3			
4 - 4	Walk	Priority: 1	
Regrade surface			\$3,200
Notes: 10% cross slope at drive for 80 lf. (2% max.)			
State: 1133B.7.1.3			
Federal: 403.3			
4 - 5	Walk	Priority: 1	
Regrade surface			\$4,080
Notes: 2.1%-4.6% cross slope for 102 lf. (2% max.)			
State: 1133B.7.1.3			
Federal: 403.3			
Repair surface			\$0
Notes: Cracked flag near utility covers.			
State: 1124B.2			
Federal: 303.2, 303.3			
4 - 6	Walk	Priority: 1	
Regrade surface			\$1,600
Notes: 16% cross slope at drive for 40 lf. (2% max.)			
State: 1133B.7.1.3

Federal: 403.3

4 - 7	Walk	Priority: 1
Regrade surface		\$1,360
Notes: 3.1%-3.8% cross slope for 34 lf. (2% max.)		
State: 1133B.7.1.3		
Federal: 403.3		
4 - 8	Walk	Priority: 1
Regrade surface		\$9,440
Notes: 2.1%-4.1% cross slope for 236 lf. (2% max.)		
State: 1133B.7.1.3		
Federal: 403.3		
Repair surface		\$0
Notes: Changes in level exceeding .25" include cracked flags near water and street light utility covers and a 1" change in level across expansion joint at utility vault.		
State: 1124B.2		
Federal: 303.2, 303.3

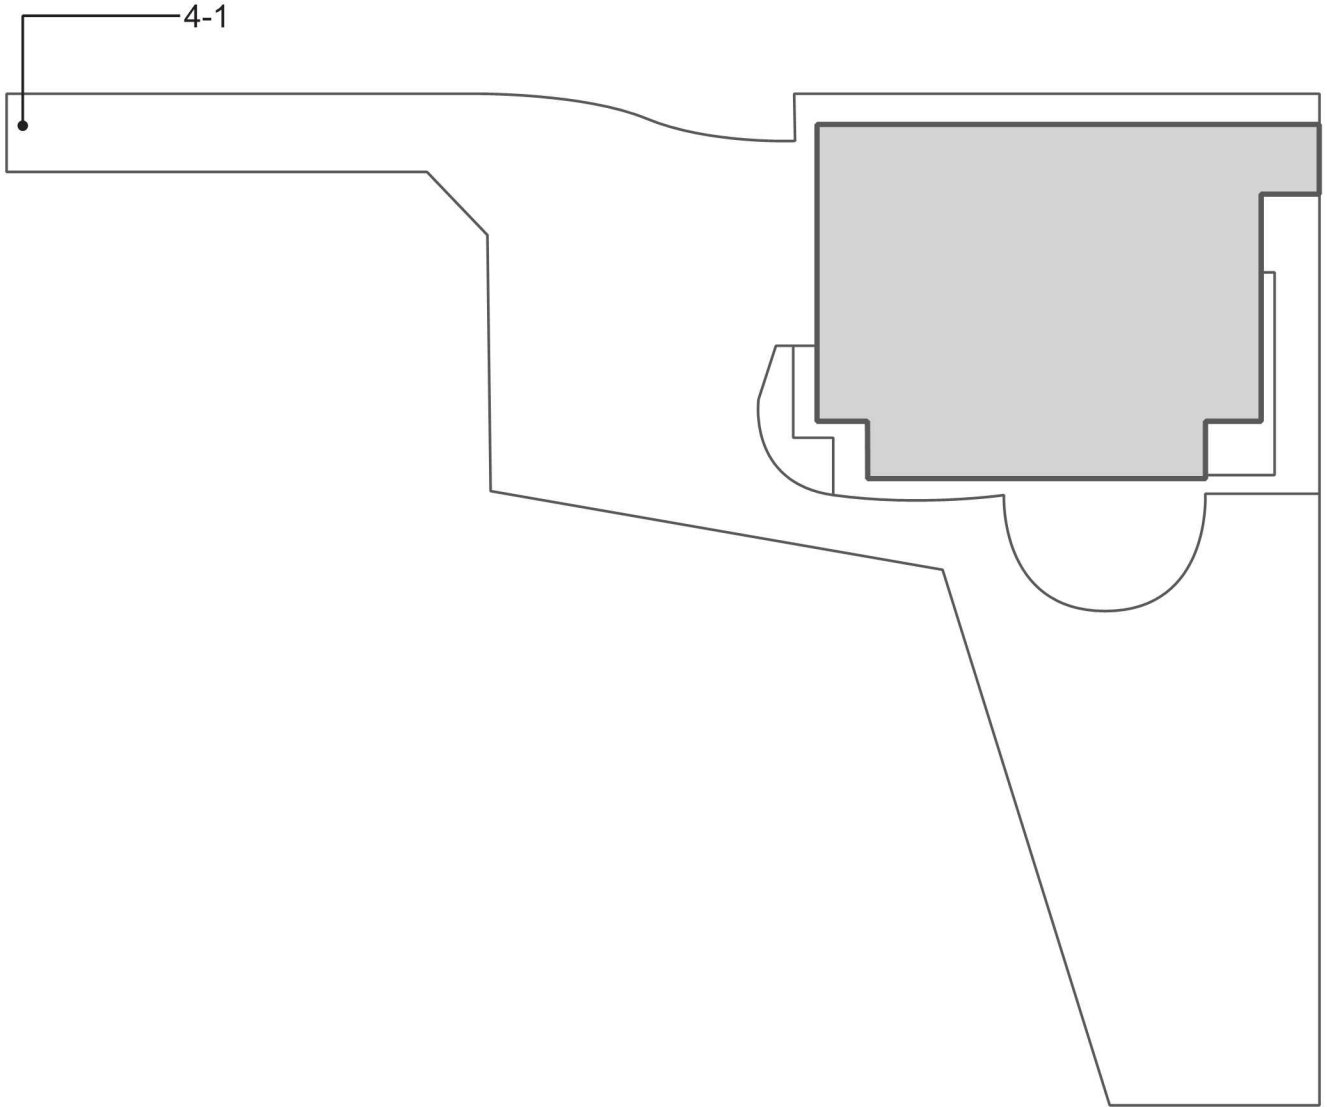
Fire Station 62
249 Harbor Way, South San Francisco, CA

4 - 1	Walk	Priority: 1
Regrade surface		\$1,200
Notes: 6.5% cross slope across drive for 30 lf. (2% max.)		
State: 1133B.7.1.3		
Federal: 403.3		
Repair surface		\$0
Notes: Deteriorated concrete surface.		
State: 1124B.2		
Federal: 303.2, 303.3

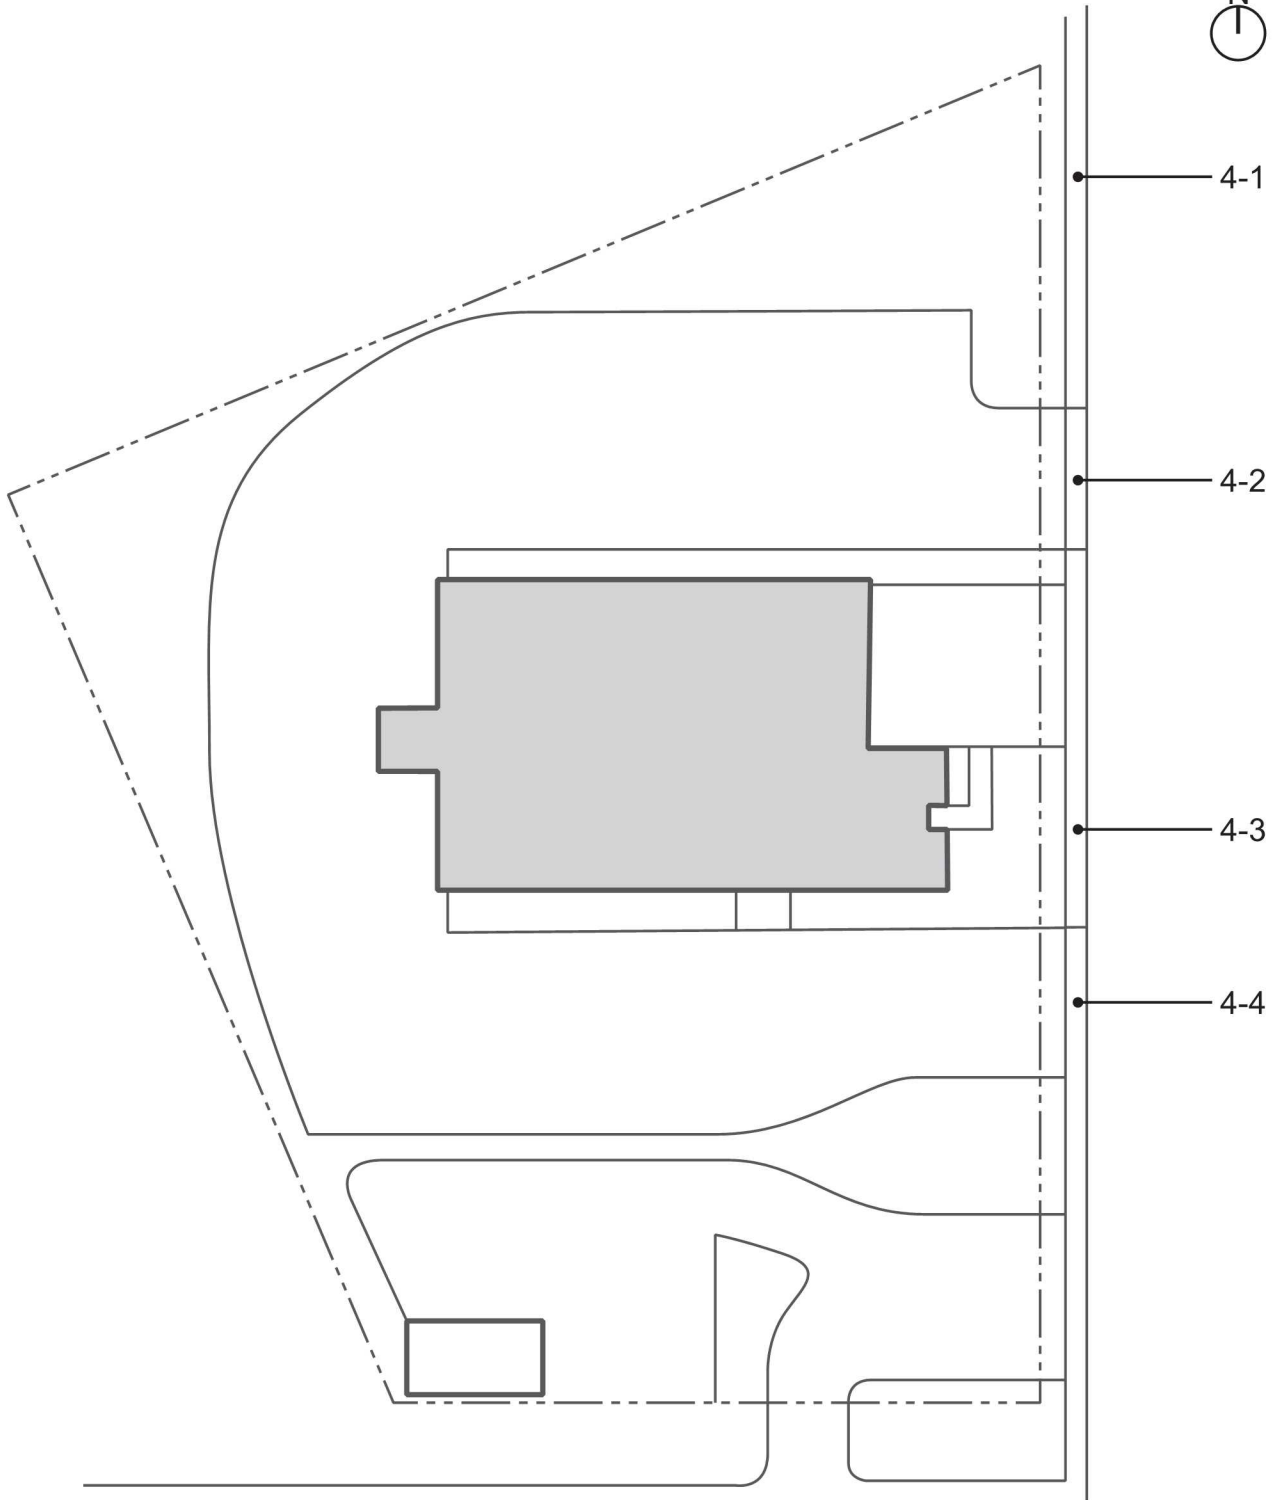
Fire Station 64
2350 Galway, South San Francisco, CA

4 - 1	Walk	Priority: 1	
Regrade surface			\$960
Notes: 2.1%-3.1% cross slope for 24 lf. (2% max.)			
State: 1133B.7.1.3			
Federal: 403.3			
4 - 2	Walk	Priority: 1	
Regrade surface			\$1,200
Notes: 8.4%-10.6% cross slope across drive for 30 lf. (2% max.)			
State: 1133B.7.1.3			
Federal: 403.3			
4 - 3	Walk	Priority: 1	
Regrade surface			\$1,200
Notes: 3.9%-6.3% cross slope for 30 lf. (2% max.)			
State: 1133B.7.1.3			
Federal: 403.3			
4 - 4	Walk	Priority: 1	
Regrade surface			\$1,360
Notes: 11% cross slope across drive for 34 lf. (2% max.)			
State: 1133B.7.1.3			
Federal: 403.3

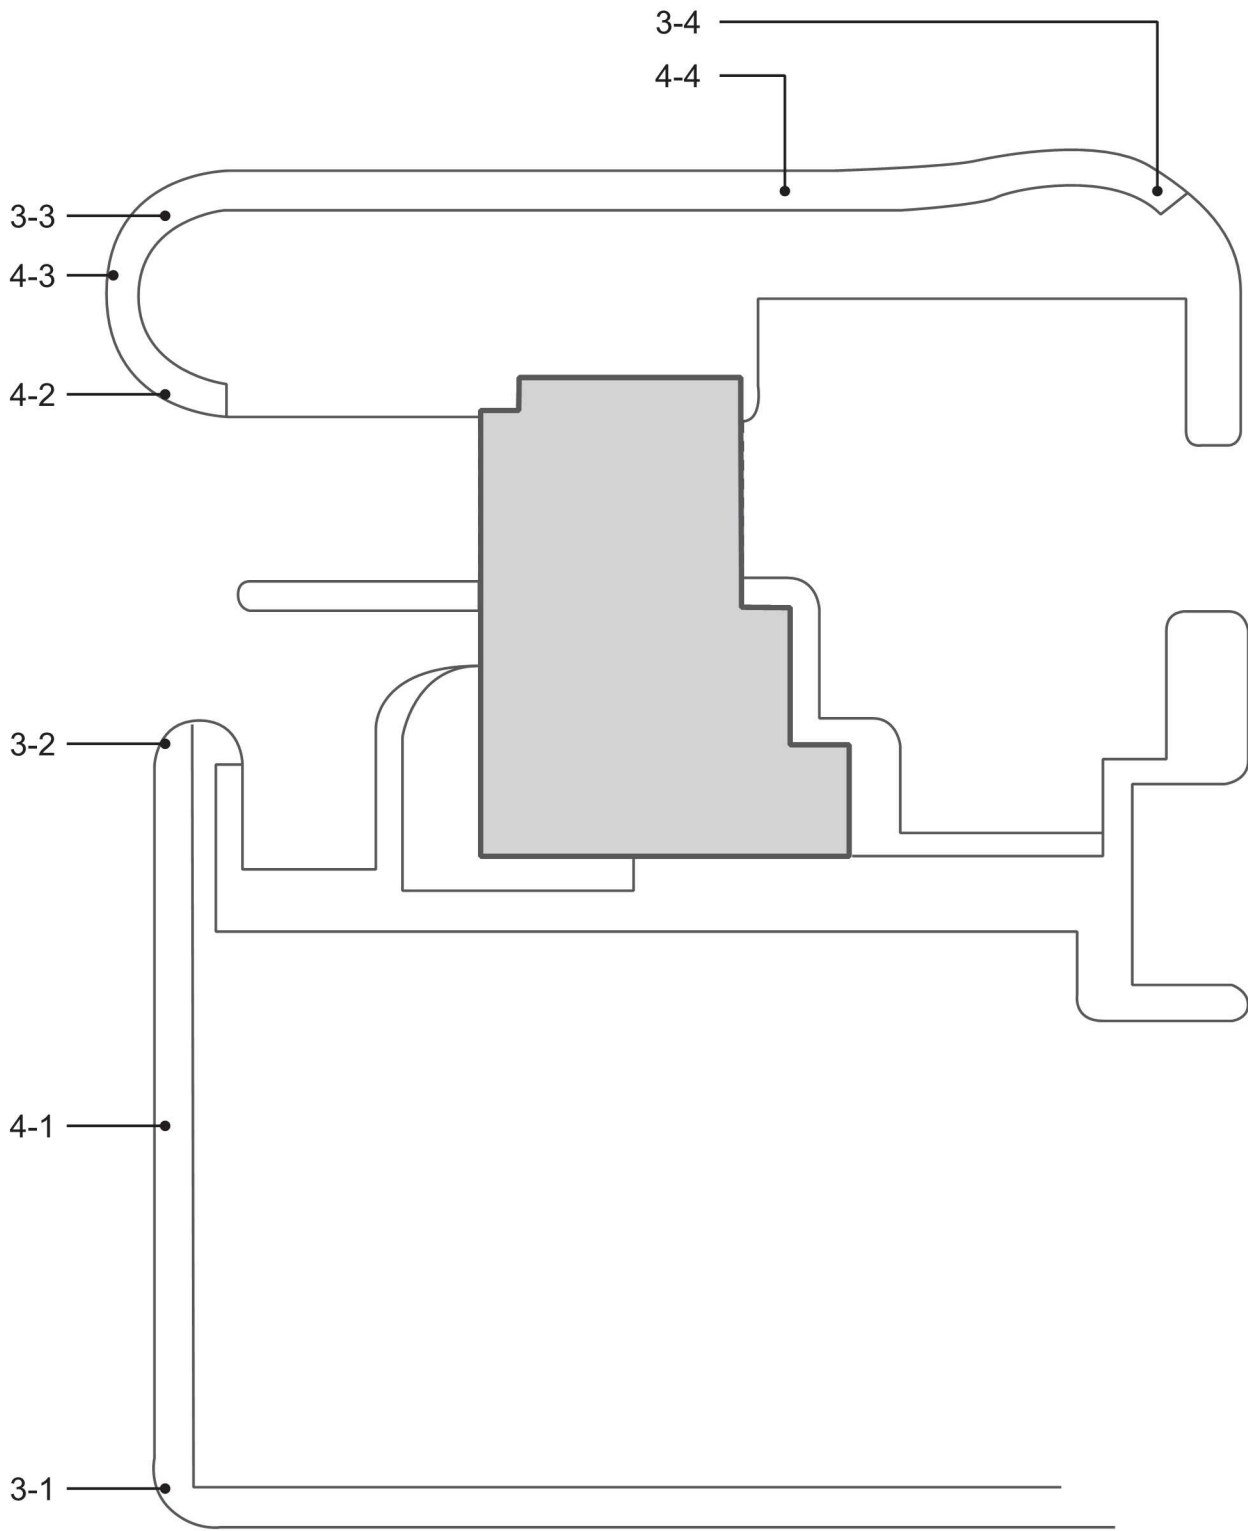
Fire Station 65

3 - 1 Curb Ramp		Priority: 1
Provide detectable warning strip		\$0
Notes:	No detectable warning provided.	
State:	1127B.5.7	
Federal:	-	
Repair surface		\$0
Notes:	.5" lip at bottom of ramp.	
State:	1127B.5.3	
Federal:	405.4	
Install, replace or modify curb ramp		\$2,500
Notes:	Running slope is 9.4%. (8.33% max.) Flared side has slope up to 15%. (10% max.)	
State:	1127B.5.3, 1127B.5.4	
Federal:	405.2, 406.3	
Provide level landing		\$0
Notes:	No level landing provided at top of ramp.	
State:	1127B.5.4	
Federal:	-	
3 - 2 Curb Ramp		Priority: 1
Provide detectable warning strip		\$0
Notes:	No detectable warning provided.	
State:	1127B.5.7	
Federal:	-	
Install, replace or modify curb ramp		\$2,500
Notes:	Flared sides have slopes up to 30%. (10% max.)	
State:	1127B.5.3, 1127B.5.4	
Federal:	406.3	
Provide level landing		\$0
Notes:	Level landing at top of ramp is 9.1% (2% max.)	
State:	1127B.5.4	
Federal:	-

3 - 3	Curb Ramp	Priority: 1	
	Provide detectable warning strip		\$1,000
	Notes: No detectable warning provided.		
	State: 1127B.5.7		
	Federal: -		
	Repair surface		\$250
	Notes: .5" lip at bottom of ramp.		
	State: 1127B.5.3		
	Federal: 405.4		
3 - 4	Curb Ramp	Priority: 1	
	Provide detectable warning strip		\$0
	Notes: No detectable warning provided.		
	State: 1127B.5.7		
	Federal: -		
	Repair surface		\$0
	Notes: .5" lip at bottom of ramp.		
	State: 1127B.5.3		
	Federal: 405.4		
	Install, replace or modify curb ramp		\$2,500
	Notes: Running slope is 8.7%. (8.33% max.)		
	State: 1127B.5.3		
	Federal: 405.2		
4 - 1	Walk	Priority: 1	
	Regrade surface		\$2,800
	Notes: 2.1%-5.3% cross slope for 70 lf. (2% max.)		
	State: 1133B.7.1.3		
	Federal: 403.3		
4 - 2	Walk	Priority: 1	
	Provide detectable warning strip		\$1,000
	Notes: No detectable warning provided.		
	State: 1133B.8.5		
	Federal: -		
4 - 3	Walk	Priority: 1	
	Regrade surface		\$810

Notes: 2.1%-2.3% cross slope for 27 lf. (2% max.)		
	State: 1133B.7.1.3		
	Federal: 403.3

4 - 4	Walk	Priority: 1
Regrade surface		\$6,400
Notes: 2.1%-3.4% cross slope for 160 lf. (2% max.)		
State: 1133B.7.1.3		
Federal: 403.3

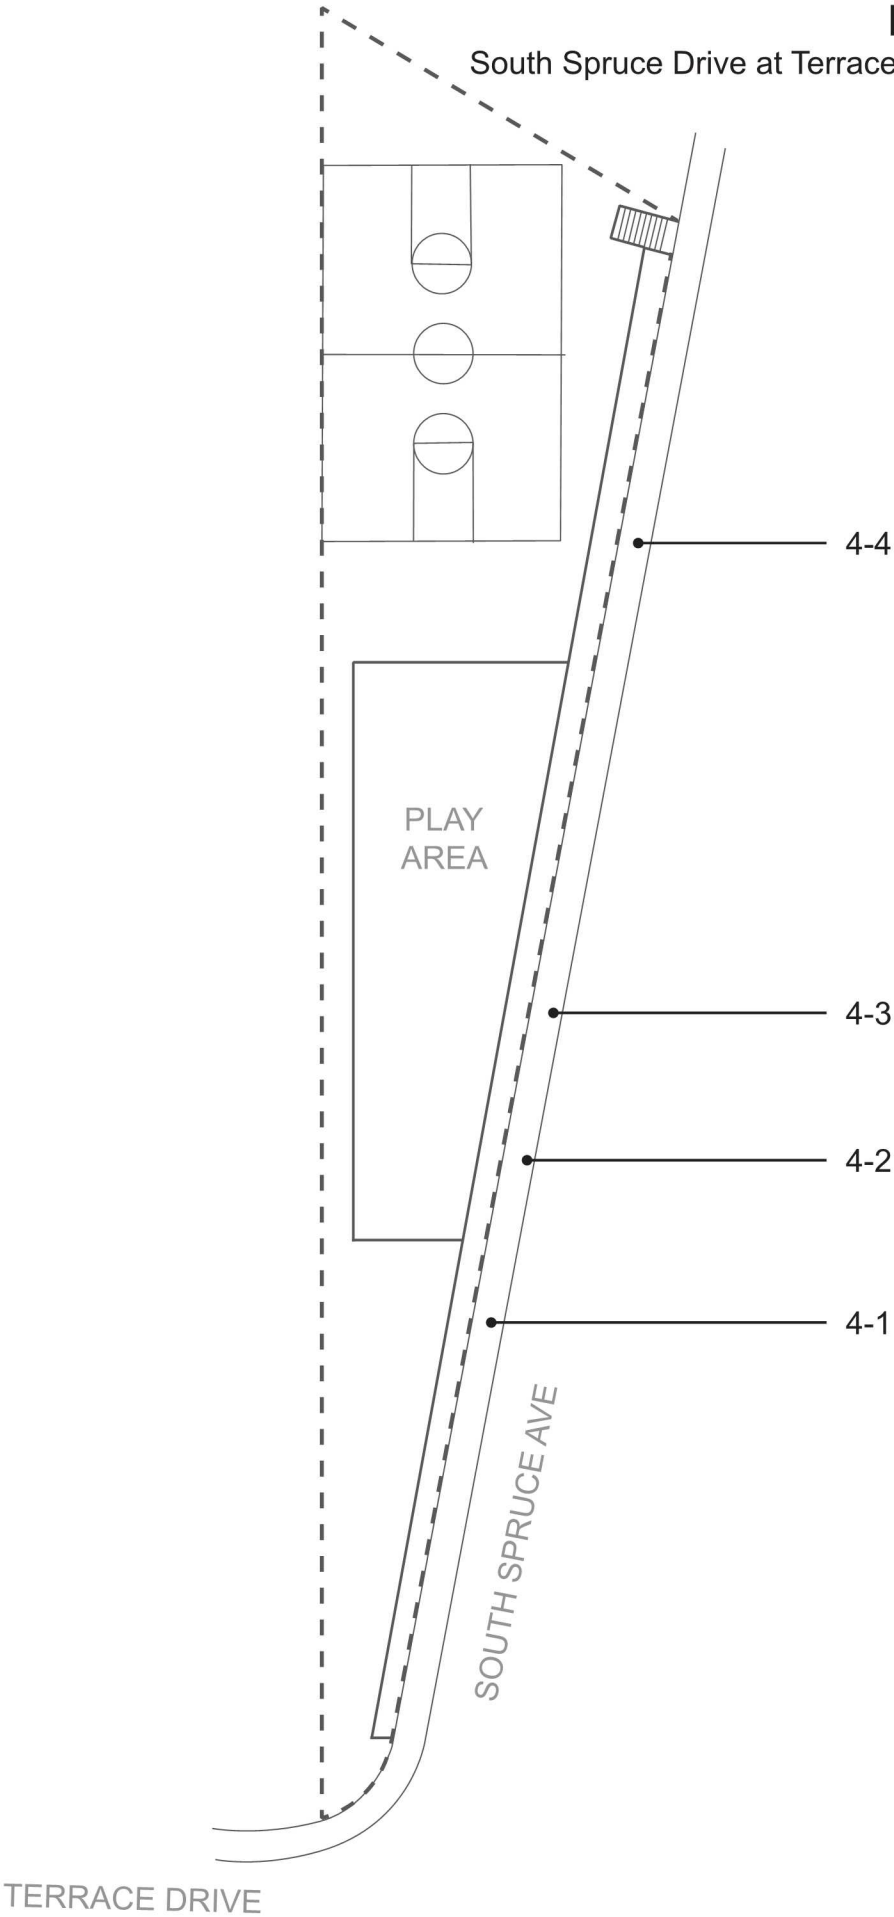
Francisco Terrace Park

4 - 1	Walk	Priority: 1	
Repair surface			\$250
Notes: .5" change in level at expansion joint across walk.			
State: 1124B.2			
Federal: 303.2, 303.3			
4 - 2	Walk	Priority: 1	
Regrade surface			\$960
Notes: 2.1%-3.1% cross slope for 24 lf. (2% max.)			
State: 1133B.7.1.3			
Federal: 403.3			
4 - 3	Walk	Priority: 1	
Repair surface			\$250
Notes: .5" change in level at expansion joint across walk.			
State: 1124B.2			
Federal: 303.2, 303.3			
4 - 4	Walk	Priority: 1	
Regrade surface			\$600
Notes: 2.1%-3.3% cross slope for 15 lf. (2% max.)			
State: 1133B.7.1.3			
Federal: 403.3

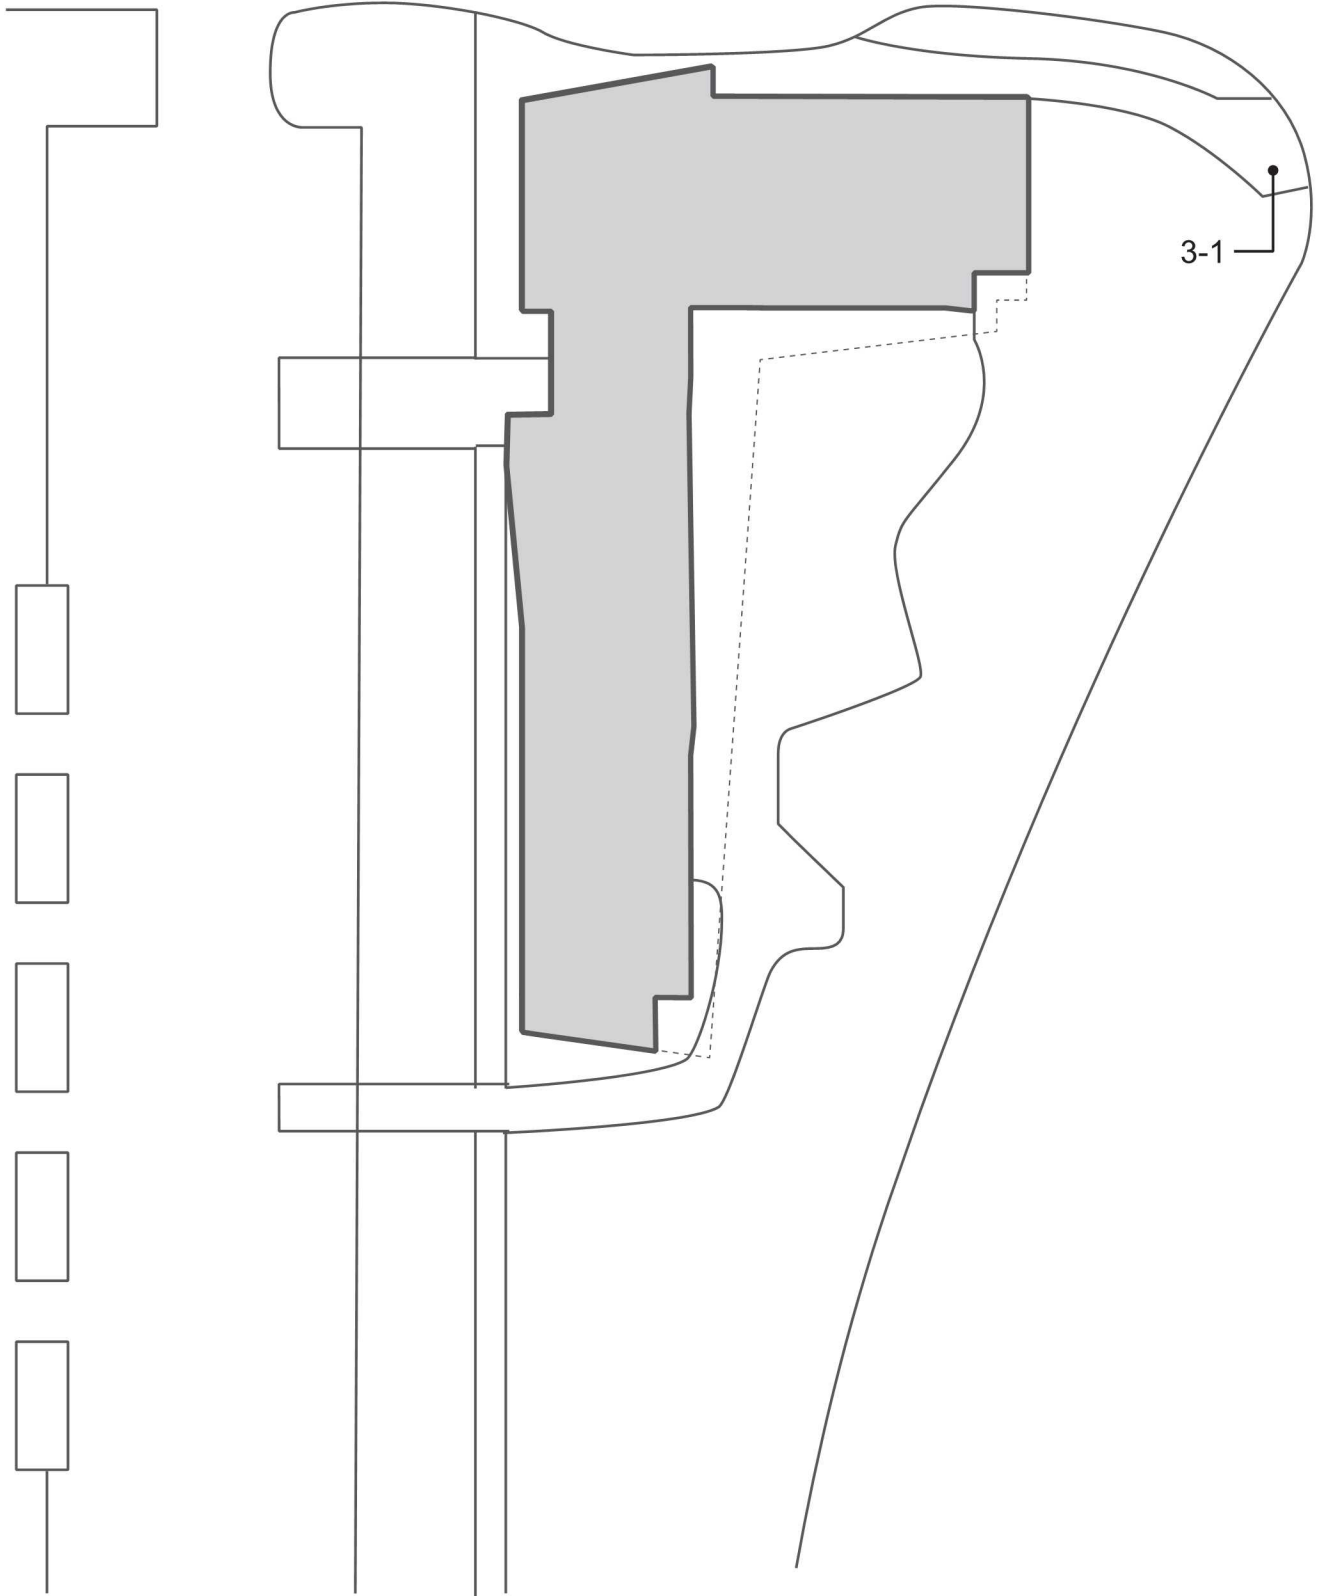
Gateway Childcare Center

3 - 1	Curb Ramp	Priority: 1
Install, replace or modify curb ramp		\$2,500
Notes: Running slope is 8.6%. (8.33% max.) Flared sides have slopes 12.3% and 27%. (10% max.)		
State: 1127B.5.3, 1127B.5.4		
Federal: 405.2, 406.3		
Provide detectable warning strip		\$0
Notes: No detectable warning provided.		
State: 1127B.5.7		
Federal: -		
Provide level landing		\$0
Notes: Level landing at top of ramp is 6.4% (2% max.)		
State: 1127B.5.4		
Federal: -

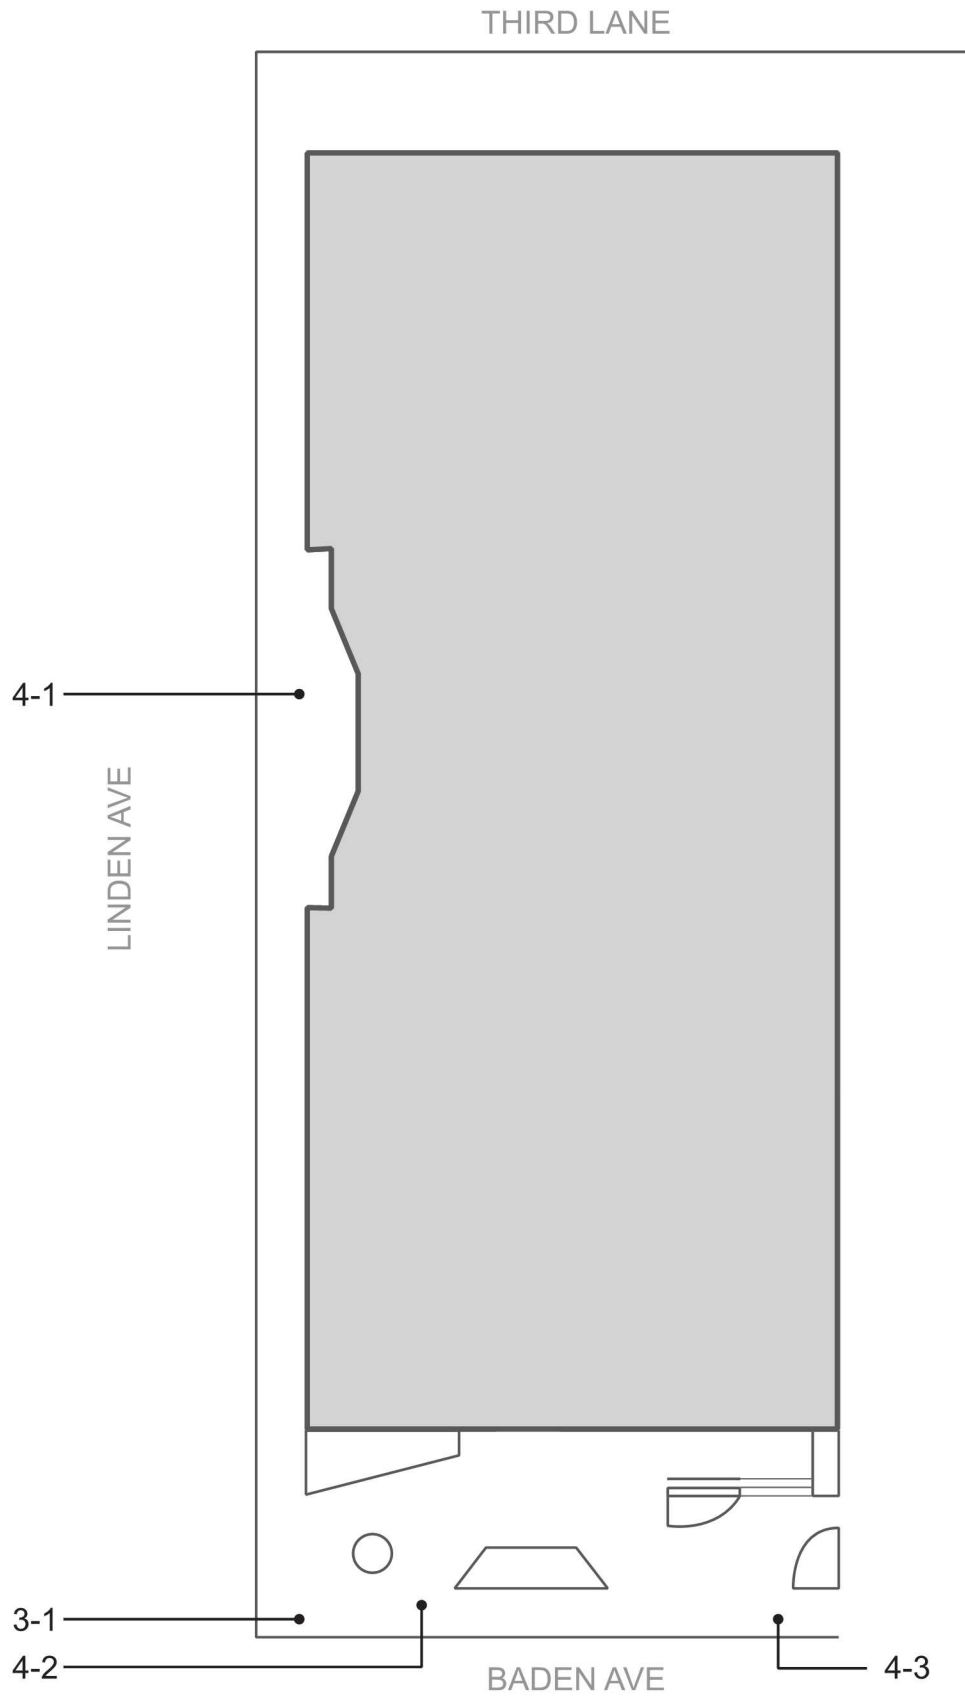
Information Technology Building

3 - 1 Curb Ramp		Priority: 1
Install, replace or modify curb ramp		\$2,500
Notes: Flared side has slope up to 13%. (10% max.)		
State: 1127B.5.3, 1127B.5.4		
Federal: 406.3		
Provide level landing		\$0
Notes: Level landing at top of ramp is 2.9% (2% max.)		
State: 1127B.5.4		
Federal: -		
Provide detectable warning strip		\$0
Notes: No detectable warning provided.		
State: 1127B.5.7		
Federal: -		
Repair surface		\$0
Notes: .5" lip at bottom of ramp. Deteriorated asphalt at gutter line.		
State: 1127B.5.3		
Federal: 405.4		
4 - 1 Walk		Priority: 1
Regrade surface		\$5,000
Notes: 2.1%-5.8% cross slope for 125 lf. (2% max.)		
State: 1133B.7.1.3		
Federal: 403.3		
4 - 2 Walk		Priority: 1
Repair surface		\$250
Notes: .5" change in level at top flag on Baden..		
State: 1124B.2		
Federal: 303.2, 303.3		
4 - 3 Walk		Priority: 1
Regrade surface		\$600
Notes: Up to 2.7% cross slope for 15 lf. (2% max.)		
State: 1133B.7.1.3		
Federal: 403.3

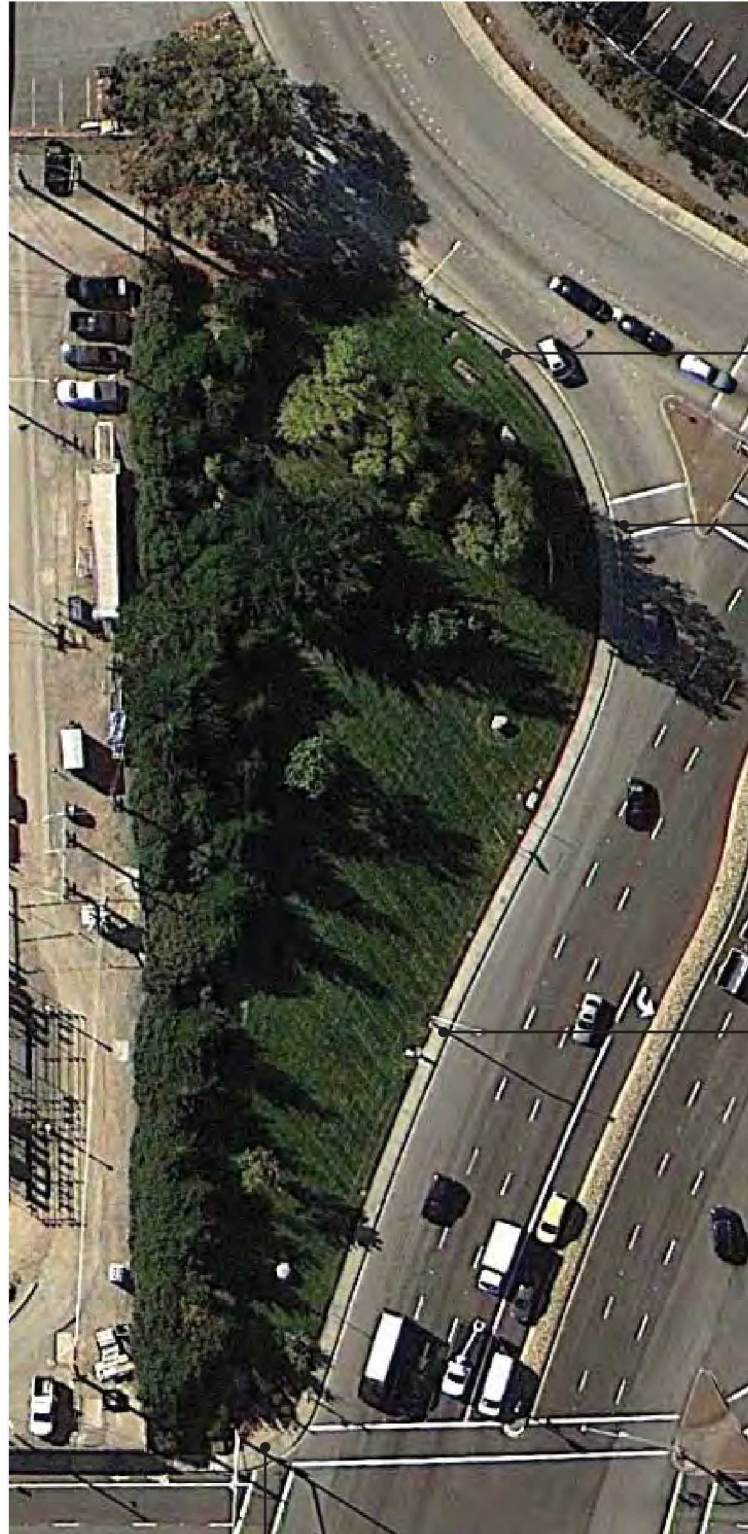
Jack Drago Park

3 - 1		Curb Ramp	Priority: 1
Install, replace or modify curb ramp			\$2,500
Notes: Running slope is 11.1%. (8.33% max.) Flared sides have slopes 11.3% and 13.9%. (10% max.)			
State: 1127B.5.3, 1127B.5.4			
Federal: 405.2, 406.3			
Provide detectable warning strip			\$0
Notes: No detectable warning provided.			
State: 1127B.5.7			
Federal: -			
Provide level landing			\$0
Notes: No level landing provided at top of ramp.			
State: 1127B.5.4			
Federal: -			
3 - 2		Curb Ramp	Priority: 1
Install, replace or modify curb ramp			\$2,500
Notes: Flared side has slope up to 13.5%. (10% max.)			
State: 1127B.5.3, 1127B.5.4			
Federal: 406.3			
Provide detectable warning strip			\$0
Notes: No detectable warning provided.			
State: 1127B.5.7			
Federal: -			
Provide level landing			\$0
Notes: Level landing at top of ramp is 6.7% (2% max.)			
State: 1127B.5.4			
Federal: -			
Repair surface			\$0
Notes: .5" lip at bottom of ramp.

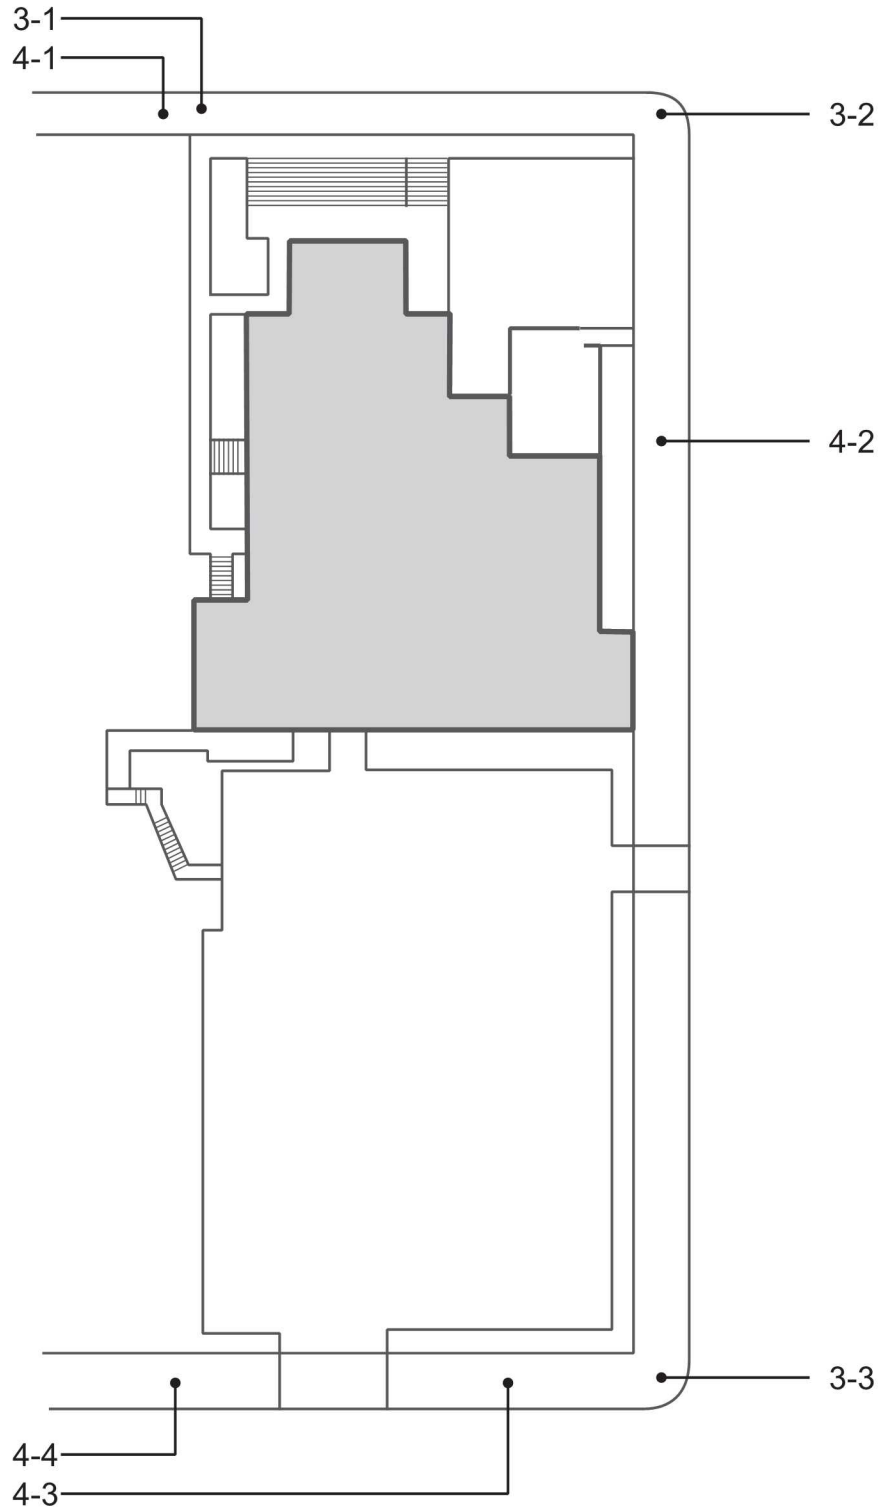
3 - 1 Curb Ramp		Priority: 1
Provide detectable warning strip		\$1,000
Notes:	No detectable warning provided.	
State:	1127B.5.7	
Federal:	-	
Provide level landing		\$250
Notes:	9.2% gutter slope, no level landing provided at bottom of ramp. (5% max.) Level landing at top of ramp is 2.6% (2% max.)	
State:	1127B.5.3, 1127B.5.4	
Federal:	406.2	
Provide surface texturing		\$1,000
Notes:	Grooved border at top of ramp is 6" wide. (12" required)	
State:	1127B.5.6	
Federal:	-	
3 - 2 Curb Ramp		Priority: 1
Provide detectable warning strip		\$0
Notes:	No detectable warning provided.	
State:	1127B.5.7	
Federal:	-	
Provide level landing		\$0
Notes:	Level landing at top of ramp is 2.9% (2% max.)	
State:	1127B.5.3, 1127B.5.4	
Federal:	406.2	
Provide surface texturing		\$0
Notes:	No grooved border provided.	
State:	1127B.5.6	
Federal:	-	
Repair surface		\$0
Notes:	1" change in level at concrete/asphalt joint.	
State:	1127B.5.3	
Federal:	405.4

Install, replace or modify curb ramp		\$2,500
Notes:	No flared sides provided. Greater than 4" change in level from top of curb ramp to gutter.	
State:	1127B.5.3, 1127B.5.4	
Federal:	406.3

3 - 3	Curb Ramp	Priority: 1	
	Provide detectable warning strip		\$0
	Notes: No detectable warning provided.		
	State: 1127B.5.7		
	Federal: -		
	Provide level landing		\$0
	Notes: Level landing at top of ramp is 4.5% (2% max.)		
	State: 1127B.5.4		
	Federal: -		
	Install, replace or modify curb ramp		\$2,500
	Notes: Running slope is 9.9%. (8.33% max.) Flared sides have slopes 17.1% and 20%. (10% max.)		
	State: 1127B.5.3, 1127B.5.4		
	Federal: 405.2, 406.3		
	Repair surface		\$0
	Notes: .5" lip at bottom of ramp.		
	State: 1127B.5.3		
	Federal: 405.4		
4 - 1	Walk	Priority: 1	
	Regrade surface		\$3,200
	Notes: Up to 2.9% cross slope for 80 lf. (2% max.)		
	State: 1133B.7.1.3		
	Federal: 403.3		
4 - 2	Walk	Priority: 1	
	Regrade surface		\$2,600
	Notes: Up to 5.6% cross slope from corner for 65 lf. (2% max.)		
	State: 1133B.7.1.3		
	Federal: 403.3		
4 - 3	Walk	Priority: 1	
	Regrade surface		\$400
	Notes: Up to 3.5% cross slope from corner for 10 lf. (2% max.)

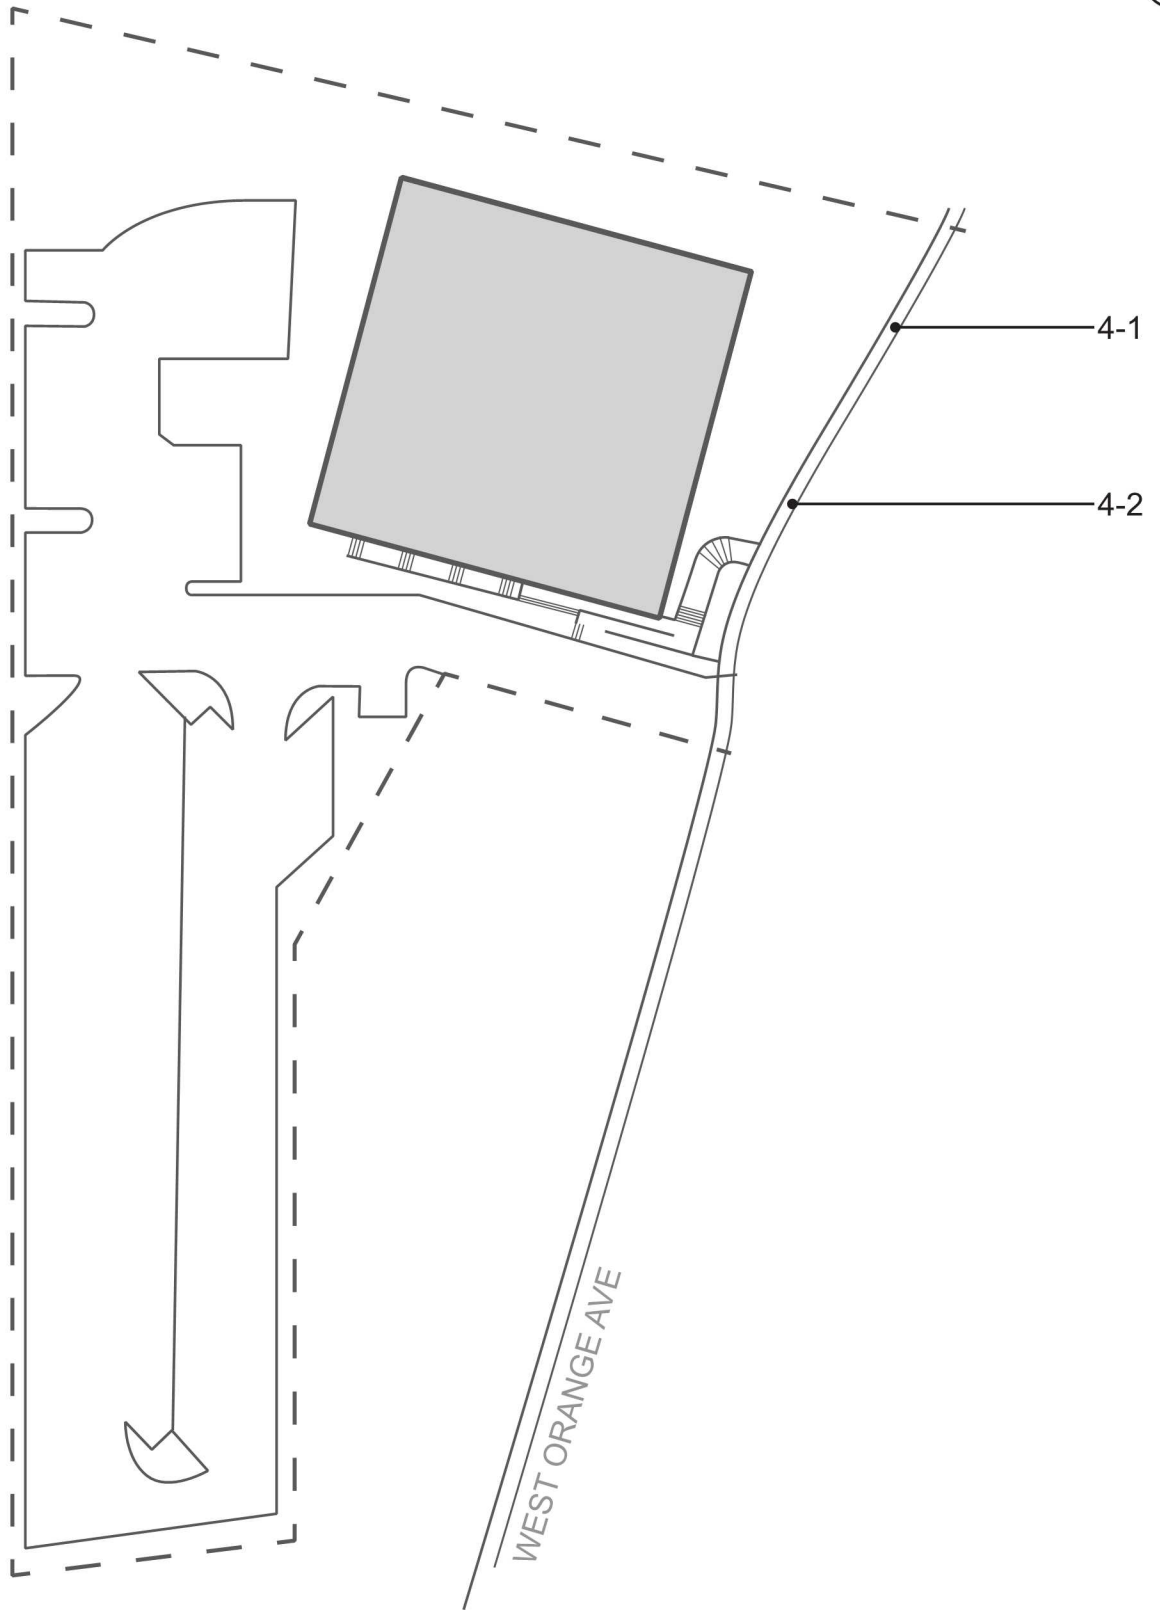
Main Library - PROW

4 - 1	Walk	Priority: 1	
Regrade surface			\$1,200
Notes: 3%-4.1% cross slope for 30 lf. (2% max.)			
State: 1133B.7.1.3			
Federal: 403.3			
4 - 2	Walk	Priority: 1	
Regrade surface			\$1,880
Notes: 2.2%-3.8% cross slope for 47 lf. (2% max.)			
State: 1133B.7.1.3			
Federal: 403.3

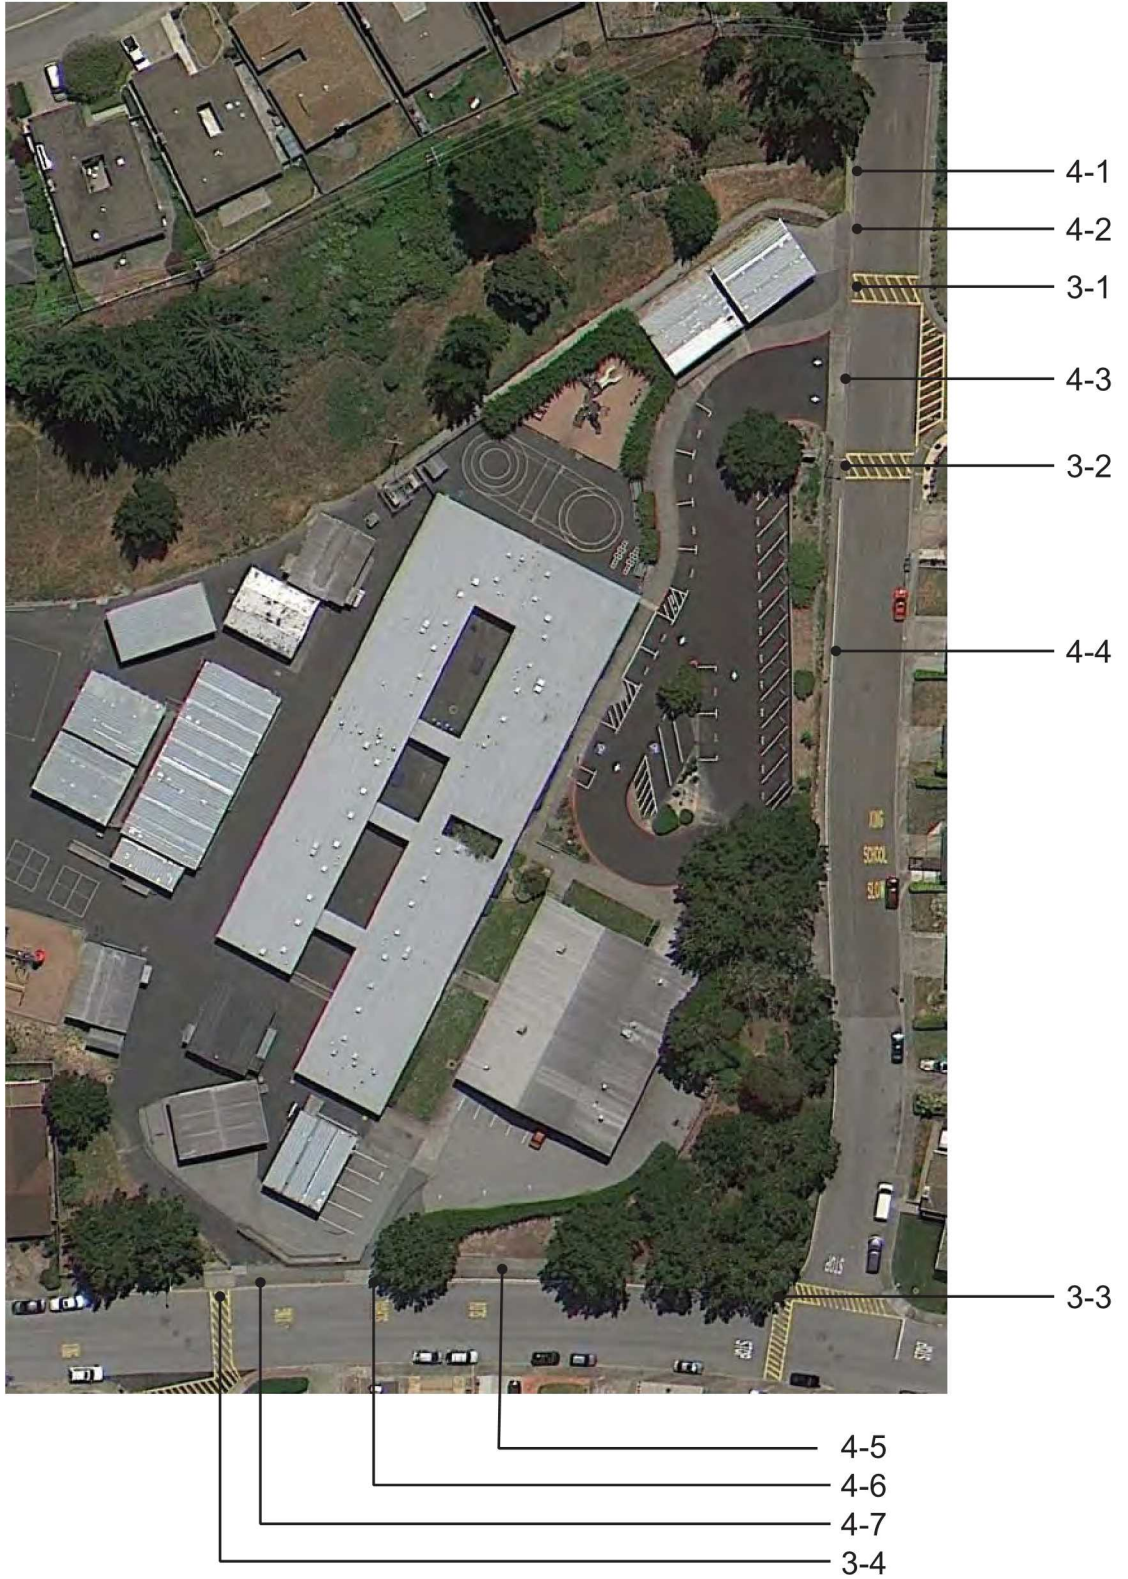
Monte Verde Portables 1 and 2

3 - 1	Curb Ramp	Priority: 1
Provide or relocate crossing or curb markings		\$2,500
Notes: No curb ramp provided at marked pedestrian crosswalk.		
State: 1127B.5		
Federal: 406.1		
3 - 2	Curb Ramp	Priority: 1
Provide or relocate crossing or curb markings		\$2,500
Notes: No curb ramp provided at marked pedestrian crosswalk.		
State: 1127B.5		
Federal: 406.1		
3 - 3	Curb Ramp	Priority: 1
Install, replace or modify curb ramp		\$2,500
Notes: Running slope is 9.4%. (8.33% max.) Flared side has slope up to 16%. (10% max.)		
State: 1127B.5.3, 1127B.5.4		
Federal: 405.2, 406.3		
Provide level landing		\$0
Notes: 5.3% gutter slope (5% max.). No level landing provided at top of ramp. (2% max.)		
State: 1127B.5.3, 1127B.5.4		
Federal: 406.2		
Provide detectable warning strip		\$0
Notes: No detectable warning provided.		
State: 1127B.5.7, IR11B-4		
Federal: -		
3 - 4	Curb Ramp	Priority: 1
Install, replace or modify curb ramp		\$2,500

Notes: Running slope is 9%. (8.33% max.) Flared side has slope up to 11%. (10% max.)		
State: 1127B.5.3, 1127B.5.4		
Federal: 405.2, 406.3		
Provide level landing		\$0
Notes: 6.5% gutter slope. (5% max.) 9% Slope at top of ramp, no level landing provided. (2% max.)		
State: 1127B.5.3, 1127B.5.4		
Federal: 406.2		
Provide detectable warning strip		\$0
Notes: No detectable warning provided.		
State: 1127B.5.7, IR11B-4		
Federal: -

4 - 7	Walk	Priority: 1
Regrade surface		\$1,480
Notes: 5% cross slope for 37 lf. (2% max.)		
State: 1133B.7.1.3		
Federal: 403.3		
Repair surface		\$0
Notes: Deteriorated asphalt surface at concrete joint.		
State: 1124B.2		
Federal: 303.2, 303.3
