CITY OF SOUTH SAN FRANCISCO

AMERICANS WITH DISABILITIES ACT self evaluation and transition plan

APPENDICES

Appendix D: Pedestrian Rights-of-Way Reports and Maps

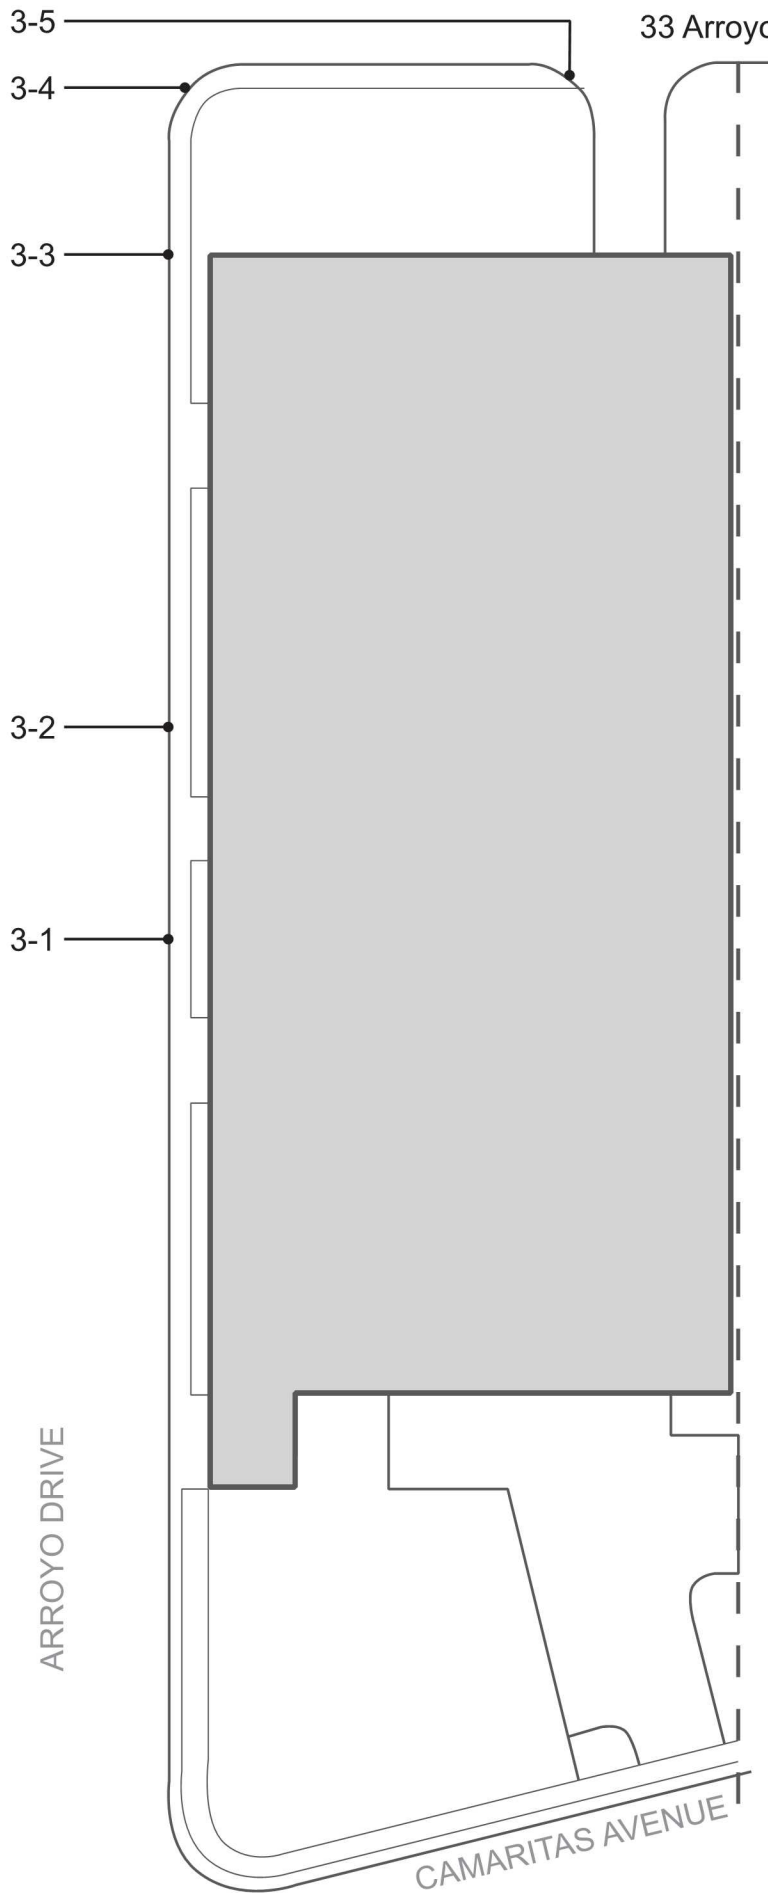
Municipal Services Building

3 - 1	Curb Ramp	Priority: 1
Install, replace or modify curb ramp		\$2,500
Notes: Running slope is 18.5%. (8.33% max.) No flared sides - CHECK!		
State: 1127B.5.3		
Federal: 405.2		
Provide detectable warning strip		\$0
Notes: No detectable warning provided.		
State: 1127B.5.7, IR11B-4		
Federal: -		
Repair surface		\$0
Notes: .5" lip at bottom of ramp.		
State: 1127B.5.3		
Federal: 405.4		
3 - 2	Curb Ramp	Priority: 1
Install, replace or modify curb ramp		\$2,500
Notes: Running slope is 13.1%. (8.33% max.)		
State: 1127B.5.3		
Federal: 405.2		
Provide detectable warning strip		\$0
Notes: No detectable warning provided.		
State: 1127B.5.7, IR11B-4		
Federal: -		
Provide level landing		\$0
Notes: Level landing at top of ramp is 2.3% (2% max.) and 36" deep (48"x48" min.)		
State: 1127B.5.4		
Federal: -

3 - 3	Curb Ramp	Priority: 1
Install, replace or modify curb ramp		\$2,500
Notes: Running slope is 10.5%. (8.33% max.) Flared sides have slopes 12.6% and 12.3%. (10% max.)		
State: 1127B.5.3, 1127B.5.4		
Federal: 405.2, 406.3		
Provide detectable warning strip		\$0
Notes: No detectable warning provided.		
State: 1127B.5.7, IR11B-4		
Federal: -		
Repair surface		\$0
Notes: .5" lip at bottom of ramp.		
State: 1127B.5.3		
Federal: 405.4		
Provide level landing		\$0
Notes: Level landing at top of ramp is 36" deep (48"x48" min.)		
State: 1127B.5.4		
Federal: -		
3 - 4	Curb Ramp	Priority: 1
Install, replace or modify curb ramp		\$2,500
Notes: Flared side has slope up to 13%. (10% max.)		
State: 1127B.5.3, 1127B.5.4		
Federal: 406.3		
Provide detectable warning strip		\$0
Notes: No detectable warning provided.		
State: 1127B.5.7, IR11B-4		
Federal: -		
Repair surface		\$0
Notes: .5" lip at bottom of ramp.		
State: 1127B.5.3

3 - 5	Curb Ramp	Priority: 1
Install, replace or modify curb ramp		\$2,500
Notes: Running slope is 11.4%. (8.33% max.)		
State: 1127B.5.3		
Federal: 405.2		
Provide detectable warning strip		\$0
Notes: No detectable warning provided.		
State: 1127B.5.7, IR11B-4		
Federal: -		
Provide level landing		\$0
Notes: Level landing at top of ramp is 3.5% (2% max.)		
State: 1127B.5.4		
Federal: -

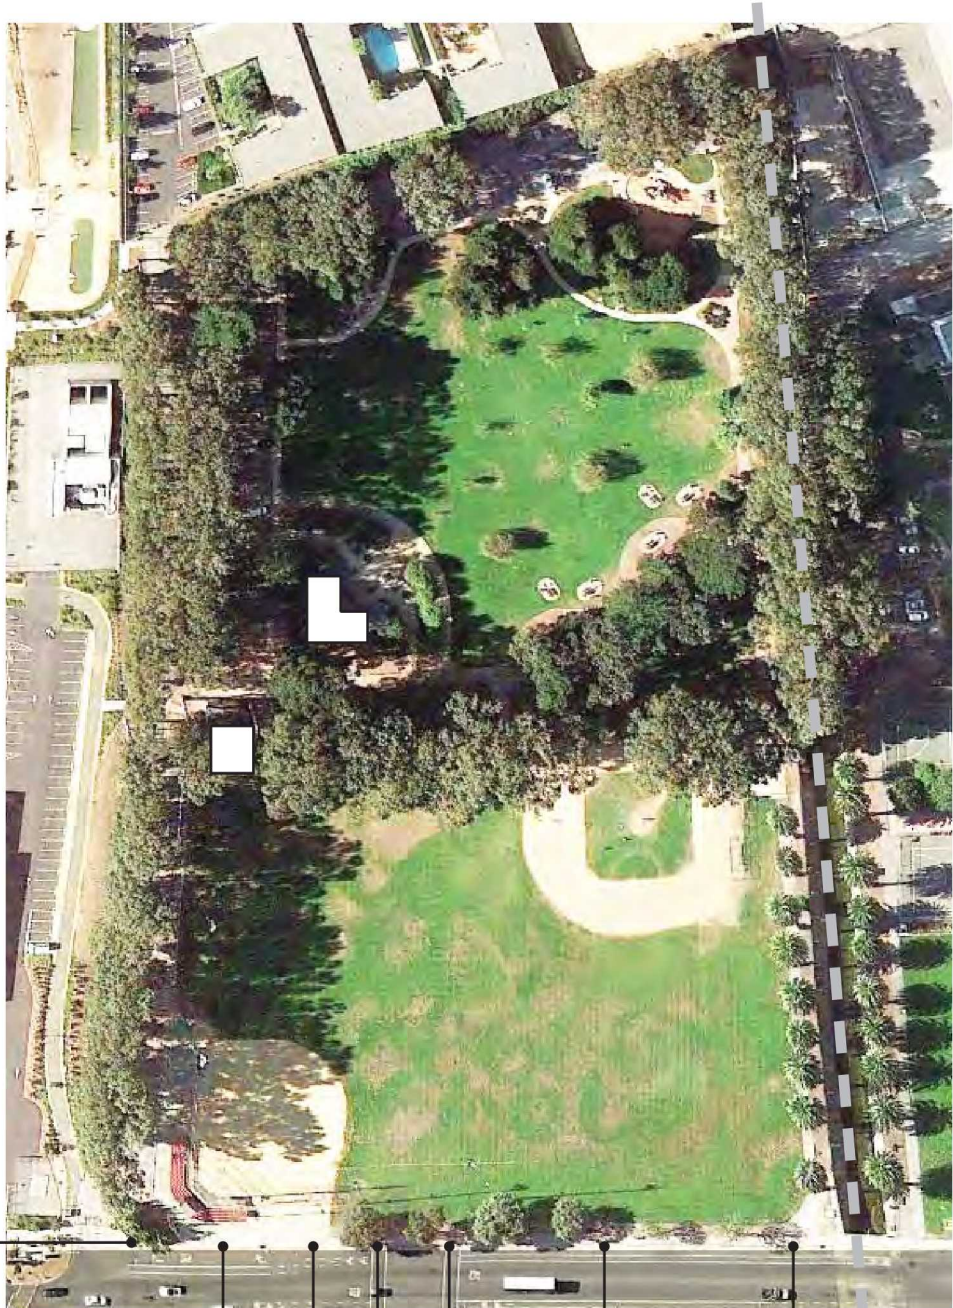
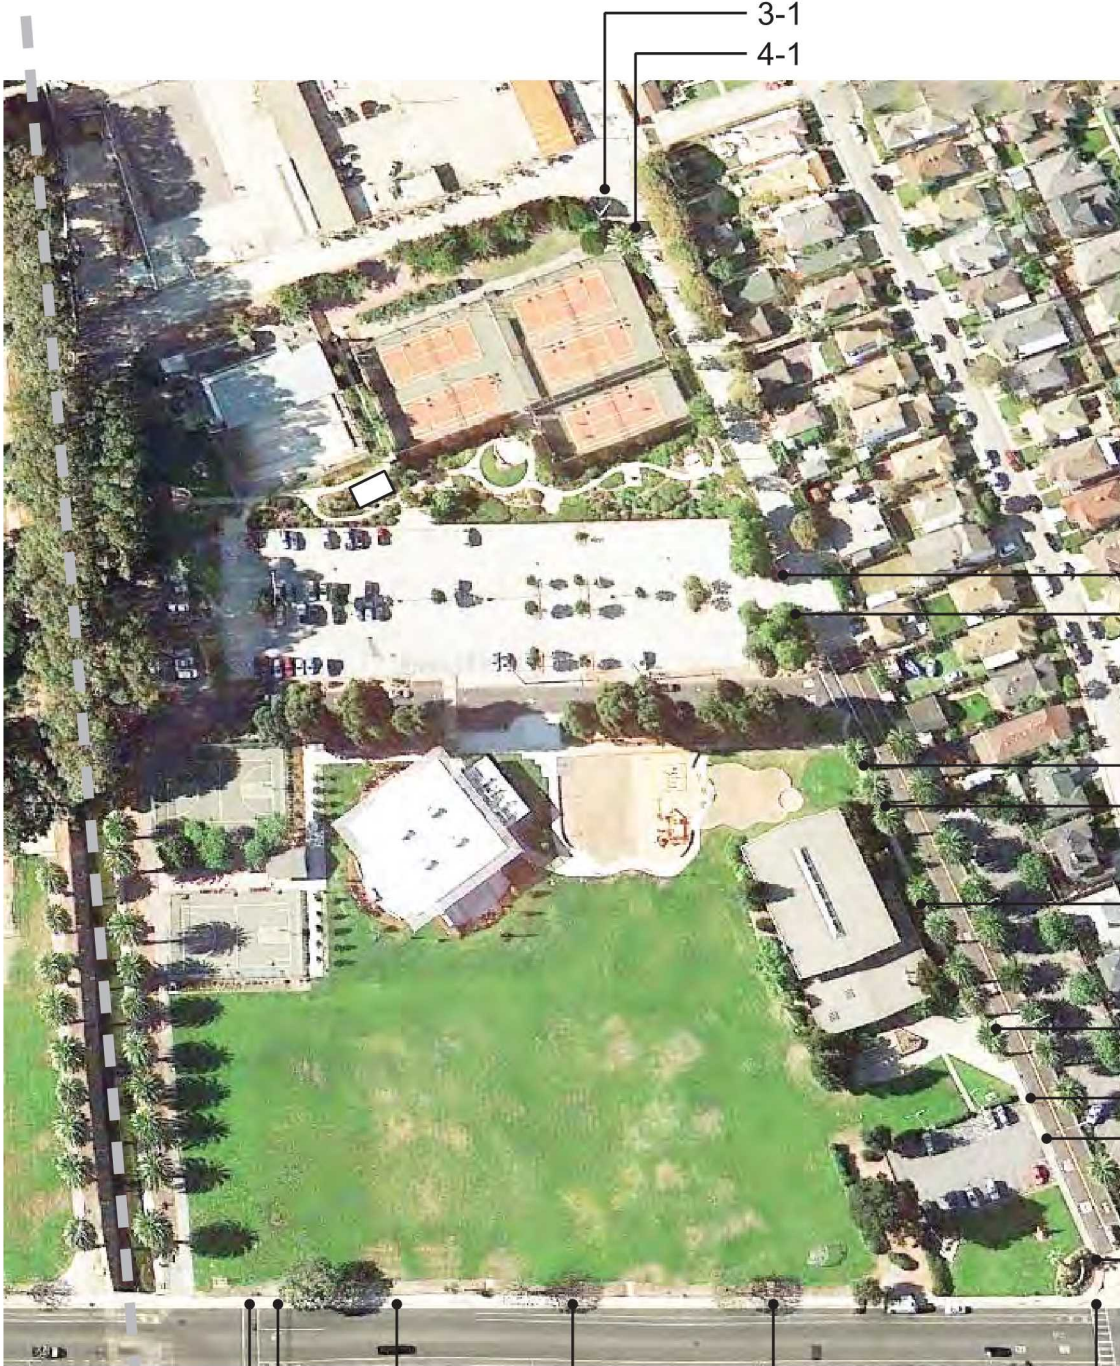
Orange Memorial Park
781 Tennis Drive, South San Francisco, CA
South Parcel

3 - 1	Curb Ramp	Priority: 1
Provide detectable warning strip		\$1,000
Notes: No detectable warning provided.		
State: 1127B.5.7, IR11B-4		
Federal: -		
3 - 2	Curb Ramp	Priority: 1
Provide detectable warning strip		\$0
Notes: No detectable warning provided.		
State: 1127B.5.7, IR11B-4		
Federal: -		
Install, replace or modify curb ramp		\$2,500
Notes: 2.7% cross slope at bottom of ramp. (Slope of ramp is to be in a single plane)		
State: 1127B.5.3		
Federal: 405.2		
3 - 3	Curb Ramp	Priority: 1
Provide detectable warning strip		\$0
Notes: No detectable warning provided.		
State: 1127B.5.7, IR11B-4		
Federal: -		
Install, replace or modify curb ramp		\$2,500
Notes: Running slope is 9.5%. (8.33% max.)		
State: 1127B.5.3		
Federal: 405.2		
Repair surface		\$0
Notes: .5" lip at asphalt/gutter joint.		
State: 1127B.5.3		
Federal: 405.4		
Provide level landing		\$0
Notes: No level landing provided at top of ramp.		
State: 1127B.5.4

3 - 4	Curb Ramp	Priority: 1
Provide detectable warning strip		\$0
Notes: No detectable warning provided.		
State: 1127B.5.7, IR11B-4		
Federal: -		
Install, replace or modify curb ramp		\$2,500
Notes: Running slope is 11.8%. (8.33% max.) Flared sides have slopes 11.8% and 13.5%. (10% max.)		
State: 1127B.5.3, 1127B.5.4		
Federal: 405.2, 406.3		
Repair surface		\$0
Notes: .5" lip at utility cover.		
State: 1127B.5.3		
Federal: 405.4		
Provide level landing		\$0
Notes: No level landing provided at top of ramp. 14.5% gutter slope, no level landing provided at bottom of ramp. (5% max.)		
State: 1127B.5.3, 1127B.5.4		
Federal: 406.2		
3 - 5	Curb Ramp	Priority: 1
Install, replace or modify curb ramp		\$2,500
Notes: Running slope ranges from 10.1%-12.7%. (8.33% max.)		
State: 1127B.5.3, 1127B.5.4		
Federal: 405.2, 406.3		
Provide detectable warning strip		\$0
Notes: No detectable warning provided.		
State: 1127B.5.7, IR11B-4

Federal: -		
Repair surface		\$0
Notes: .5" lip at bottom of ramp.		
State: 1127B.5.3		
Federal: 405.4		
Provide level landing		\$0
Notes: Level landing at top of ramp is 2.5% (2% max.) 9% gutter slope, no level landing provided at bottom of ramp. (5% max.)		
State: 1127B.5.3, 1127B.5.4		
Federal: 406.2

3 - 6	Curb Ramp	Priority: 1
Install, replace or modify curb ramp		\$2,500
Notes: Running slope ranges from 10.5%-11%. (8.33% max.)		
State: 1127B.5.3, 1127B.5.4		
Federal: 405.2, 406.3		
Provide detectable warning strip		\$0
Notes: No detectable warning provided.		
State: 1127B.5.7, IR11B-4		
Federal: -		
Repair surface		\$0
Notes: .75" lip at bottom of ramp and .5" change in level at asphalt joint.		
State: 1127B.5.3		
Federal: 405.4		
Provide level landing		\$0
Notes: Level landing at top of ramp has 3% cross slope. (2% max.) 7.9% gutter slope, no level landing provided at bottom of ramp. (5% max.)		
State: 1127B.5.3, 1127B.5.4		
Federal: 406.2		
3 - 7	Curb Ramp	Priority: 1
Provide or relocate crossing or curb markings		\$2,500
Notes: No curb ramp provided at marked pedestrian crossing.		
State: 1127B.5		
Federal: 406.1		
3 - 8	Curb Ramp	Priority: 1
Provide detectable warning strip		\$1,000
Notes: No detectable warning provided.

4 - 8	Walk	Priority: 1	
Provide detectable warning strip			\$1,000
Notes: No detectable warning provided at crosswalk.			
State: 1133B.8.5			
Federal: -			
4 - 9	Walk	Priority: 1	
Regrade surface			\$1,280
Notes: Up to 2.6% cross slope for 32 lf. (2% max.)			
State: 1133B.7.1.3			
Federal: 403.3			
Repair surface			\$0
Notes: Deteriorated concrete, 32 lf.			
State: 1124B.2			
Federal: 303.2, 303.3			
4 - 10	Walk	Priority: 1	
Regrade surface			\$1,200
Notes: 7.1%-8.2% cross slope across drive for 30 lf. (2% max.)			
State: 1133B.7.1.3			
Federal: 403.3			
4 - 11	Walk	Priority: 1	
Regrade surface			\$800
Notes: Up to 4% cross slope for 20 lf. (2% max.)			
State: 1133B.7.1.3			
Federal: 403.3			
Repair surface			\$0
Notes: .5" change in level at expansion joint near corner.			
State: 1124B.2			
Federal: 303.2, 303.3			
4 - 12	Walk	Priority: 1	
Regrade surface			\$800
Notes: Up to 2.5% cross slope near tree for 20 lf. (2% max.)

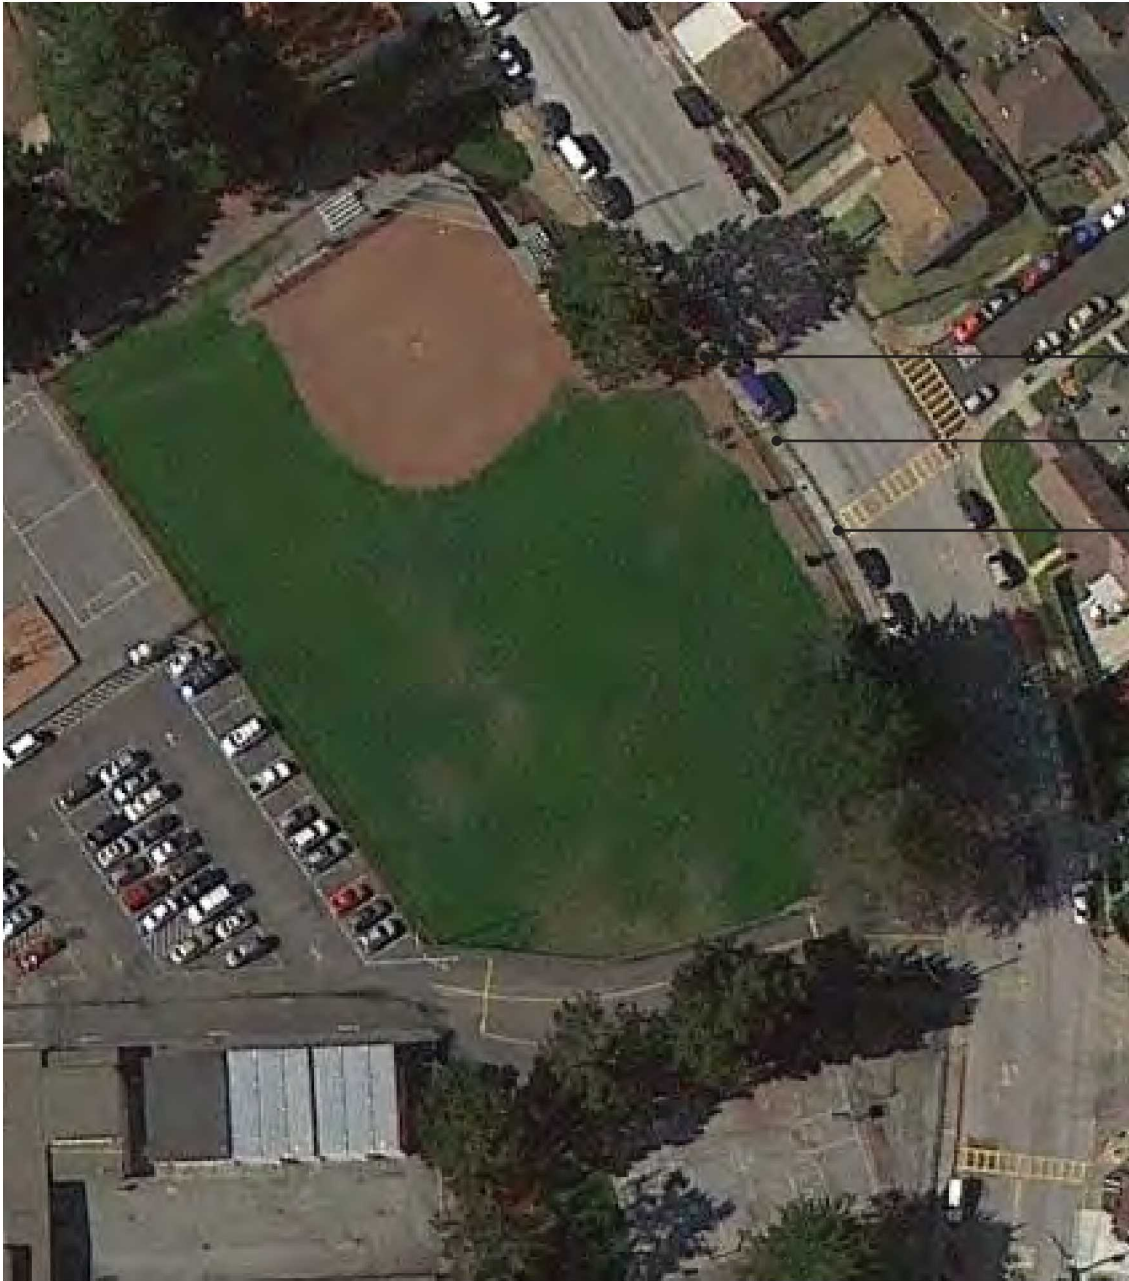
Paradise Valley Ballfields

3 - 1	Curb Ramp	Priority: 1	
Provide or relocate crossing or curb markings			\$2,500
Notes: No curb ramp provided at marked pedestrian crossing.			
State: 1127B.5			
Federal: 406.1			
4 - 1	Walk	Priority: 1	
Repair surface			\$250
Notes: Changes in level have been ground, still require patching, typical.			
State: 1124B.2			
Federal: 303.2, 303.3			
4 - 2	Walk	Priority: 1	
Repair surface			\$600
Notes: Deteriorated cracked concrete, 15 lf.			
State: 1124B.2			
Federal: 303.2, 303.3

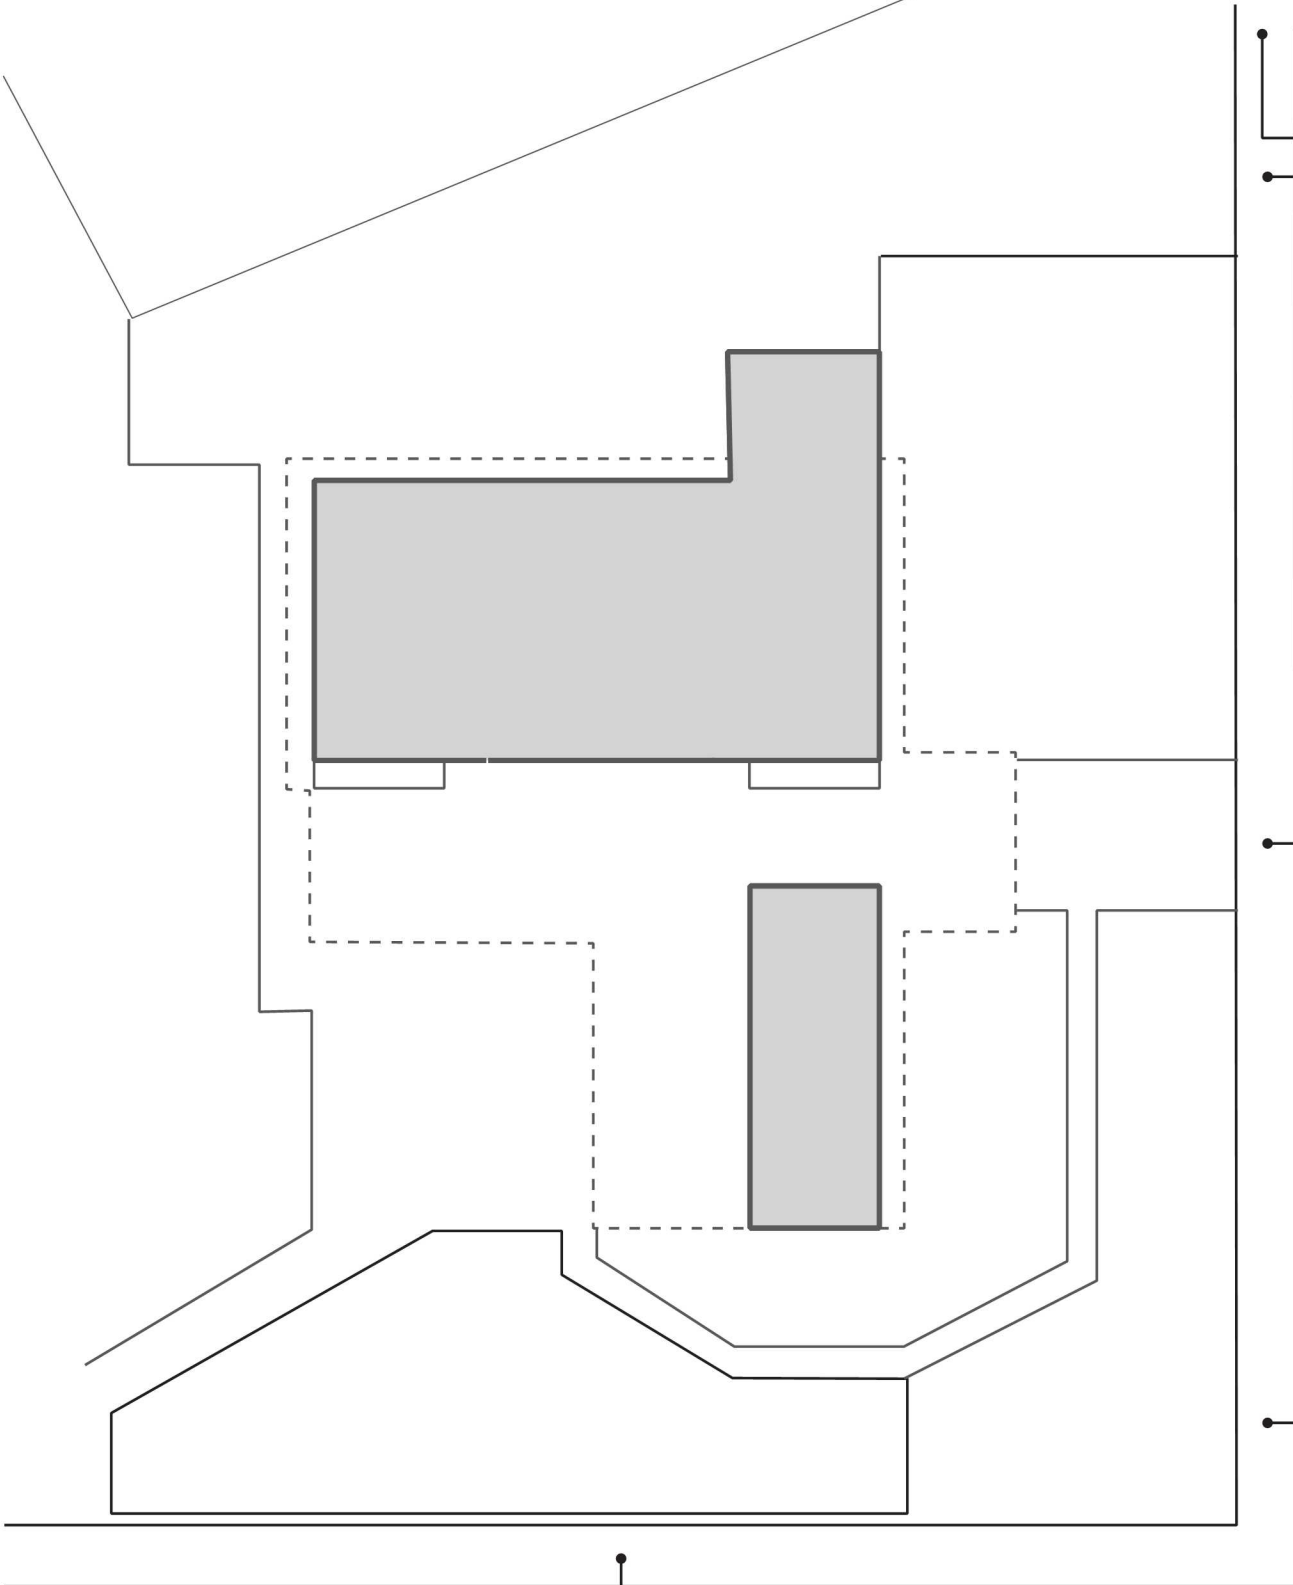
Paradise Valley Recreation Center - PROW

3 - 1	Curb Ramp	Priority: 1	
	Provide or relocate crossing or curb markings		\$2,500
	Notes: No curb ramp provided at marked pedestrian crossing.		
	State: 1127B.5		
	Federal: 406.1		
3 - 2	Curb Ramp	Priority: 1	
	Provide or relocate crossing or curb markings		\$2,500
	Notes: No curb ramp provided at marked pedestrian crossing.		
	State: 1127B.5		
	Federal: 406.1		
4 - 1	Walk	Priority: 1	
	Repair surface		\$5,000
	Notes: Deteriorated asphalt walk, 125 lf.		
	State: 1124B.2		
	Federal: 303.2, 303.3		
4 - 2	Walk	Priority: 1	
	Regrade surface		\$480
	Notes: 2.6% cross slope for 12 lf. (2% max.)		
	State: 1133B.7.1.3		
	Federal: 403.3		
4 - 3	Walk	Priority: 1	
	Repair surface		\$250
	Notes: Asphalt walk cracked at joint.		
	State: 1124B.2		
	Federal: 303.2, 303.3		
	Widen walk		\$150
	Notes: Walk reduced to 36" wide due to landscape debris. (48" min.) Maintenance required.		
	State: 1133B.7.1		
	Federal: -

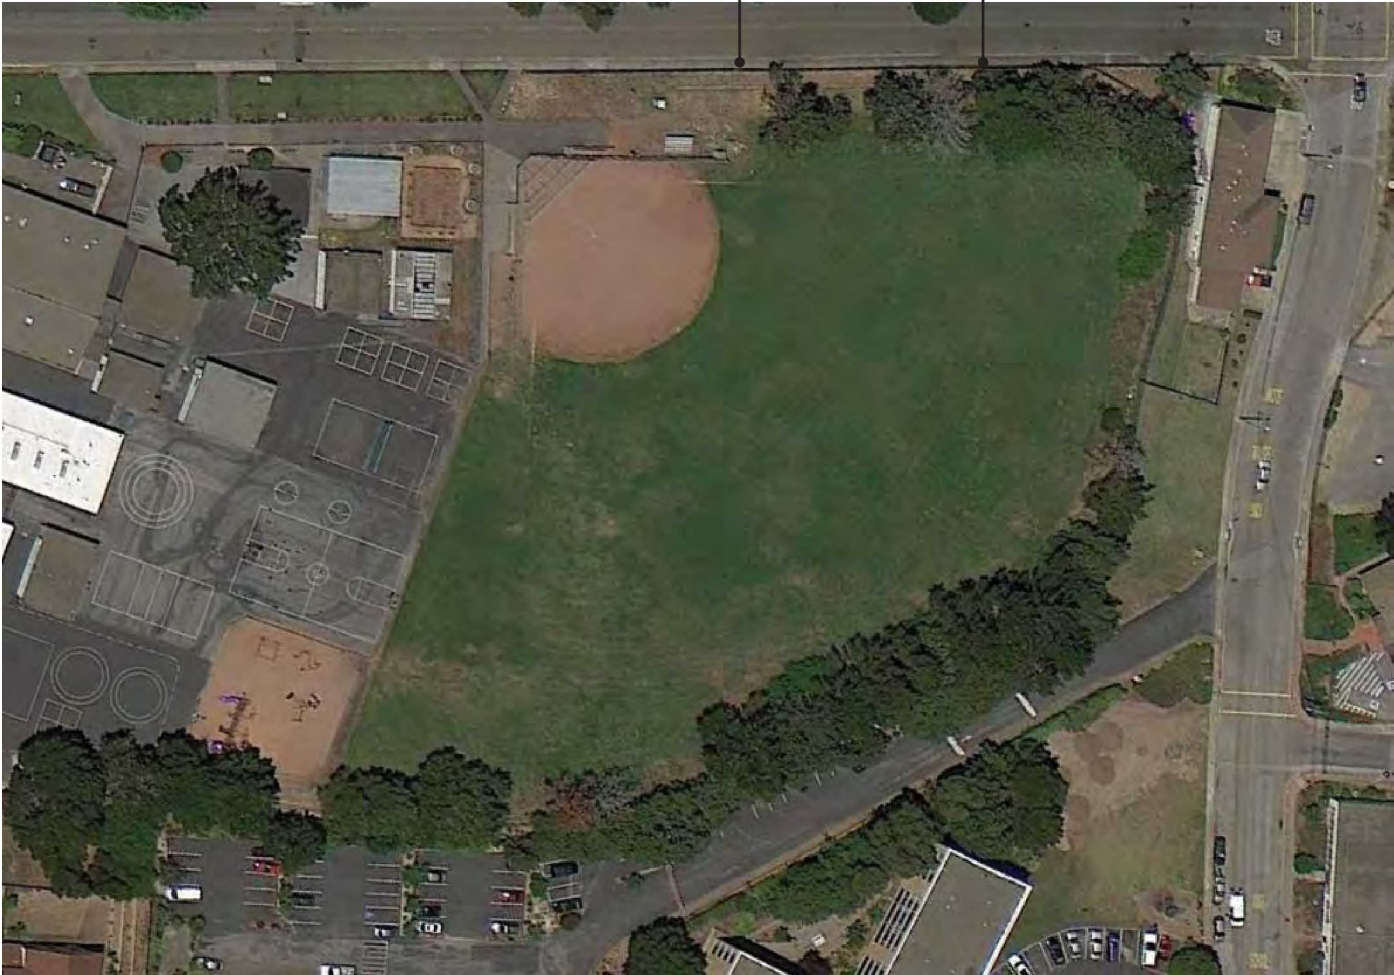
Ponderosa School Ballfields - PROW

4 - 1	Walk	Priority: 1
Regrade surface		\$14,000
Notes: 2.1%-3.5% cross slope, up to 4% at pathway, for 350 lf. (2% max.)		
State: 1133B.7.1.3		
Federal: 403.3		
4 - 2	Walk	Priority: 1
Repair surface		\$250
Notes: .5" change in level at expansion joints across walk have been flagged for addressing, typical.		
State: 1124B.2		
Federal: 303.2, 303.3

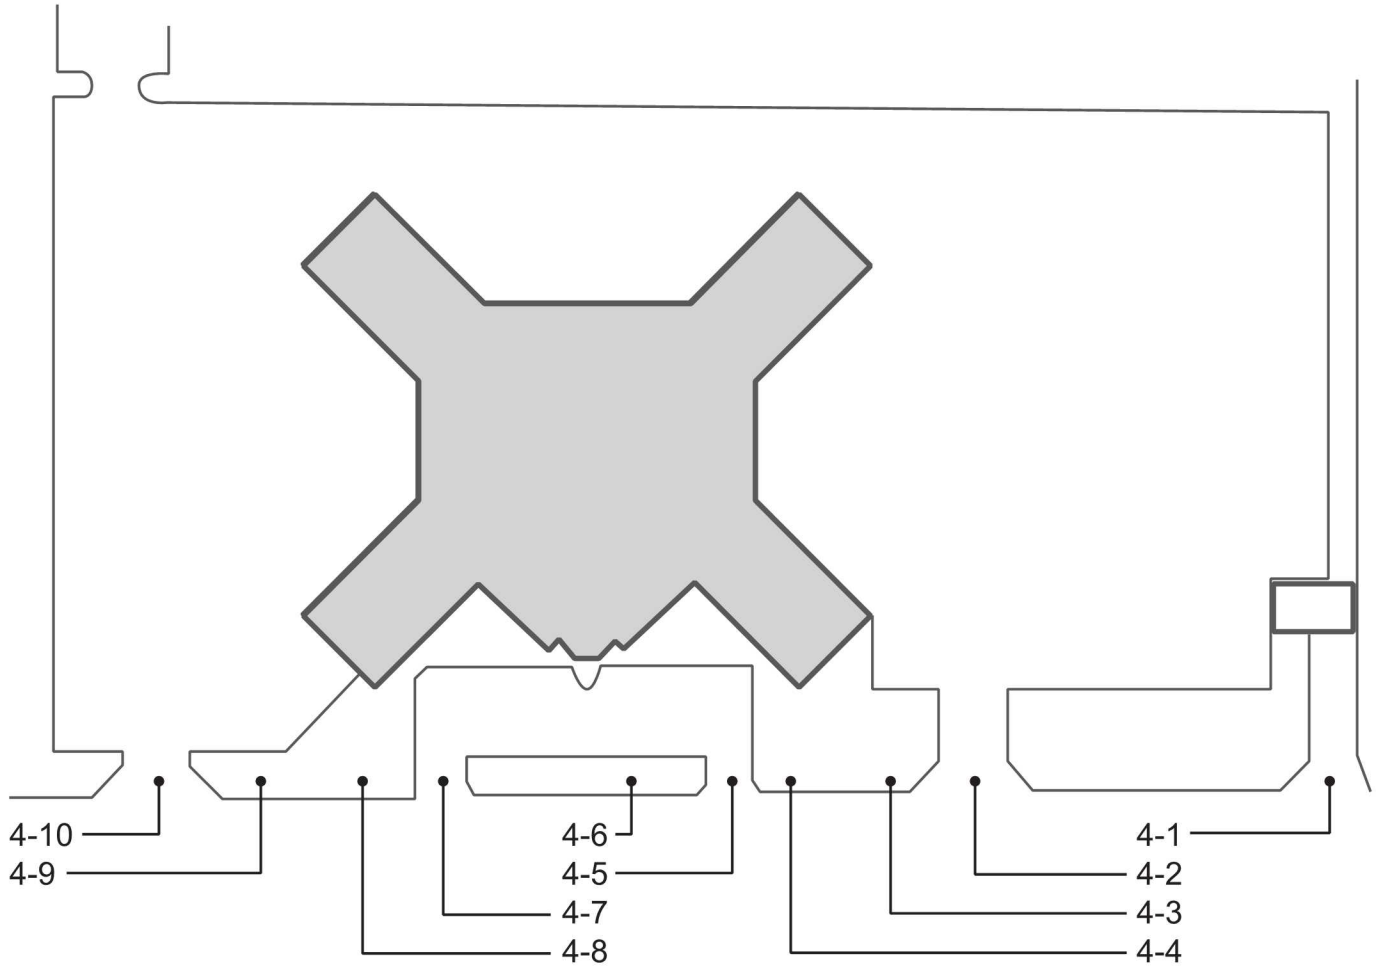
Public Works Corporation Yard
550 North Canal Street, South San Francisco, CA

4 - 1	Walk	Priority: 1	
	Regrade surface		\$1,520
Notes: Up to 9.3% cross slope across drive for 38 lf. (2% max.)			
State: 1133B.7.1.3			
Federal: 403.3			
4 - 2	Walk	Priority: 1	
	Regrade surface		\$2,480
Notes: Up to 10.2% cross slope across drive for 62 lf. (2% max.)			
State: 1133B.7.1.3			
Federal: 403.3			
4 - 3	Walk	Priority: 1	
	Regrade surface		\$640
Notes: 2.1%-2.5% cross slope at hydrant for 16 lf. (2% max.)			
State: 1133B.7.1.3			
Federal: 403.3			
4 - 4	Walk	Priority: 1	
	Regrade surface		\$600
Notes: 2.1%-2.5% cross slope at water vault for 15 lf. (2% max.)			
State: 1133B.7.1.3			
Federal: 403.3			
4 - 5	Walk	Priority: 1	
	Regrade surface		\$1,360
Notes: 2.1%-9.9% cross slope across drive and at adjacent flag, 34 lf. (2% max.)			
State: 1133B.7.1.3			
Federal: 403.3			
4 - 6	Walk	Priority: 1	
	Regrade surface		\$1,840
Notes: 2.1%-2.6% cross slope for 46 lf. (2% max.)			
State: 1133B.7.1.3			
Federal: 403.3

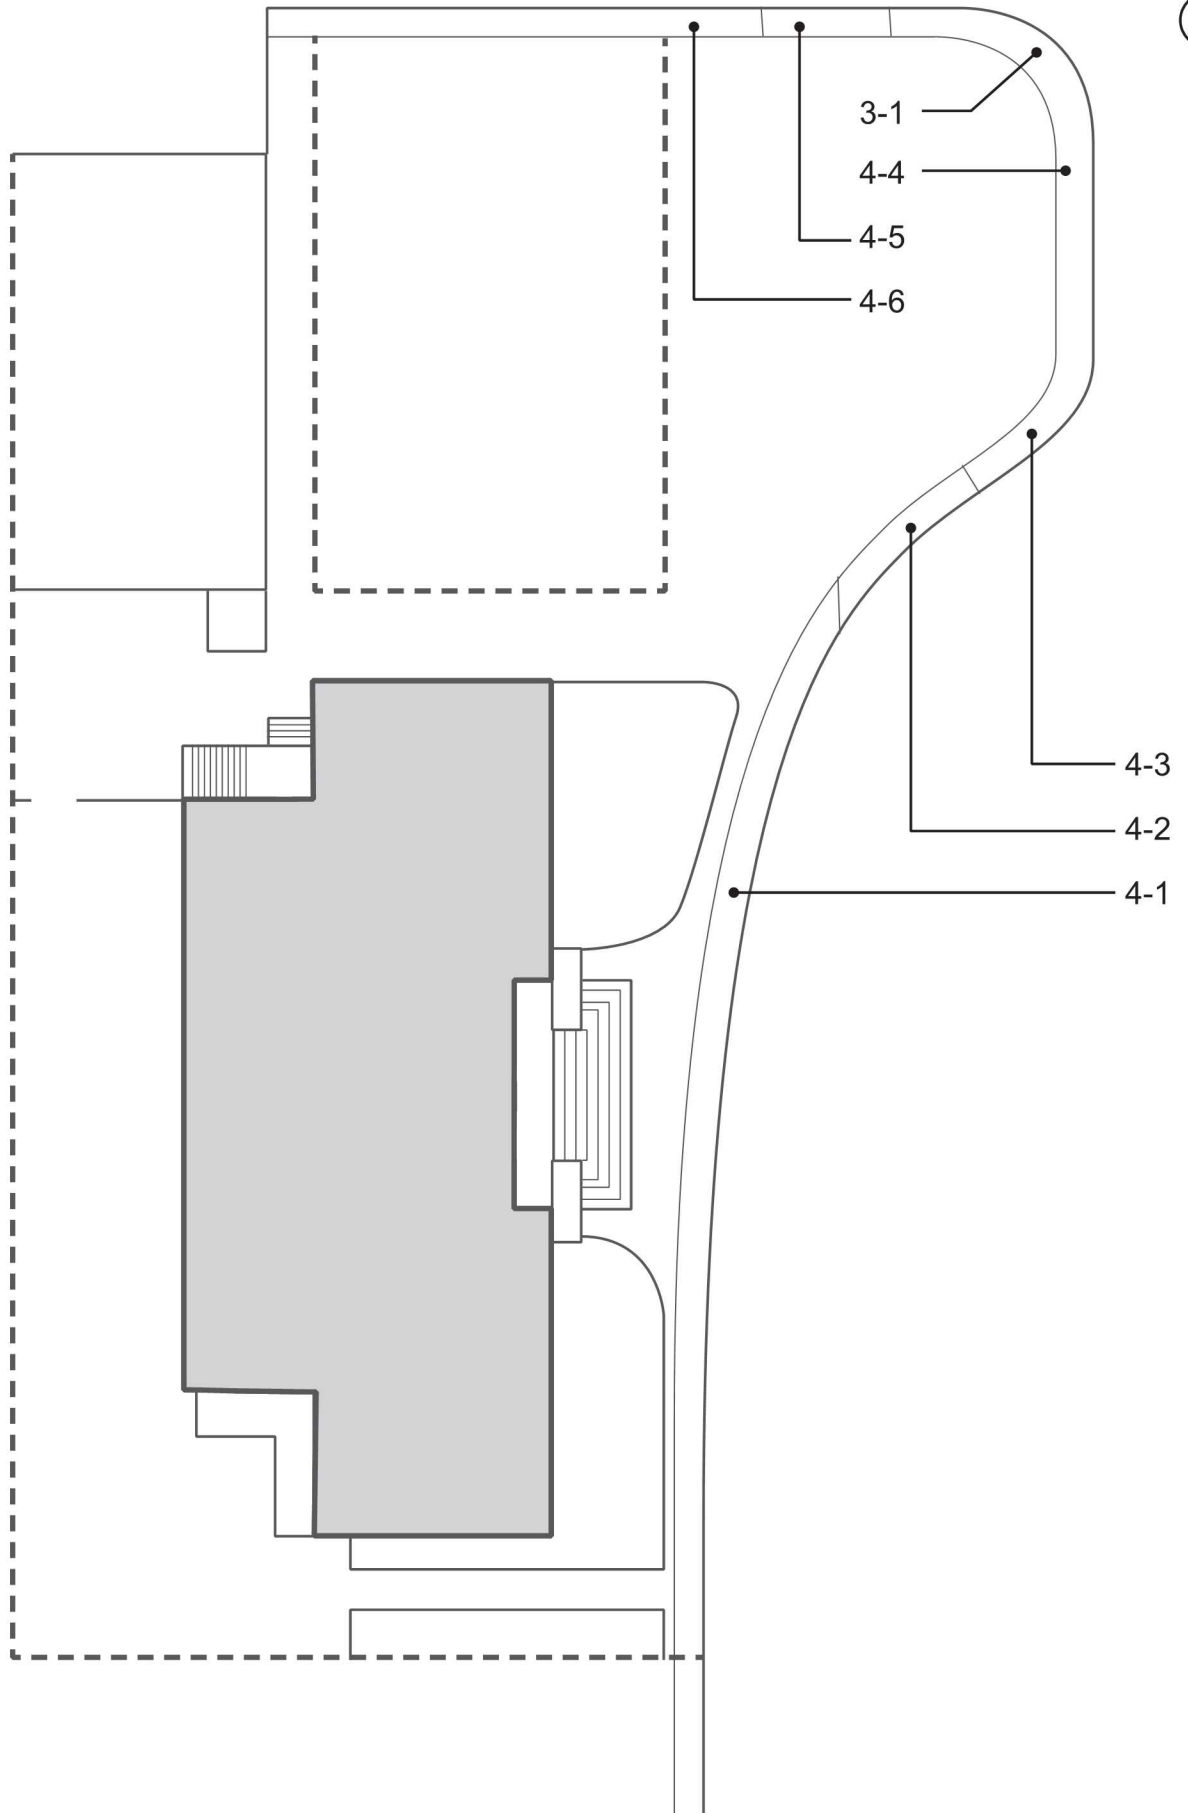
Siebecker Center

3 - 1	Curb Ramp	Priority: 1	
	Provide or relocate crossing or curb markings		\$2,500
	Notes: No curb ramp provided at marked pedestrian crossing.		
	State: 1127B.5		
	Federal: 406.1		
4 - 1	Walk	Priority: 1	
	Widen walk		\$3,800
	Notes: Walk is 44" wide for 45 lf. (48" min.)		
	State: 1133B.7.1		
	Federal: -		
	Regrade surface		\$7,800
	Notes: 2.1%-3.8% cross slope for 95 lf. (2% max.)		
	State: 1133B.7.1.3		
	Federal: 403.3		
4 - 2	Walk	Priority: 1	
	Regrade surface		\$1,200
	Notes: 11.4% cross slope across drive for 30 lf. (2% max.)		
	State: 1133B.7.1.3		
	Federal: 403.3		
4 - 3	Walk	Priority: 1	
	Widen walk		\$0
	Notes: Walk is 44" wide for 45 lf. (48" min.)		
	State: 1133B.7.1		
	Federal: -		
	Regrade surface		\$3,800
	Notes: 2.1%-4.1% cross slope for 95 lf. (2% max.)		
	State: 1133B.7.1.3		
	Federal: 403.3		
4 - 4	Walk	Priority: 1	
	Regrade surface		\$2,000
	Notes: 2.1%-4.4% cross slope for 50 lf. (2% max.)		
	State: 1133B.7.1.3

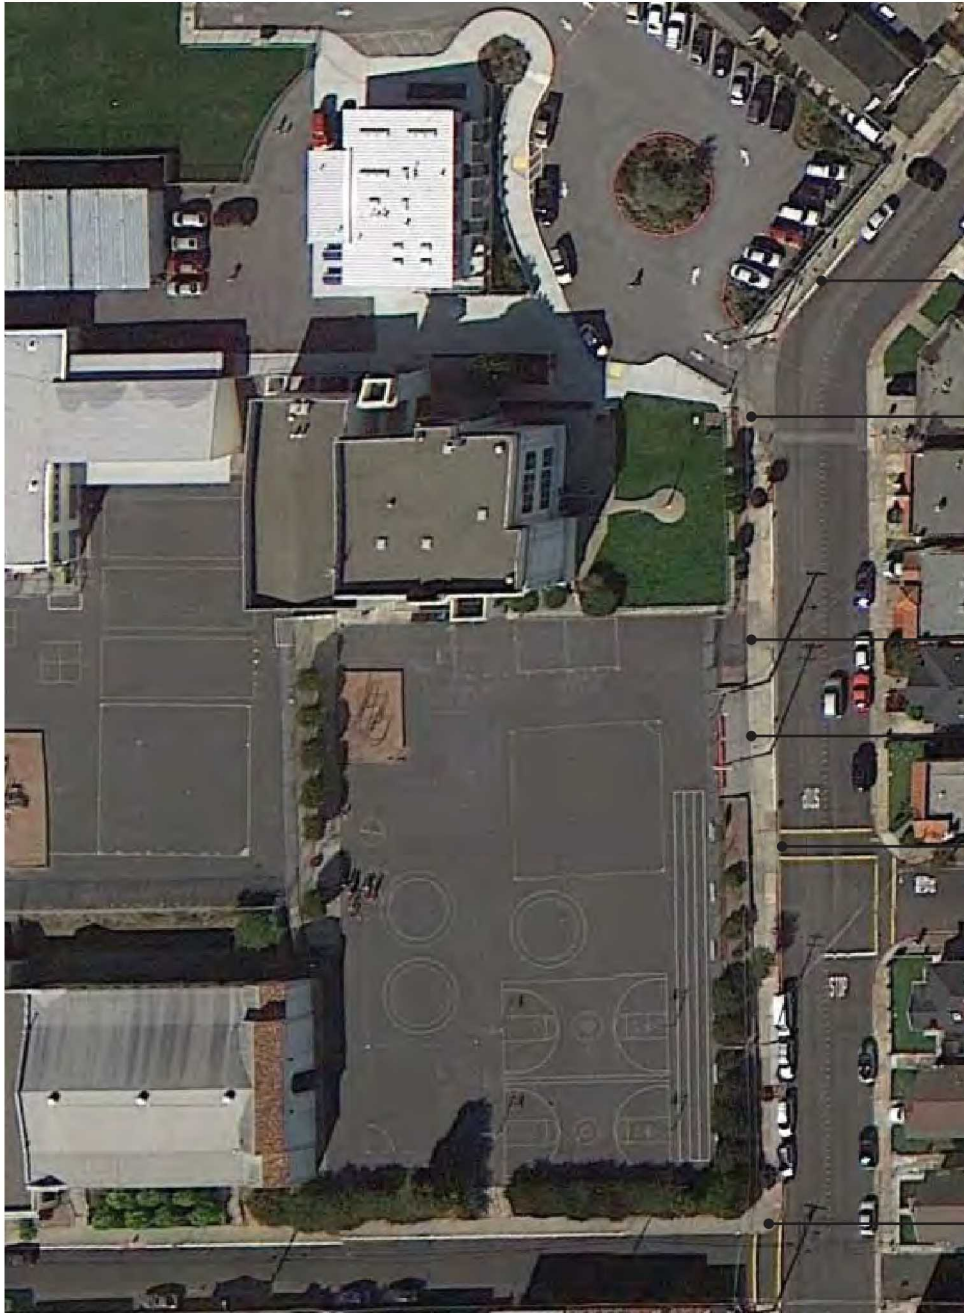
Spruce Gymnasium and Portable

3 - 1 Curb Ramp		Priority: 1
Install, replace or modify curb ramp		\$2,500
Notes:	Running slope is 10%. (8.33% max.) Flared sides have slopes 11.1% and 15.1%. (10% max.)	
State:	1127B.5.3, 1127B.5.4	
Federal:	406.3	
Provide detectable warning strip		\$0
Notes:	No detectable warning provided.	
State:	1127B.5.7, IR11B-4	
Federal:	-	
Repair surface		\$0
Notes:	.5" lip at bottom of ramp.	
State:	1127B.5.3	
Federal:	405.4	
Provide level landing		\$0
Notes:	Level landing at top of ramp is 4.2% (2% max.) 6.9% gutter slope, no level landing provided at bottom of ramp. (5% max.)	
State:	1127B.5.3, 1127B.5.4	
Federal:	406.2	
Provide surface texturing		\$0
Notes:	Grooved border not provided on all sides of curb ramp.	
State:	1127B.5.6	
Federal:	-	
3 - 2 Curb Ramp		Priority: 1
Provide or relocate crossing or curb markings		\$2,500
Notes:	No curb ramp provided at marked pedestrian crossing.	
State:	1127B.5	
Federal:	406.1	
4 - 1 Walk		Priority: 1

Provide detectable warning strip		\$1,000
Notes:	No detectable warning provided.	
State:	1133B.8.5	
Federal:	-	
Repair surface		\$250
Notes:	1.5" change in level at concrete/asphalt joint.	
State:	1124B.2	
Federal:	303.2, 303.3

4 - 2	Walk	Priority: 1	
Provide detectable warning strip			\$1,000
Notes: No detectable warning provided.			
State: 1133B.8.5			
Federal: -			
4 - 3	Walk	Priority: 1	
Repair surface			\$920
Notes: Deteriorated concrete surface at drive, 23 lf.			
State: 1124B.2			
Federal: 303.2, 303.3			
4 - 4	Walk	Priority: 1	
Regrade surface			\$7,600
Notes: 2.3%-4.7% cross slope for 190 lf. (2% max.)			
State: 1133B.7.1.3			
Federal: 403.3

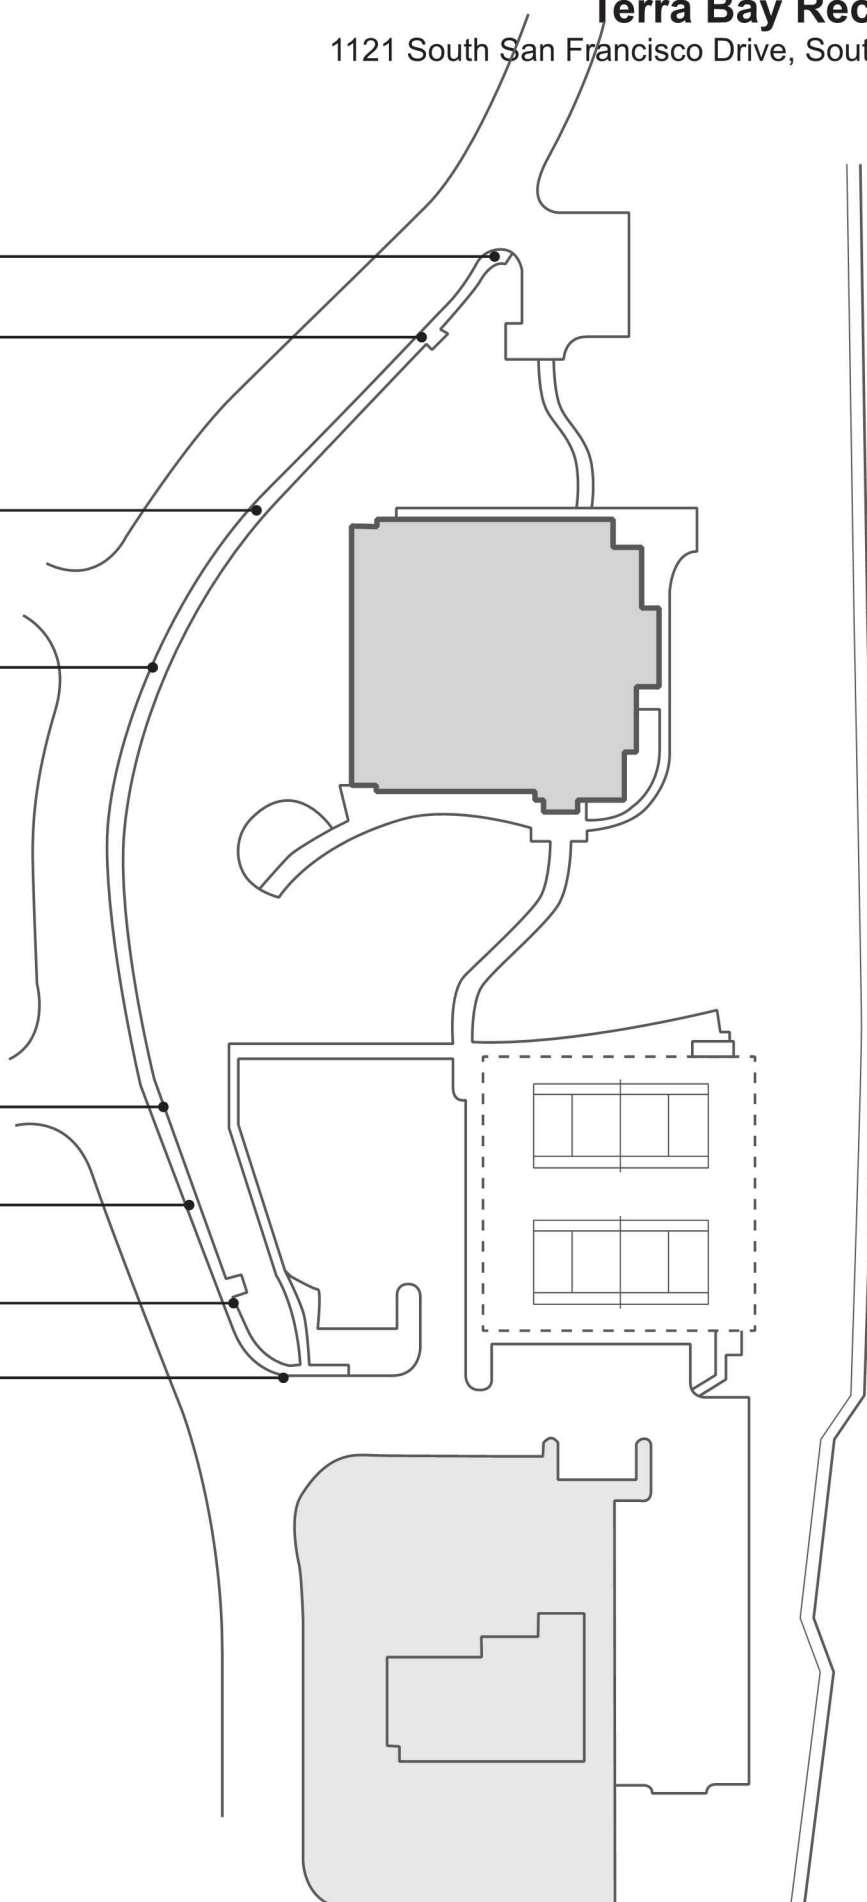
Terra Bay Recreation Center - PROW

3 - 1 Curb Ramp		Priority: 1
Provide detectable warning strip		\$1,000
Notes:	No detectable warning provided.	
State:	1127B.5.7, IR11B-4	
Federal:	-	
Repair surface		\$250
Notes:	.5" lip at bottom of ramp.	
State:	1127B.5.3	
Federal:	405.4	
3 - 2 Curb Ramp		Priority: 1
Provide detectable warning strip		\$0
Notes:	No detectable warning provided.	
State:	1127B.5.7, IR11B-4	
Federal:	-	
Install, replace or modify curb ramp		\$2,500
Notes:	Running slope on one run of a parallel ramp is 14.6%. (8.33% max.)	
State:	1127B.5.3, 1127B.5.4	
Federal:	406.3	
3 - 3 Curb Ramp		Priority: 1
Provide detectable warning strip		\$0
Notes:	No detectable warning provided.	
State:	1127B.5.7, IR11B-4	
Federal:	-	
Install, replace or modify curb ramp		\$2,500
Notes:	Running slope on one run of a parallel ramp is 9%. (8.33% max.)	
State:	1127B.5.3, 1127B.5.4	
Federal:	406.3

3 - 4	Curb Ramp	Priority: 1	
	Provide detectable warning strip		\$0
	Notes: No detectable warning provided.		
	State: 1127B.5.7, IR11B-4		
	Federal: -		
	Install, replace or modify curb ramp		\$2,500
	Notes: Running slope is up to 19%. (8.33% max.)		
	State: 1127B.5.3, 1127B.5.4		
	Federal: 406.3		
	Repair surface		\$0
	Notes: .5" lip at bottom of ramp.		
	State: 1127B.5.3		
	Federal: 405.4		
4 - 1	Walk	Priority: 1	
	Widen walk		\$2,250
	Notes: Walk is 42" wide, 550 lf. (48" min. from back of curb)		
	State: 1133B.7.1		
	Federal: -		
4 - 2	Walk	Priority: 1	
	Repair surface		\$560
	Notes: Four cracked concrete flags, 14 lf.		
	State: 1124B.2		
	Federal: 303.2, 303.3		
4 - 3	Walk	Priority: 1	
	Repair surface		\$280
	Notes: Two cracked concrete flags, 7 lf.		
	State: 1124B.2		
	Federal: 303.2, 303.3		
4 - 4	Walk	Priority: 1	
	Repair surface		\$500
	Notes: Cracked, deteriorated concrete at utility vault.		
	State: 1124B.2

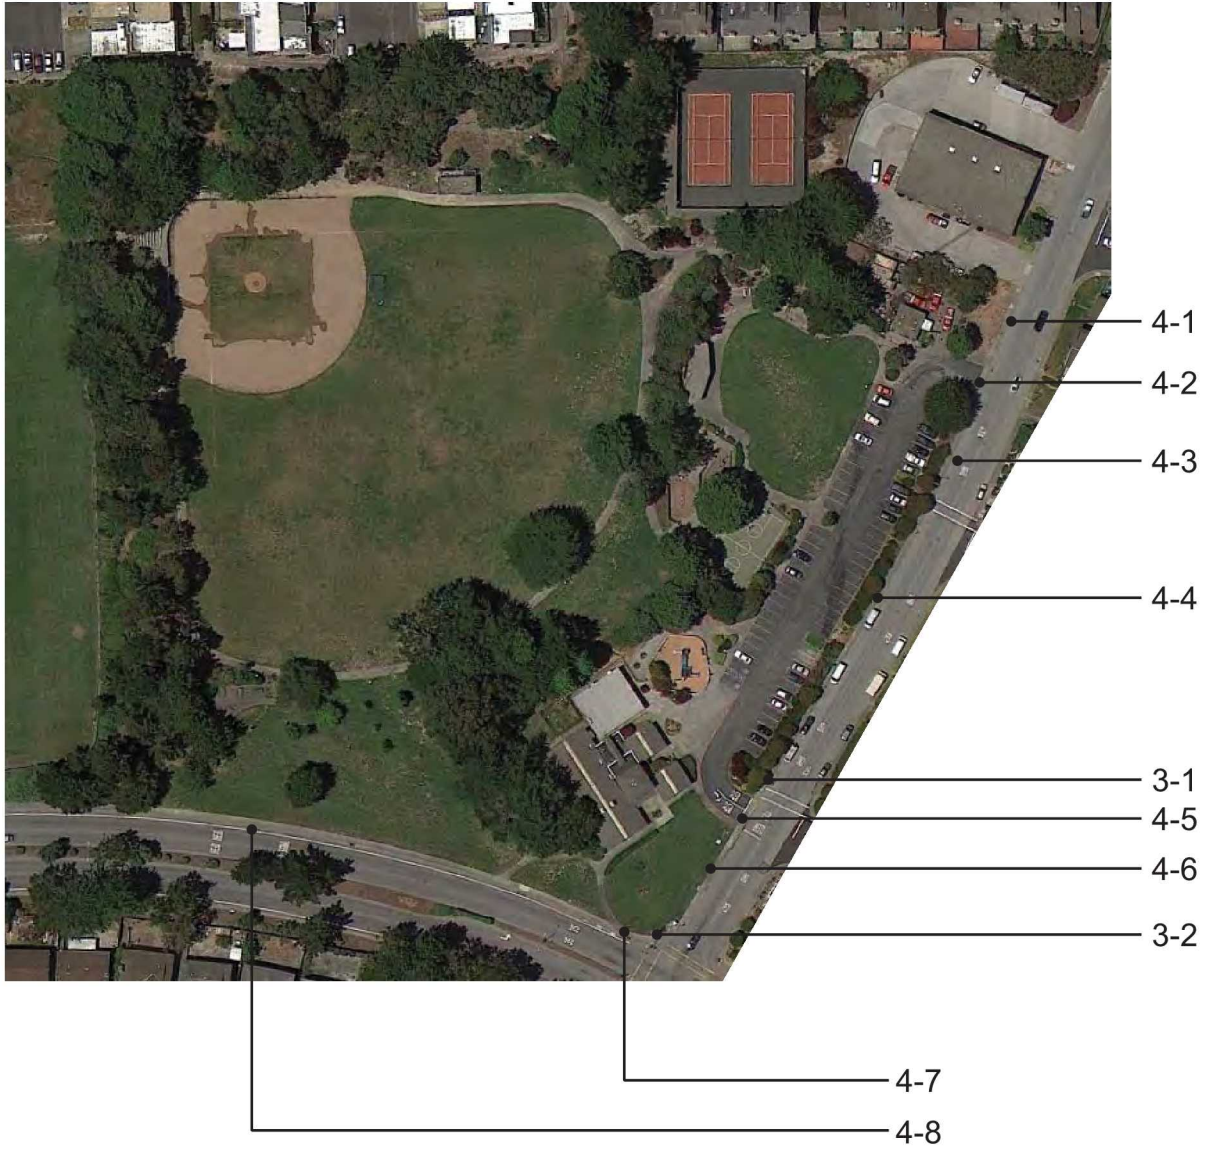
Westborough Park

3 - 1	Curb Ramp	Priority: 1	
	Provide or relocate crossing or curb markings		\$2,500
	Notes: No curb ramp provided at marked pedestrian crossing.		
	State: 1127B.5		
	Federal: 406.1		
3 - 2	Curb Ramp	Priority: 1	
	Provide or relocate crossing or curb markings		\$2,500
	Notes: No curb ramp provided at marked pedestrian crossing.		
	State: 1127B.5		
	Federal: 406.1		
4 - 1	Walk	Priority: 1	
	Regrade surface		\$1,240
	Notes: 2.1%-2.8% cross slope for 56 lf. (2% max.)		
	State: 1133B.7.1.3		
	Federal: 403.3		
	Repair surface		\$250
	Notes: .5" change in level at utility vault cover.		
	State: 1124B.2		
	Federal: 303.2, 303.3		
4 - 2	Walk	Priority: 1	
	Regrade surface		\$1,080
	Notes: 11% cross slope across drive for 27 lf. (2% max.)		
	State: 1133B.7.1.3		
	Federal: 403.3		
4 - 3	Walk	Priority: 1	
	Regrade surface		\$560
	Notes: 2.6%-3.0% cross slope at tree for 14 lf. (2% max.)		
	State: 1133B.7.1.3		
	Federal: 403.3
