CITY OF SOUTH SAN FRANCISCO

AMERICANS WITH DISABILITIES ACT self evaluation and transition plan

APPENDICES

Appendix D: Pedestrian Rights-of-Way Reports and Maps

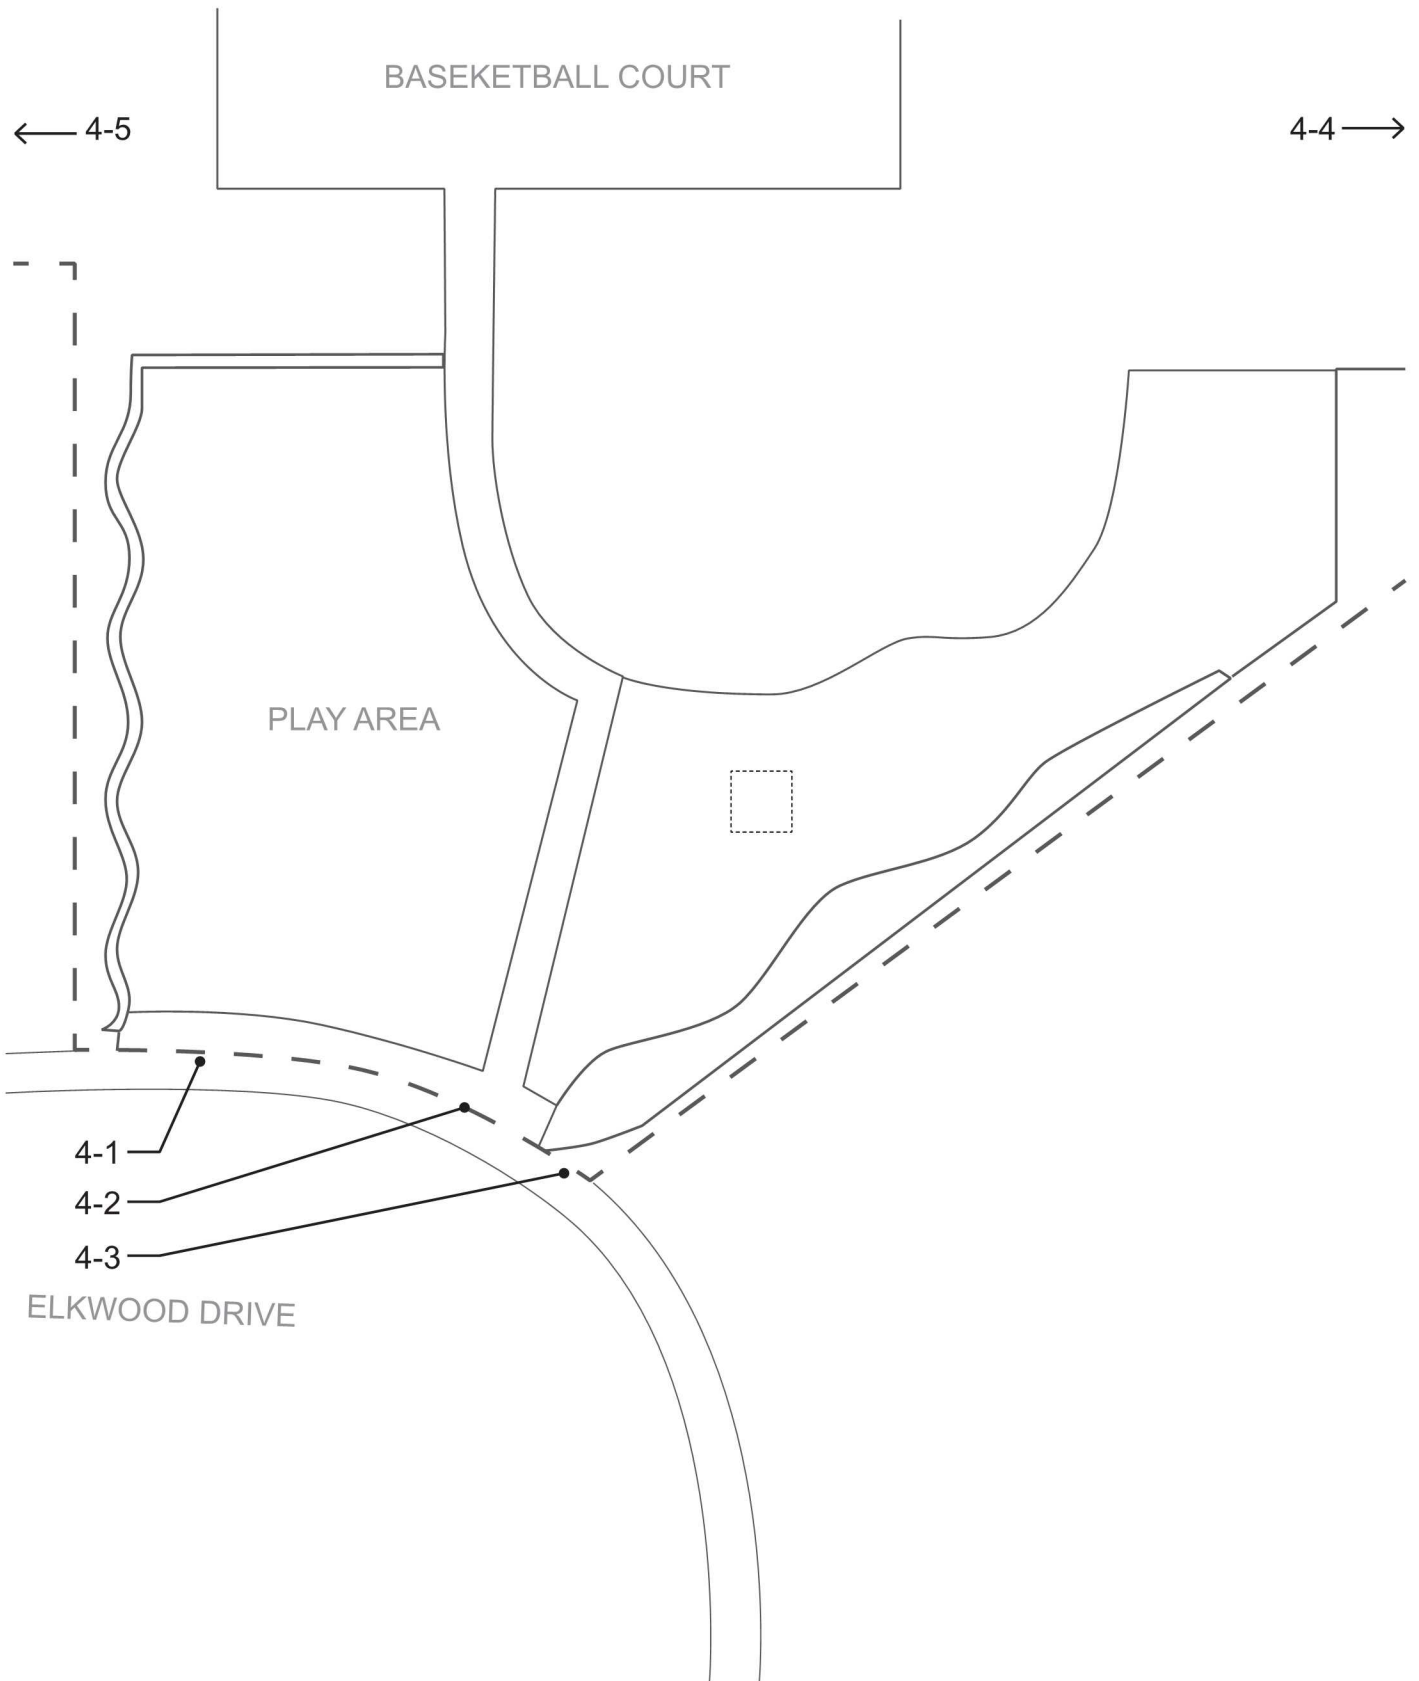
Winston Manor - Elkwood Park

4 - 1	Walk	Priority: 1	
Regrade surface			\$800
Notes: 2.1%-3.5% cross slope for 20 lf. (2% max.)			
State: 1133B.7.1.3			
Federal: 403.3			
4 - 2	Walk	Priority: 1	
Repair surface			\$240
Notes: Deteriorated concrete at joint, 8 lf.			
State: 1124B.2			
Federal: 303.2, 303.3			
4 - 3	Walk	Priority: 1	
Regrade surface			\$240
Notes: 2.1%-2.2% cross slope near entrance for 8 lf. (2% max.)			
State: 1133B.7.1.3			
Federal: 403.3			
4 - 4	Walk	Priority: 1	
Regrade surface			\$240
Notes: 2.1%-3.8% cross slope at crosswalk for 8 lf. (2% max.)			
State: 1133B.7.1.3			
Federal: 403.3			
4 - 5	Walk	Priority: 1	
Regrade surface			\$2,880
Notes: 2.1%-4.5% cross slope for 72 lf. (2% max.)			
State: 1133B.7.1.3			
Federal: 403.3

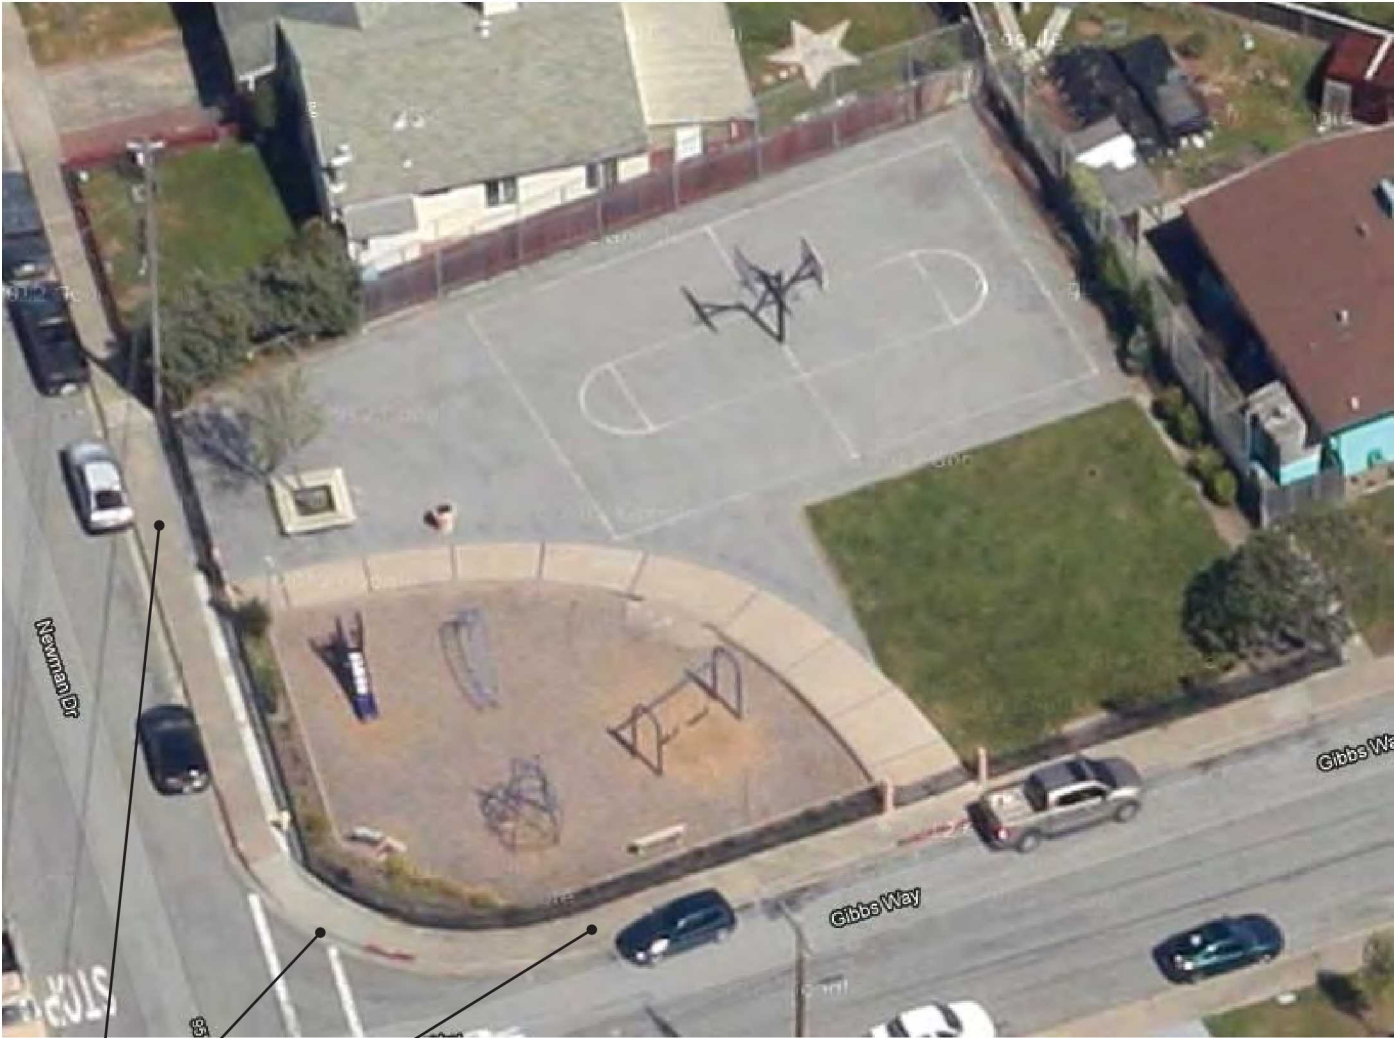
Winston Manor - Newman & Gibbs Park

3 - 1		Curb Ramp	Priority: 1
Install, replace or modify curb ramp			\$2,500
Notes: Running slope is 14.3%. (8.33% max.)			
State: 1127B.5.3			
Federal: 405.2			
Provide detectable warning strip			\$0
Notes: No detectable warning provided.			
State: 1127B.5.7, IR11B-4			
Federal: -			
Provide level landing			\$0
Notes: 8.2% gutter slope, no level landing provided at bottom of ramp. (5% max.)			
State: 1127B.5.3			
Federal: 406.2			
4 - 1		Walk	Priority: 1
Regrade surface			\$1,200
Notes: 2.1%-2.8% cross slope for 30 lf. (2% max.)			
State: 1133B.7.1.3			
Federal: 403.3			
4 - 2		Walk	Priority: 1
Regrade surface			\$3,840
Notes: 2.1%-3.8% cross slope for 96 lf. (2% max.)			
State: 1133B.7.1.3			
Federal: 403.3

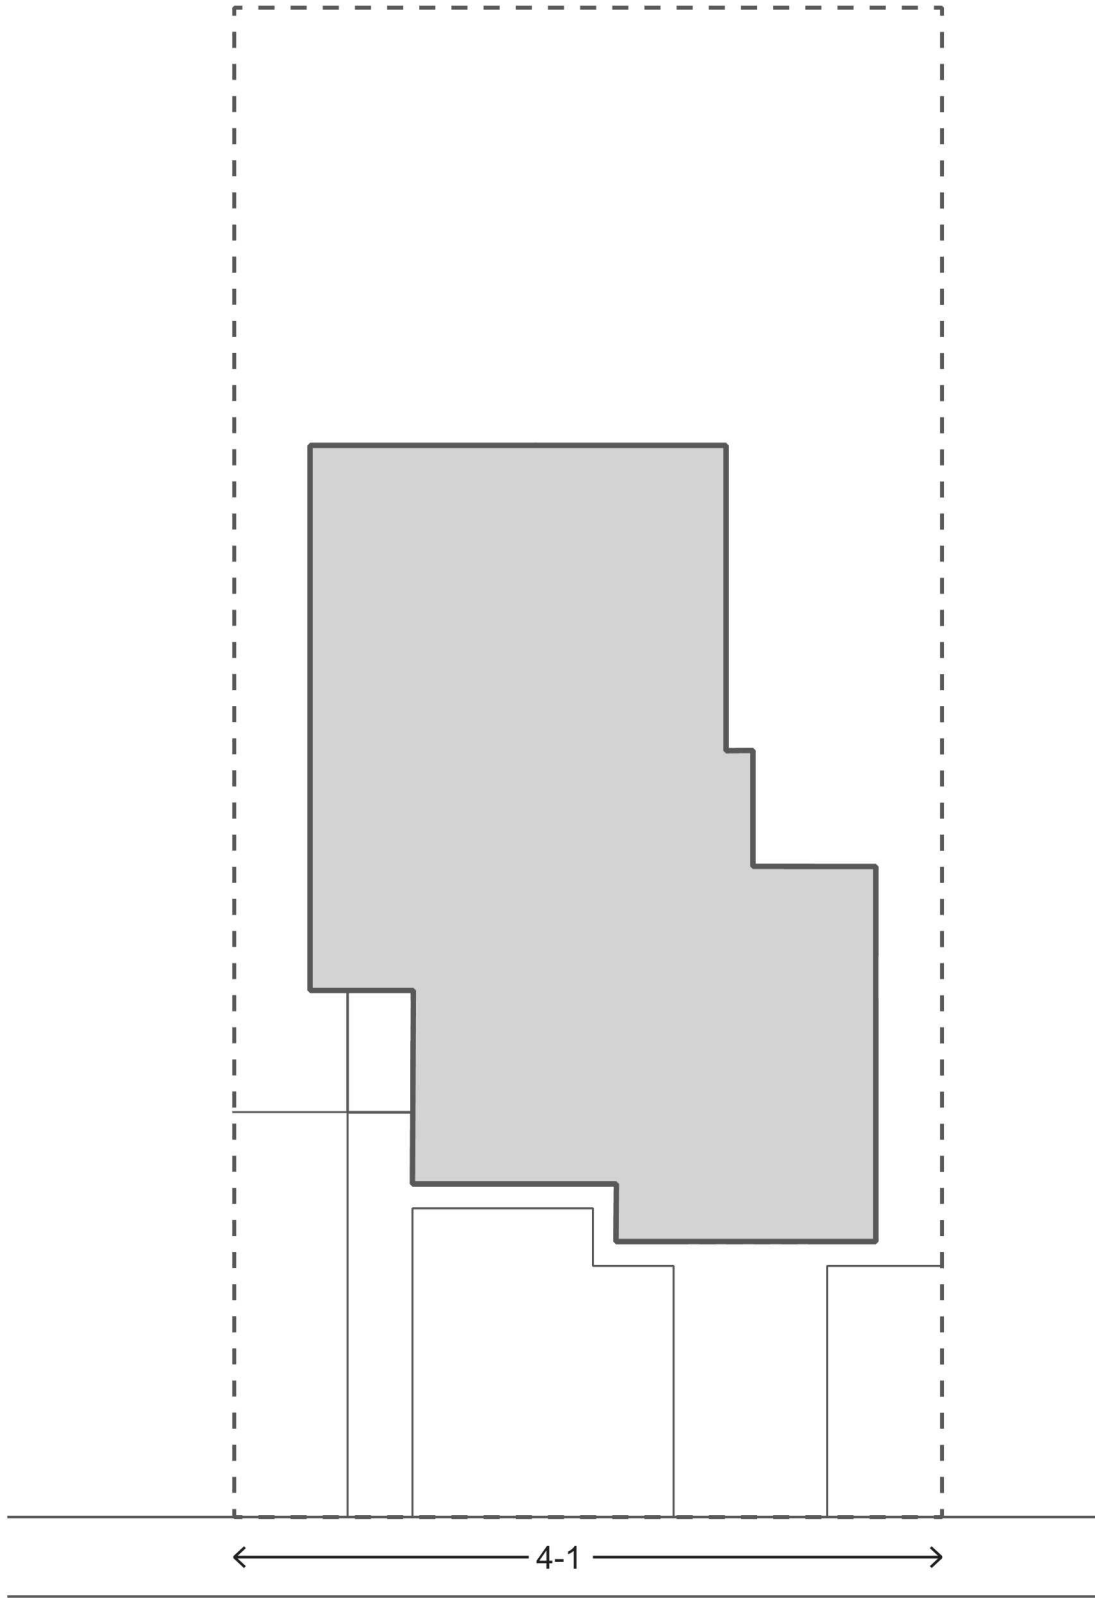
X-Ray House

4 - 1	Walk	Priority: 1
Regrade surface		\$1,800
Notes: 2.1%-3.7% cross slope for 45 lf. (2% max.)		
State: 1133B.7.1.3		
Federal: 403.3
